**INDIGENOUS TREE REPORT
FOR
RESIDENTIAL VACANT LAND**

**ARCH PLACE
GLENDALE, CA 91206
(APN:5666-004-019)**

January 23, 2023

Arsen Margossian, MSc., Consulting Arborist
Bardez Landscape Services, Inc.

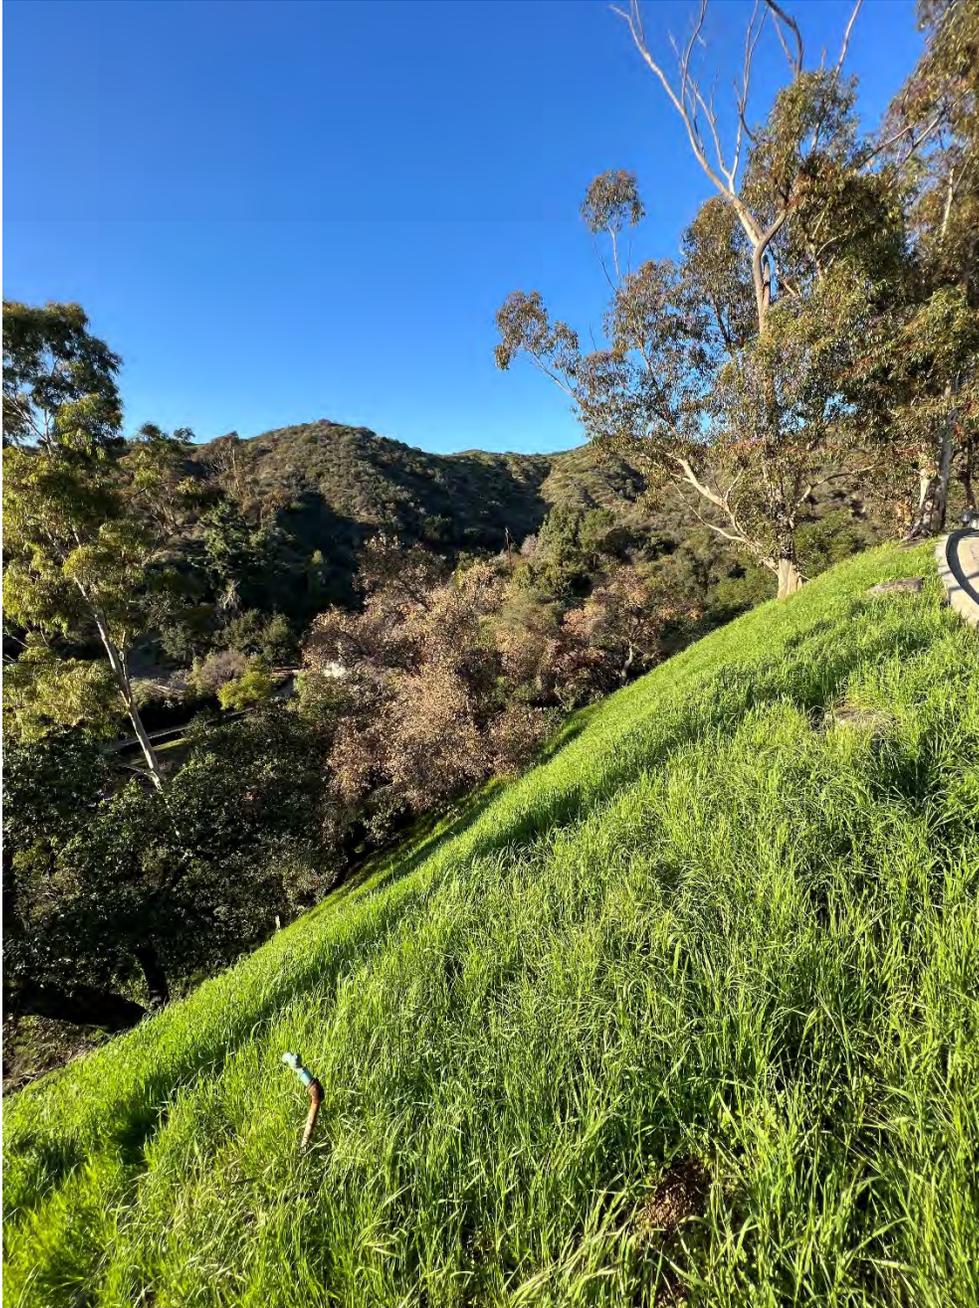
View of the property from the south side.
(This and the following photographs were taken on January 20, 2023.)

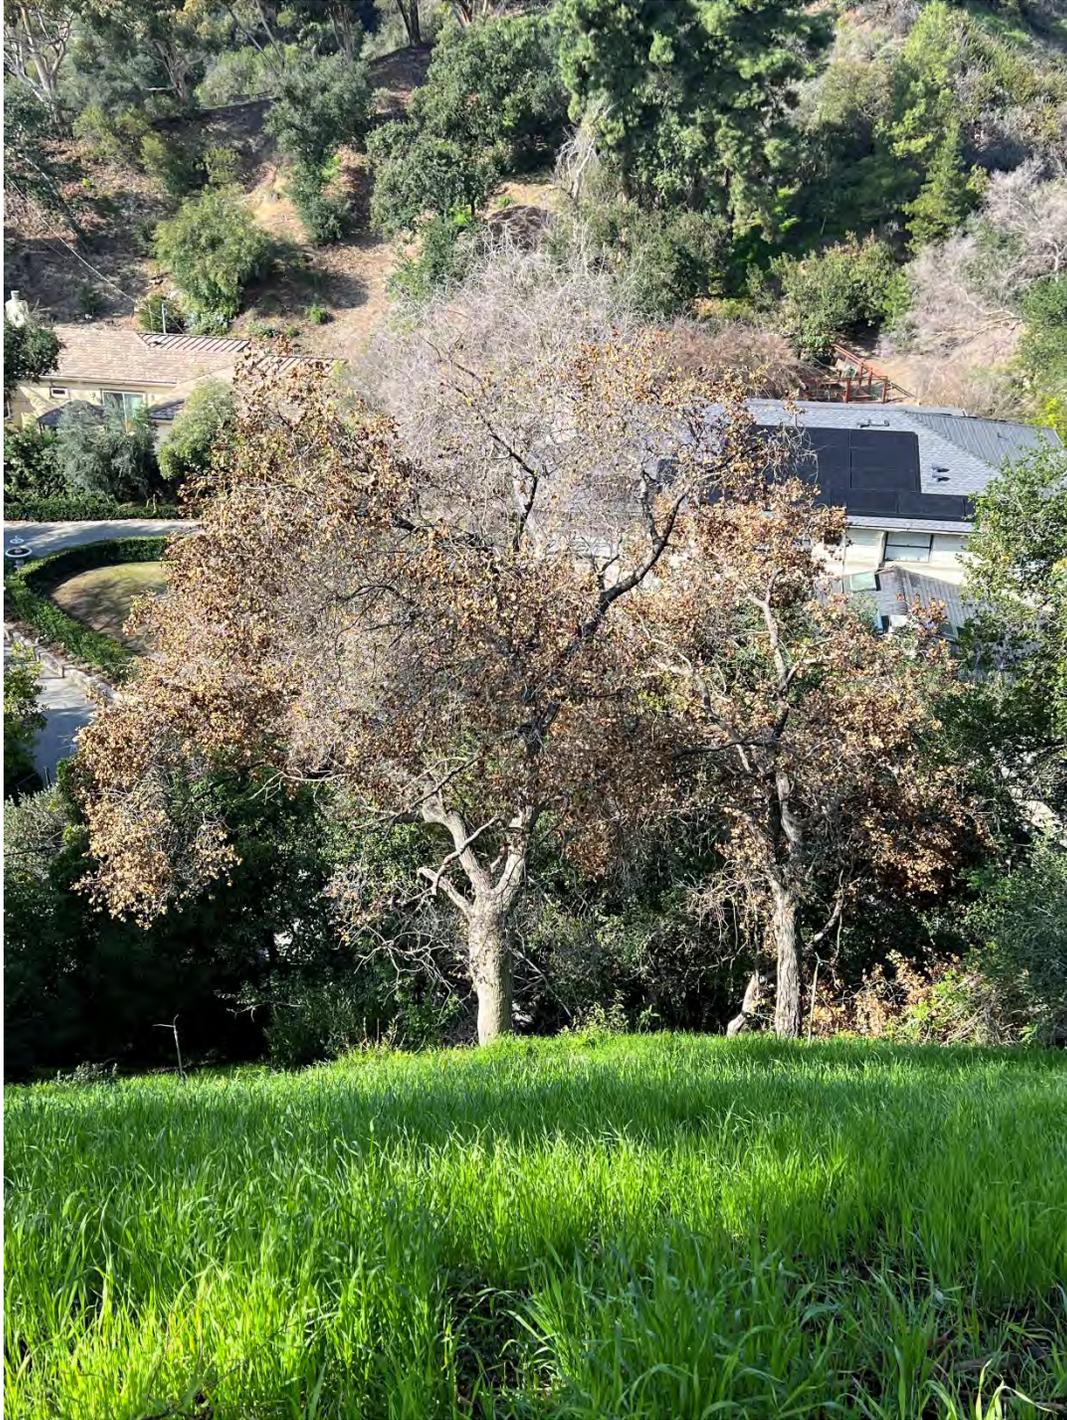
This California Live oak tree is located toward the northeast side of the property. It has two stems, one with 10 inch and the other with 15 inch DBH. The combined DBH of this tree is 18 inches.

The height of the tree **crown** is about 20 feet, and the canopy spread is of 27 feet. The stem with 15 -inch DBH has a major columnar **decay cavity**. This and boring beetle holes are the reasons why this tree has died.

View of Tree #1 (in the front) and Tree #2 (in the rear) seen from the street.

This tree is far from the construction footprint and it could be removed or retained for wildlife habitat.

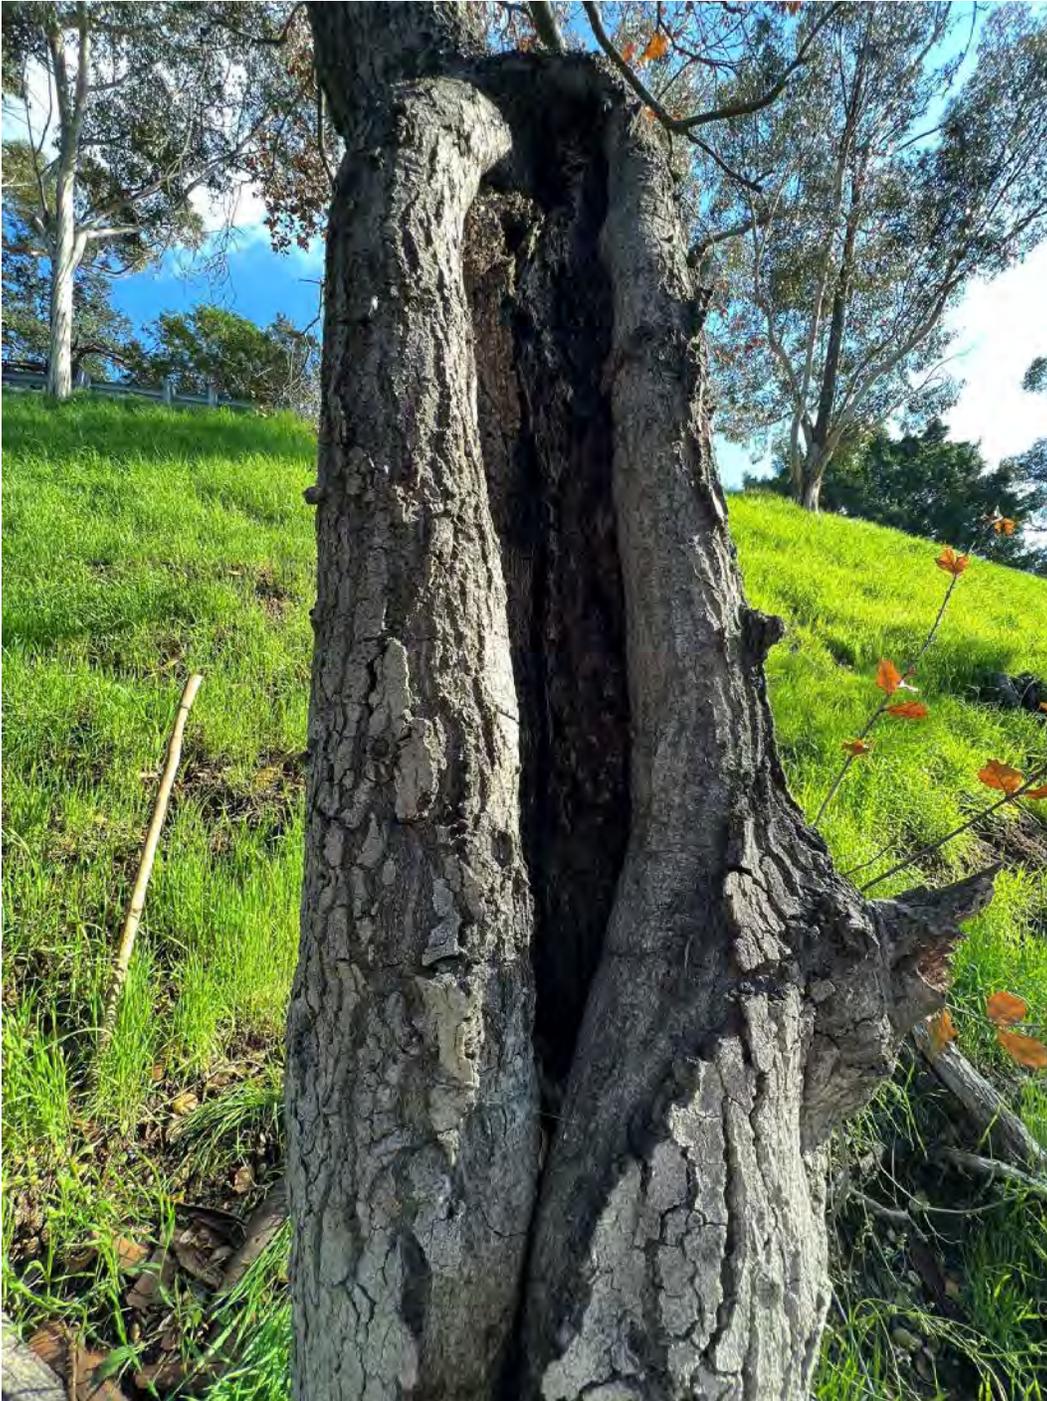
Decay column on Tree #1.

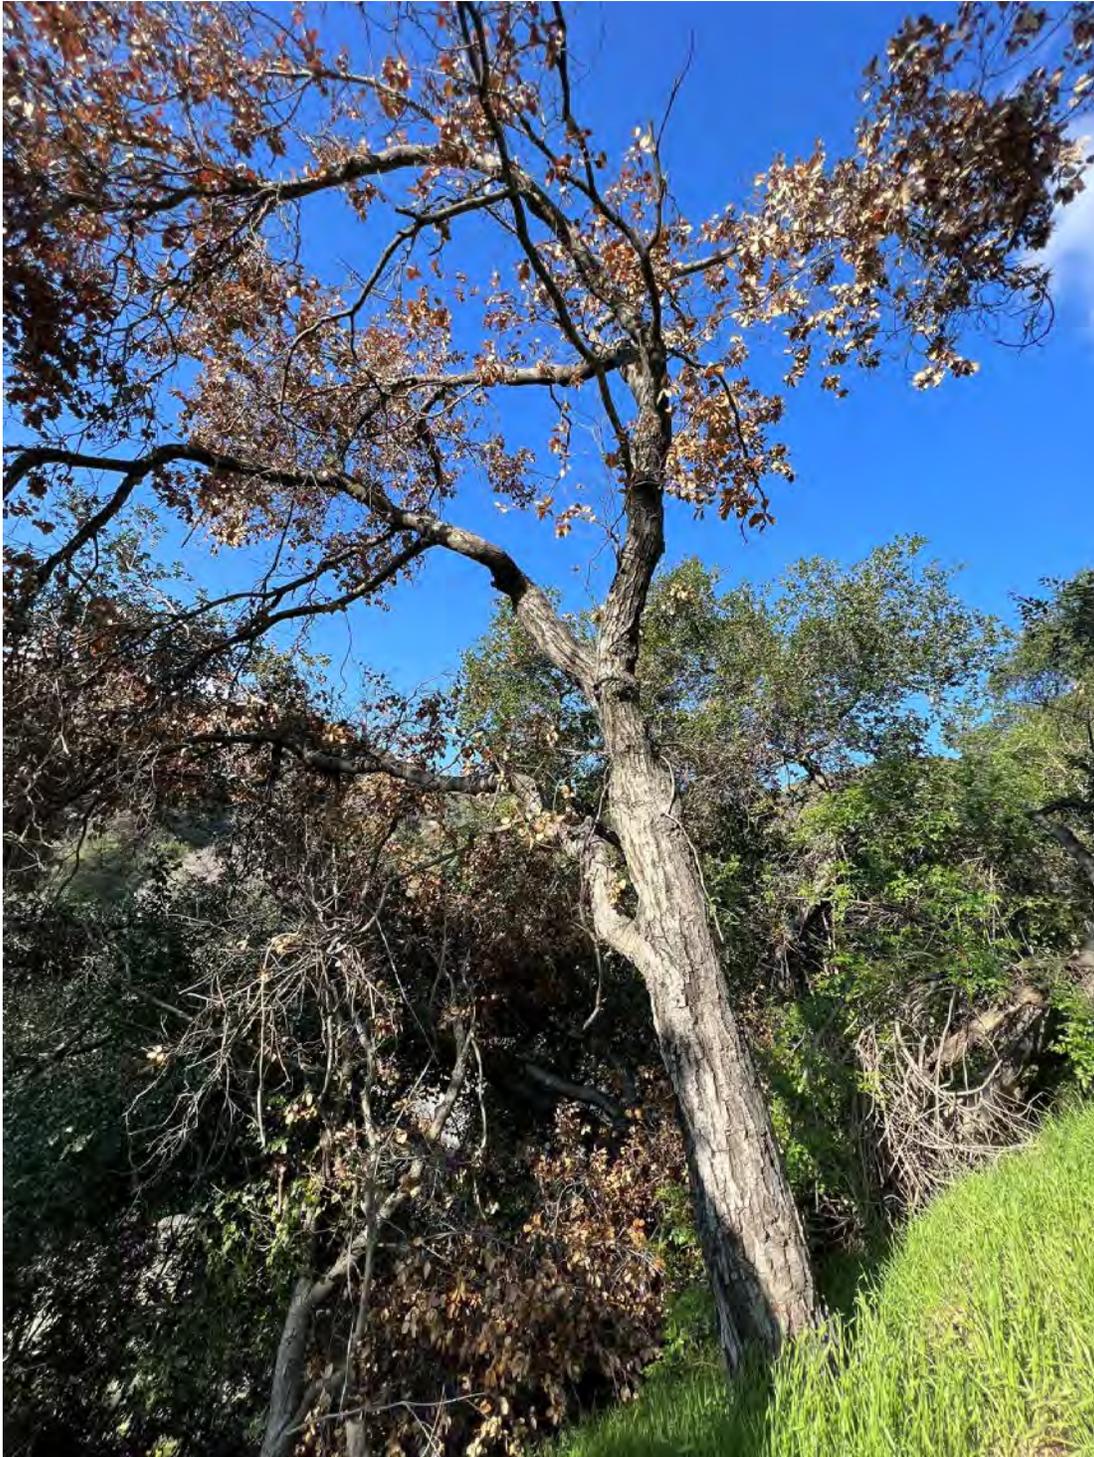
Tree #2.

This is a smaller California Live oak tree, located some 12 feet northeast of Tree #1.

The trunk has a DBH of 11 inches, and the overall tree height is about 15 feet. The overall canopy spread is about 20 feet. This tree also is completely dead; boring beetle holes on the **bark** are an indication of the possible cause. This tree also is far from the construction footprint and it could be removed or retained for wildlife habitat.

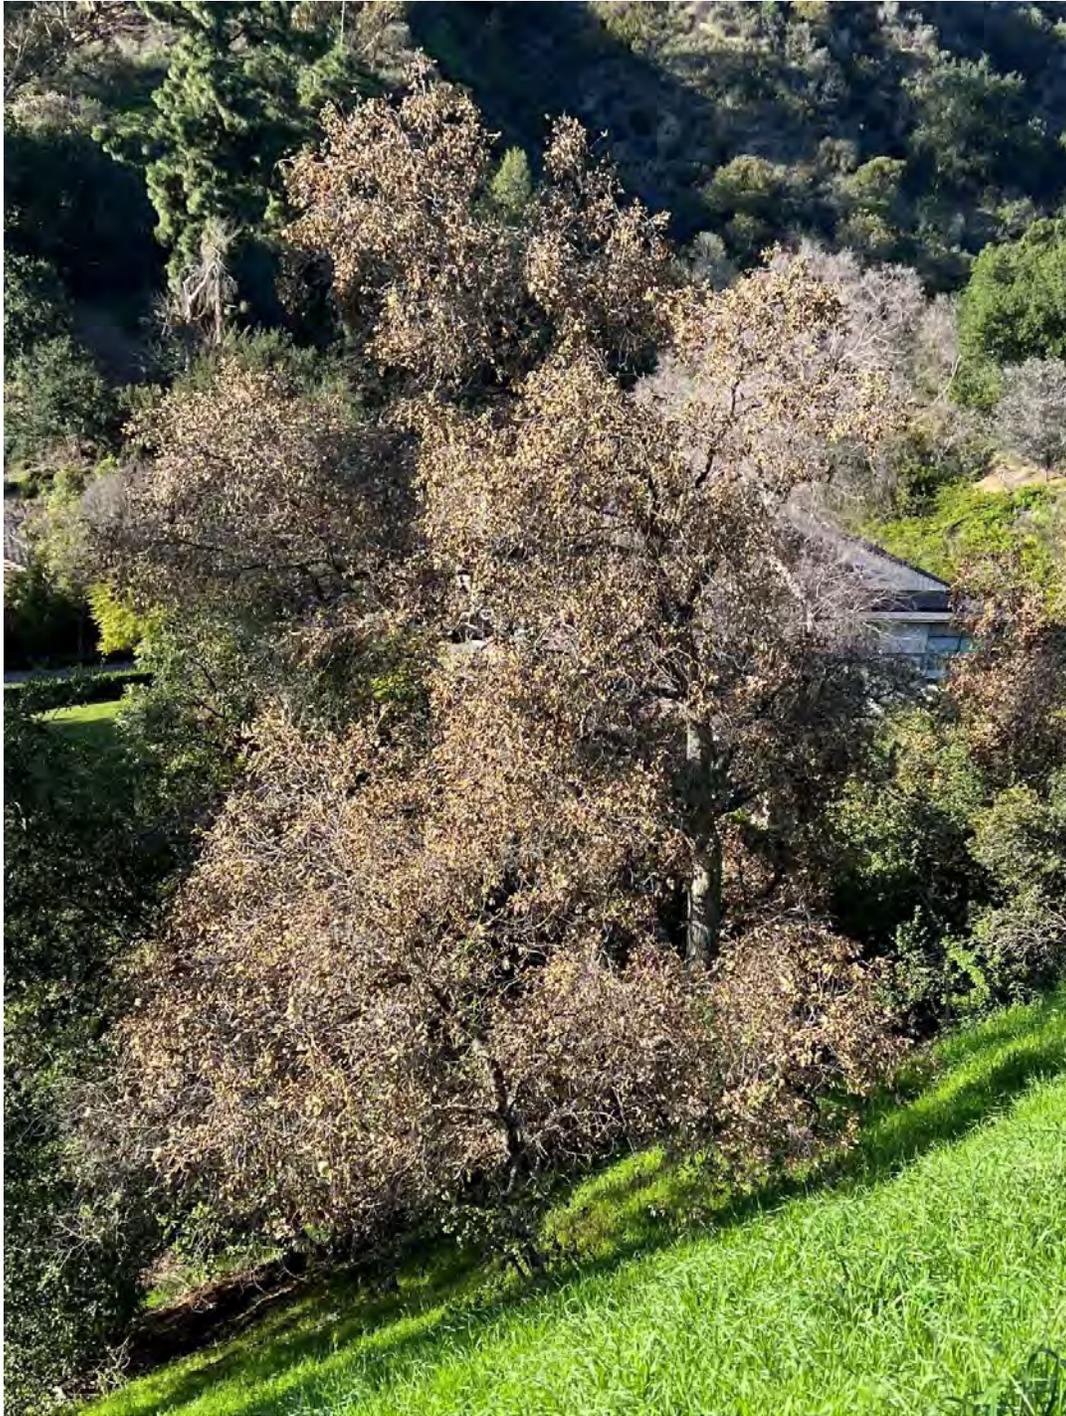
Tree #3.

Another mature California Live oak tree, located midway on the property. The main trunk divides to two stems, respectively with 14 and 15 inch DBH, and a combined DBH of 20.5 inches. This tree has a substantial size crown, with an overall height of 25 feet and about 50 feet canopy spread. This tree also is completely dead; probably boring beetles being the culprit. This tree should be removed, because it is in conflict with the proposed dwelling.

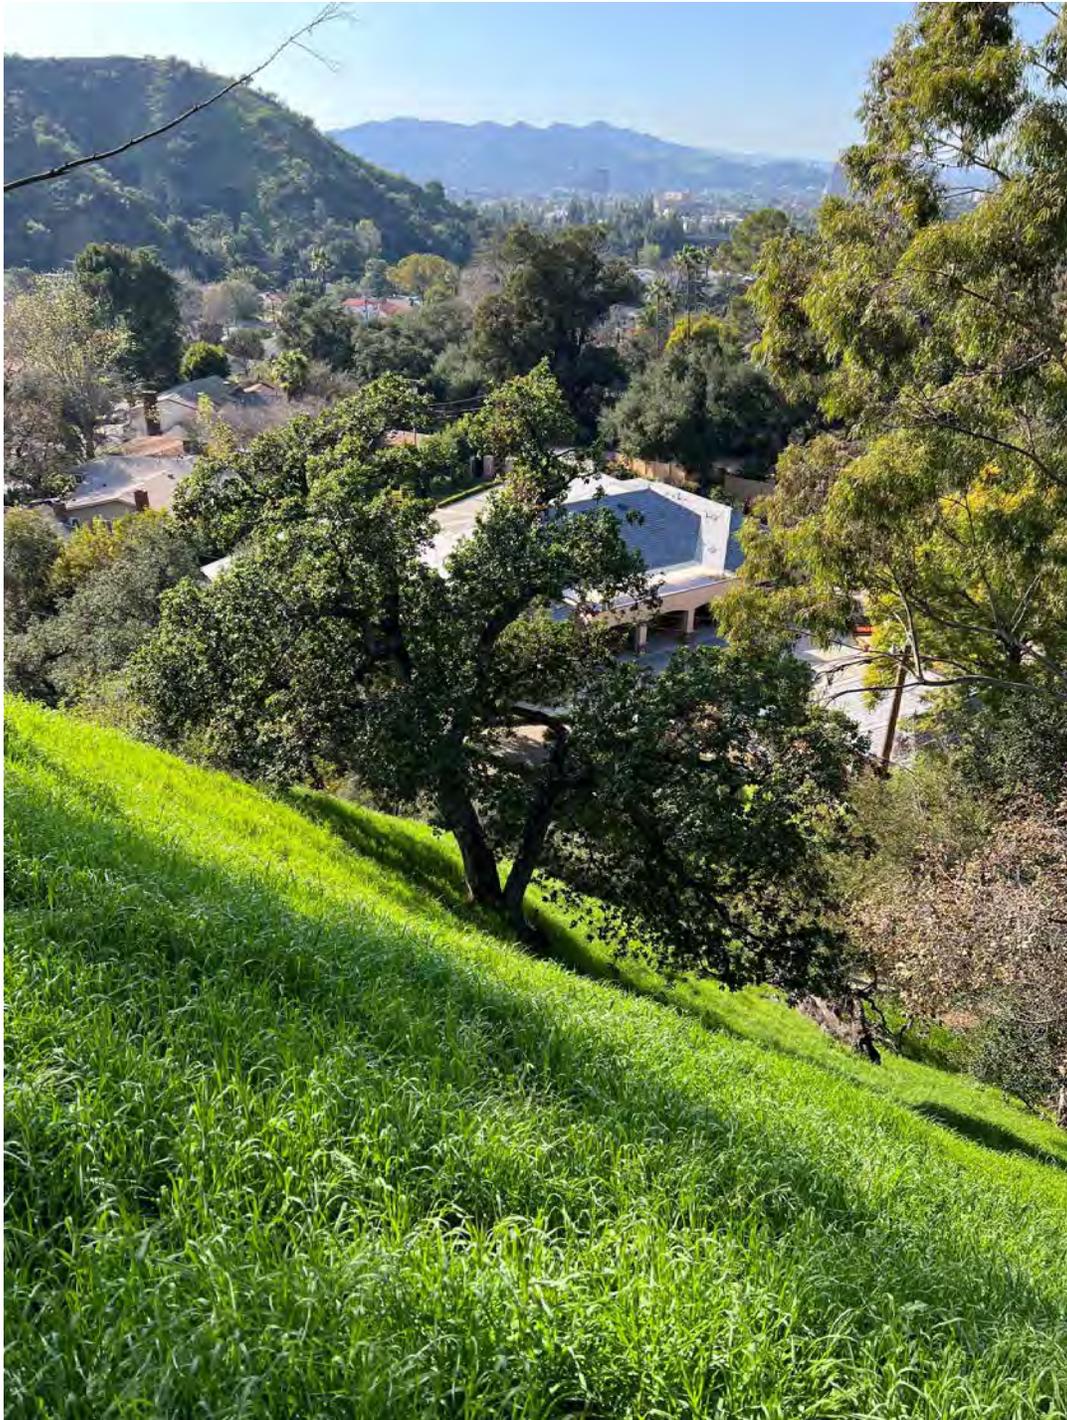
This is the only live indigenous tree that was surveyed. Two stems emerge from the main trunk flare, and they respectively have 11 and 19 inches DBH. The combined DBH is 22 inches. The height of the crown is about 20 feet. Crown density is acceptable, and **foliage** looks healthy with no signs of disease. There is no **included bark** at the **crotch** of the main stems and **scaffold branches**, an indication that the union is strong and not prone to failure. There are some decay cavities on the smaller main stem. The overall **vigor** of this tree is acceptable. On a 0 to 5 scale (0 being dead and 5 being excellent), the **condition rating** for this tree is 3 (Average). This tree is in conflict with the proposed dwelling; therefore, it should be removed.

Other than already dead three indigenous oak trees, there is an additional live one (Tree #4), which because of its location, is in conflict with the possible design. Accordingly, this tree must be removed and mitigation trees can be planted on site.

As mentioned earlier, other than the four indigenous oak trees, there are others too toward the lowest grades of the property. Because of the property's topography, and to be able to reasonably develop the land, removal of Tree #4 is necessitated. And because the major portion of the land cannot be used, mitigation trees can be planted, to compensate for the loss of Tree #4.

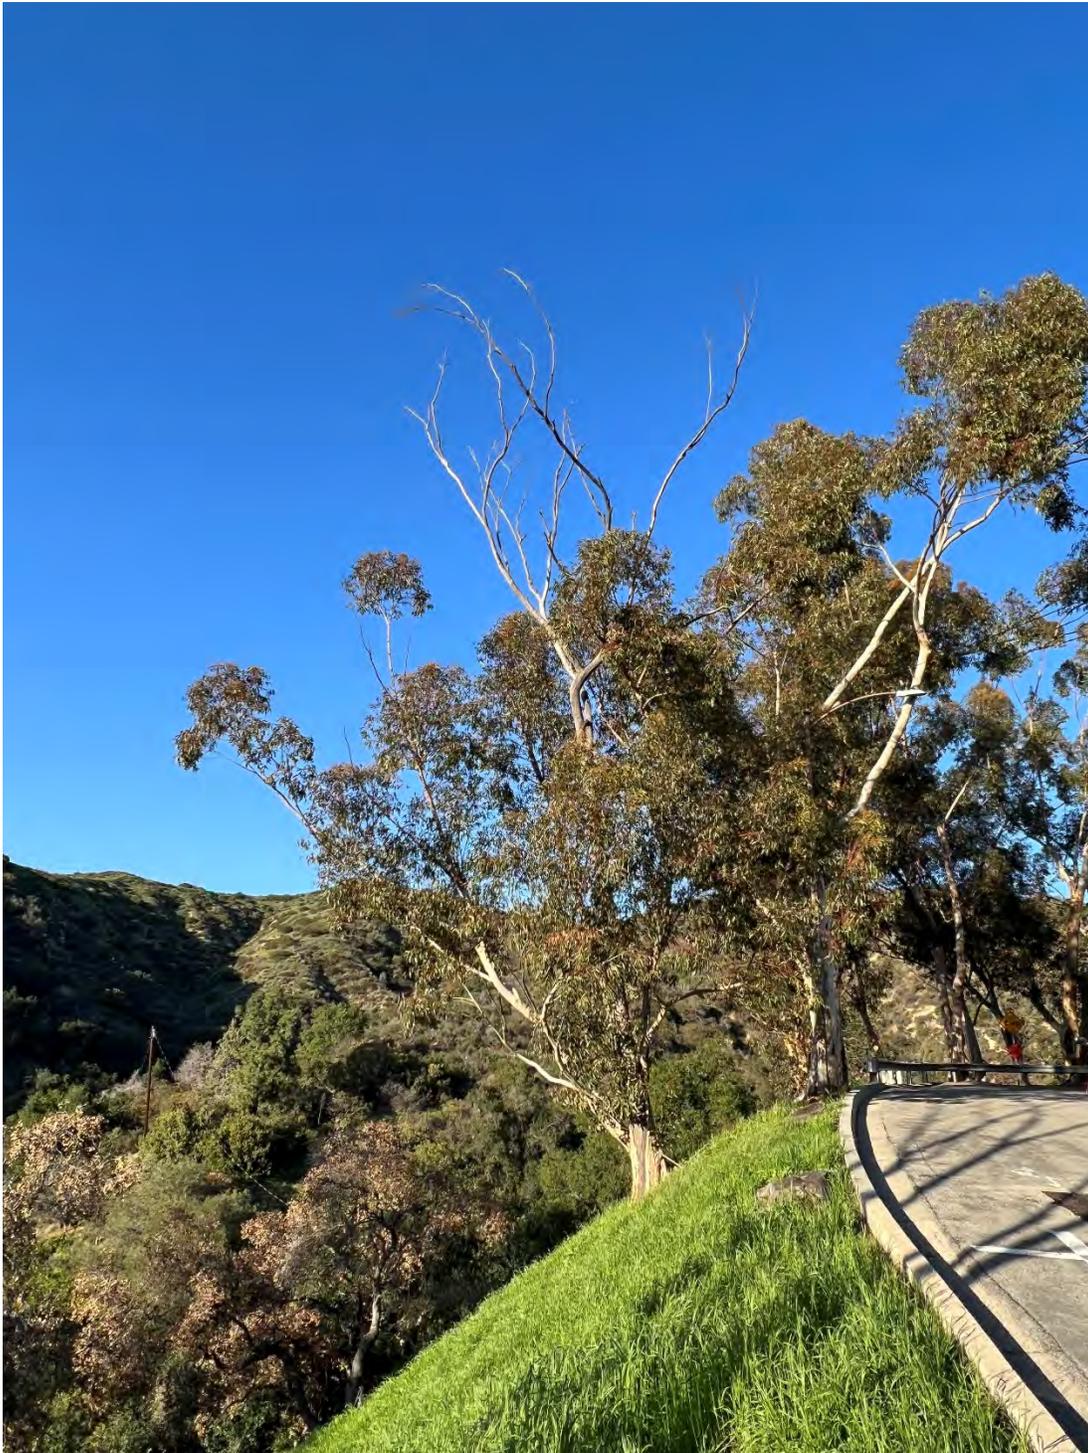
As indicated earlier, other than the four indigenous oak trees on site, there are also two Gum trees. One of them is completely dead, and stumps of other Gum trees in that vicinity indicate that other Gum trees have been removed from the site. This Gum tree is identified as G1 in the tree inventory and the site plan.

Other live Gum trees are also found toward the north side, these are identified as G2, G3, G4 and G5, and they actually are outside the property lines, and eventually could be removed because of future street improvements. The characteristics of these five trees are included in the tree inventory.

The Gum trees seen from the south side.

The only tree that must be protected during the construction activities, is Tree G2, one of the Gum trees that is close to the northeast corner of the proposed house. Because it is a City of Glendale street tree, Urban Forestry will decide to have it removed for the future sidewalk, or the best plan for its preservation.
