**INDIGENOUS TREE REPORT  
FOR  
RESIDENTIAL VACANT LAND**

**ARCH PLACE  
GLENDALE, CA 91206  
(APN:5666-004-019)**

January 23, 2023

**Arsen Margossian, MSc., Consulting Arborist**  
**Bardez Landscape Services, Inc.**

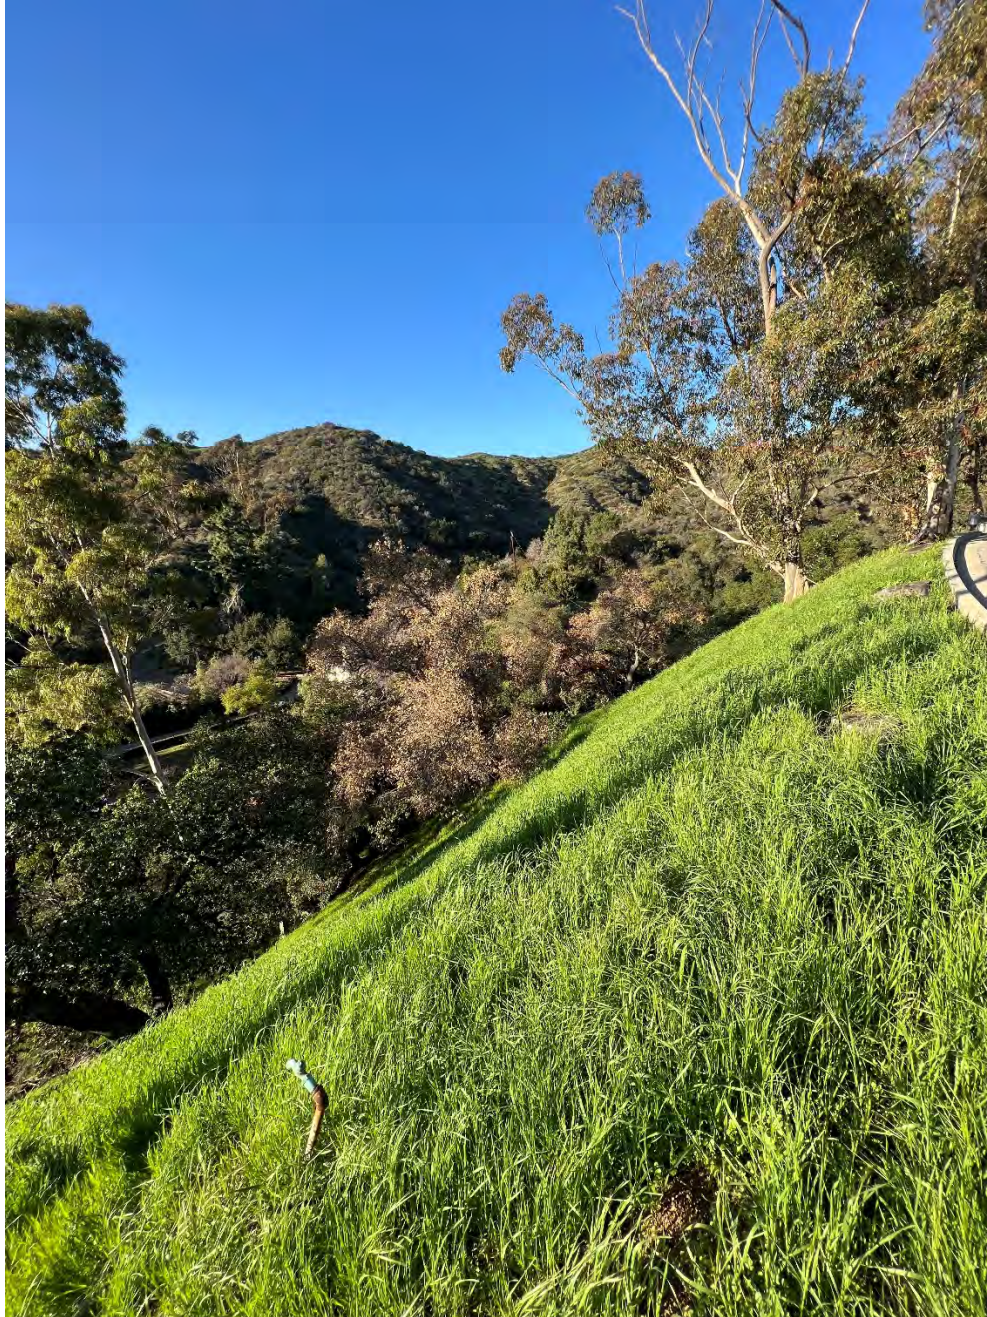
**View of the property from the south side.**

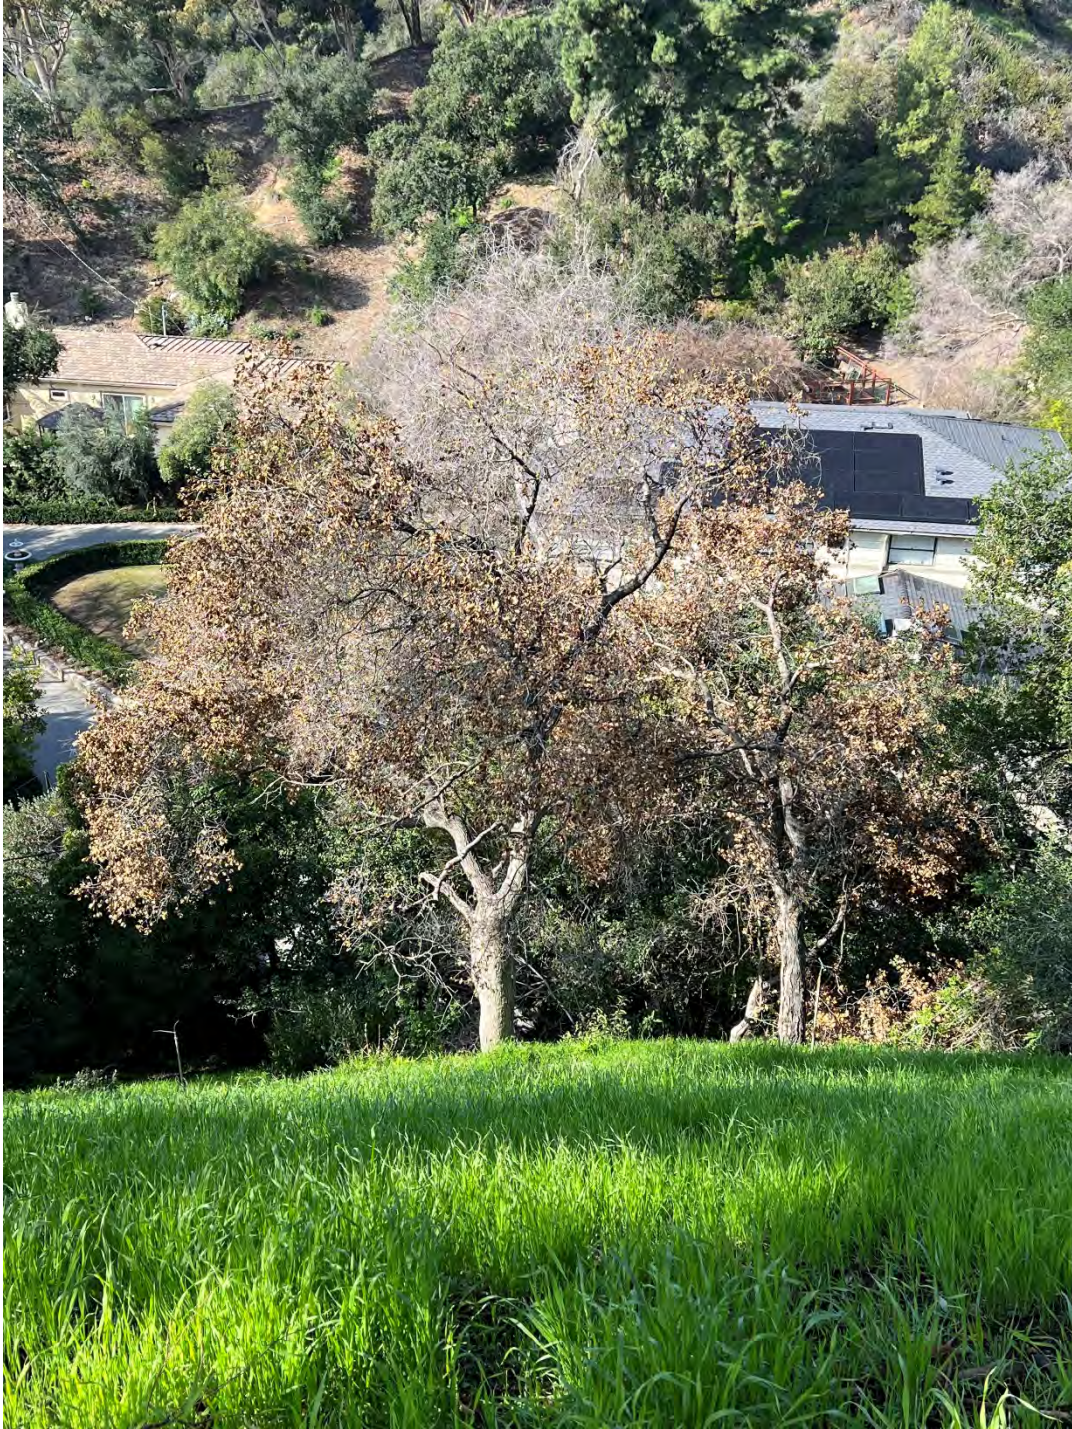
**View of Tree #1 (in the front) and Tree #2 (in the rear) seen from the street.**

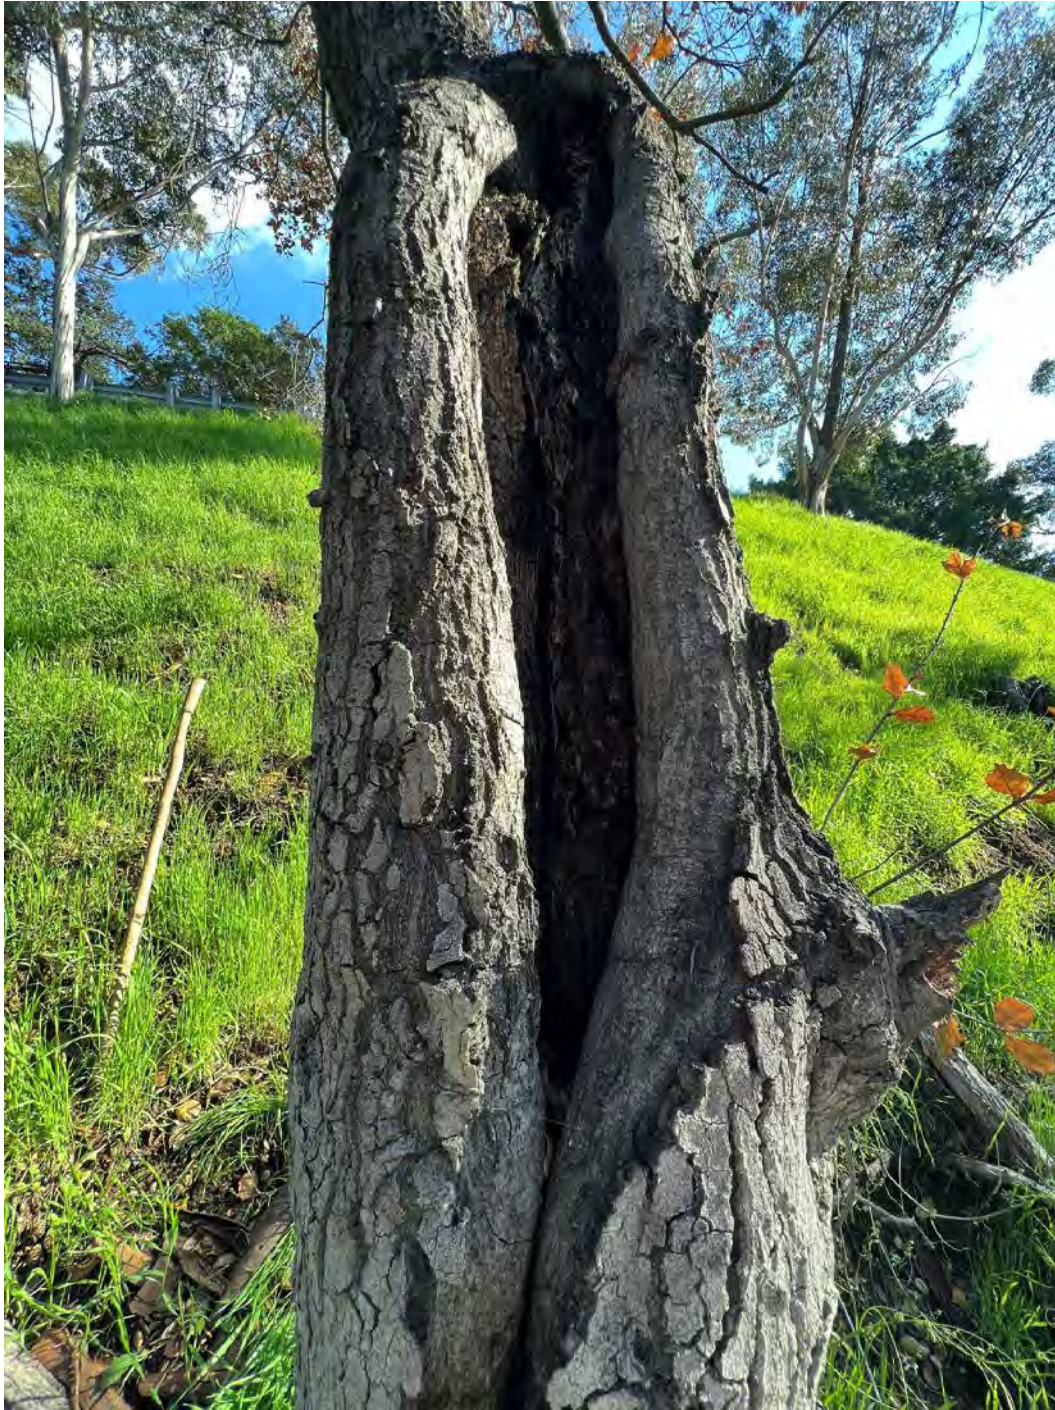
The height of the tree **crown** is about 20 feet, and the canopy spread is of 27 feet. The stem with 15 -inch DBH has a major columnar **decay cavity**. This and boring beetle holes are the reasons why this tree has died.

**Decay column on Tree #1.**

This tree is far from the construction footprint and it could be removed or retained for wildlife habitat.

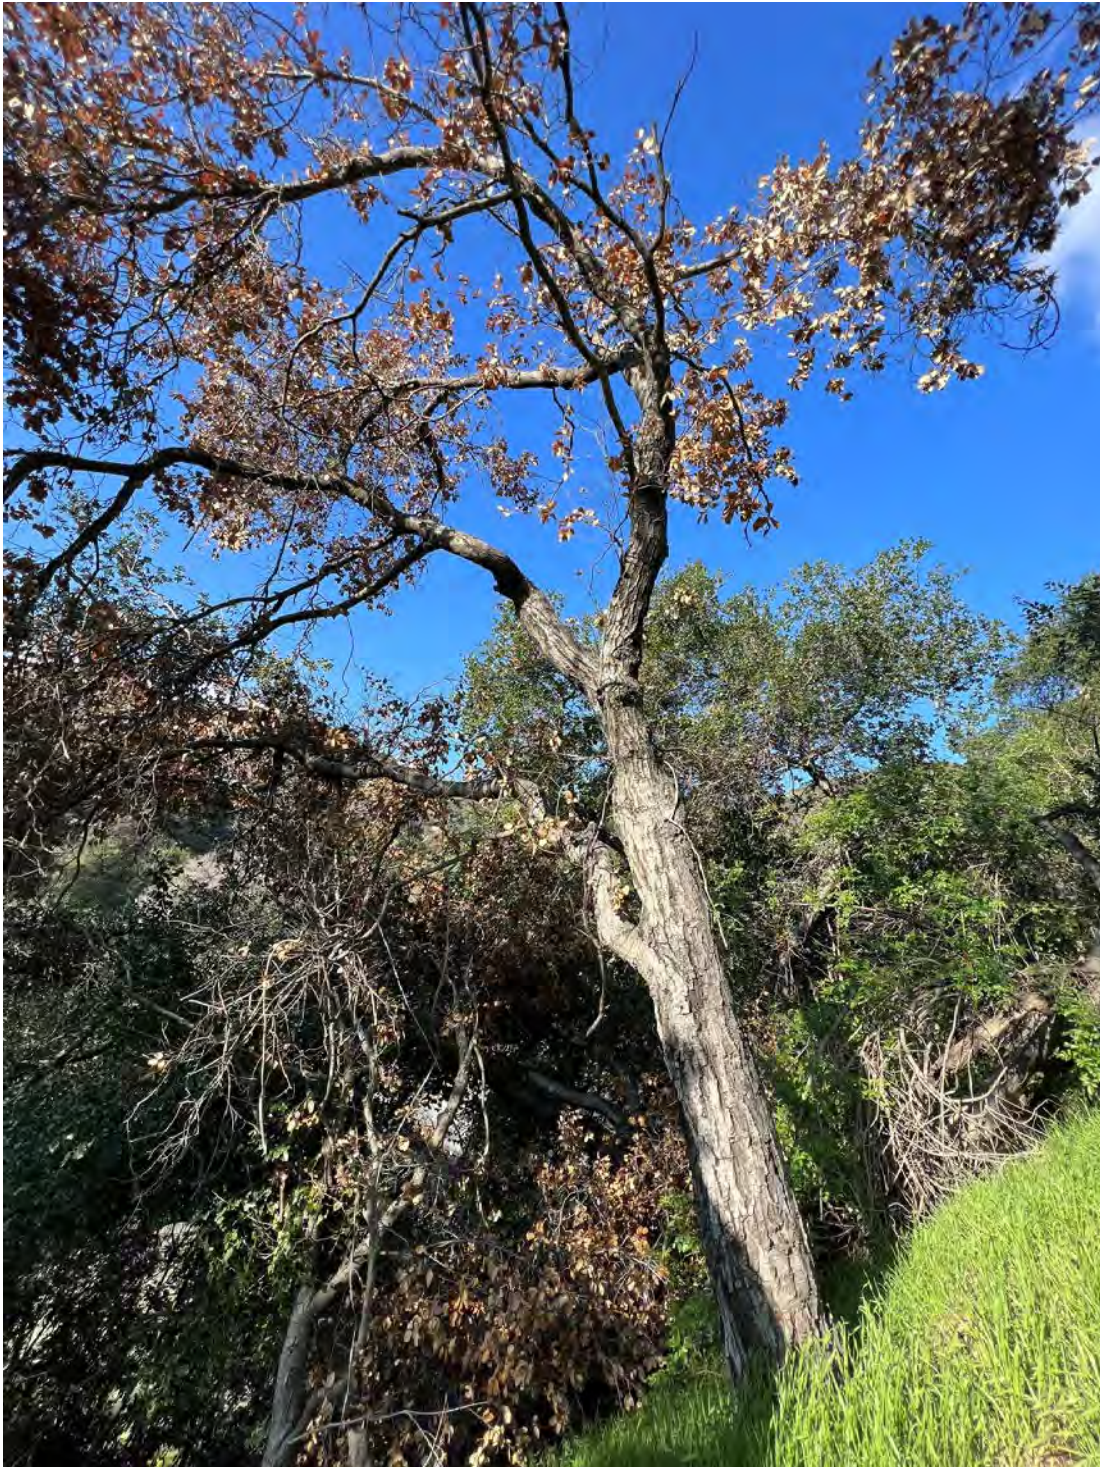
**Tree #2.**

This is a smaller California Live oak tree, located some 12 feet northeast of Tree #1.

The trunk has a DBH of 11 inches, and the overall tree height is about 15 feet.

The overall canopy spread is about 20 feet.

This tree also is completely dead; boring beetle holes on the **bark** are an indication of the possible cause.

This tree also is far from the construction footprint and it could be removed or retained for wildlife habitat.

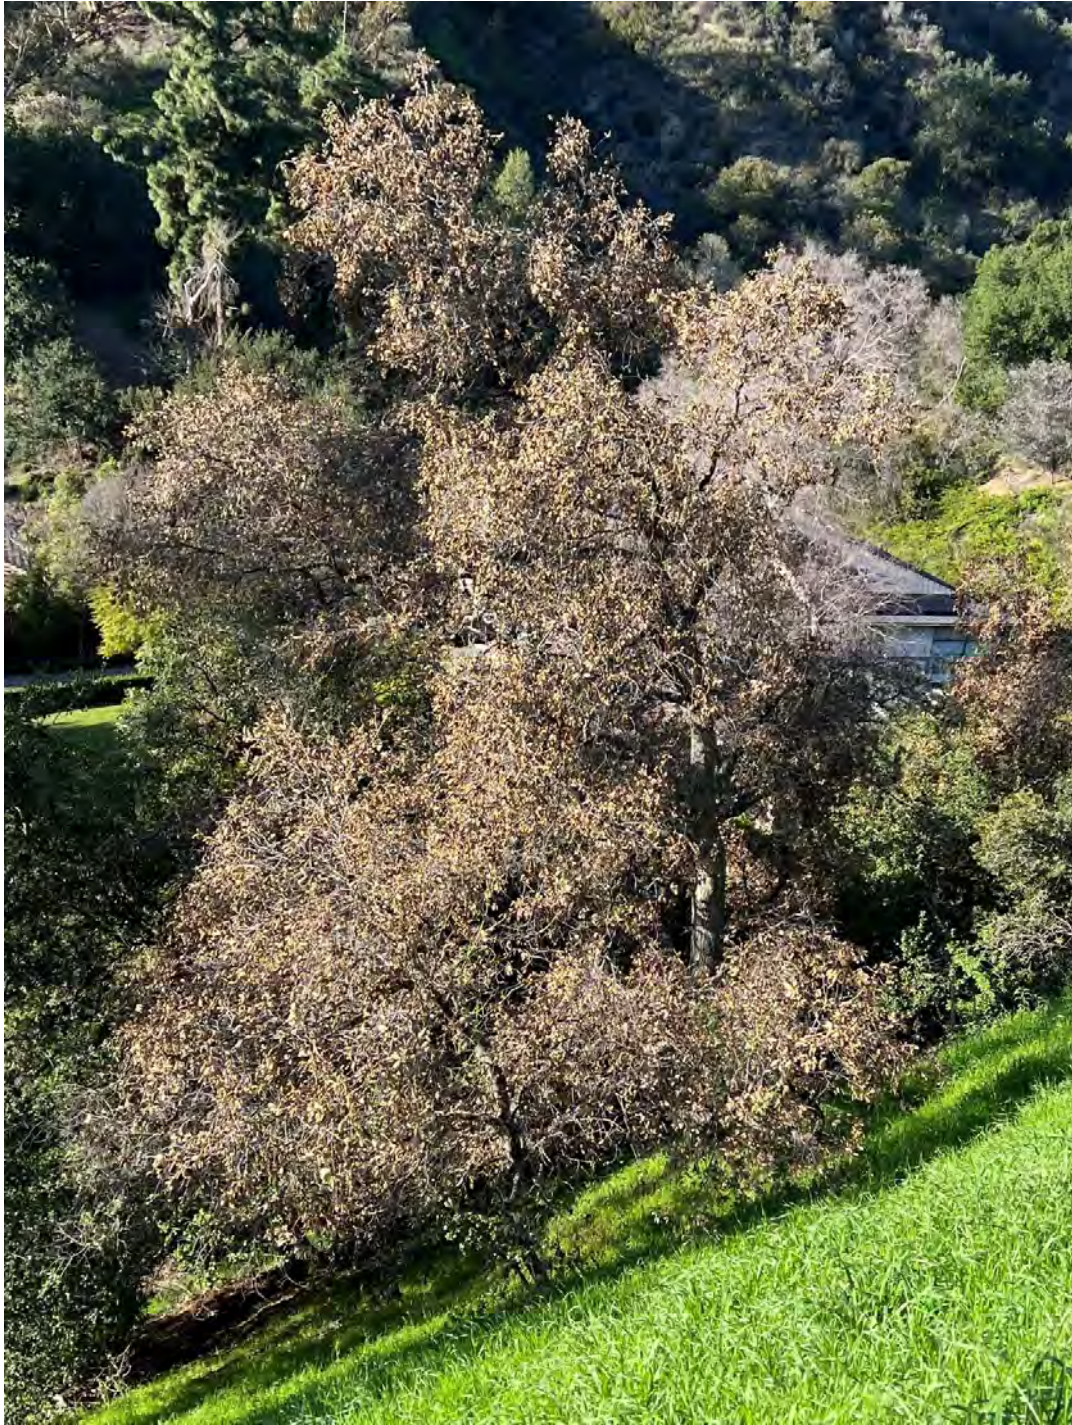
**Tree #3.**

Another mature California Live oak tree, located midway on the property. The main trunk divides to two stems, respectively with 14 and 15 inch DBH, and a combined DBH of 20.5 inches.

This tree has a substantial size crown, with an overall height of 25 feet and about 50 feet canopy spread.

This tree also is completely dead; probably boring beetles being the culprit.

This tree should be removed, because it is in conflict with the proposed dwelling.

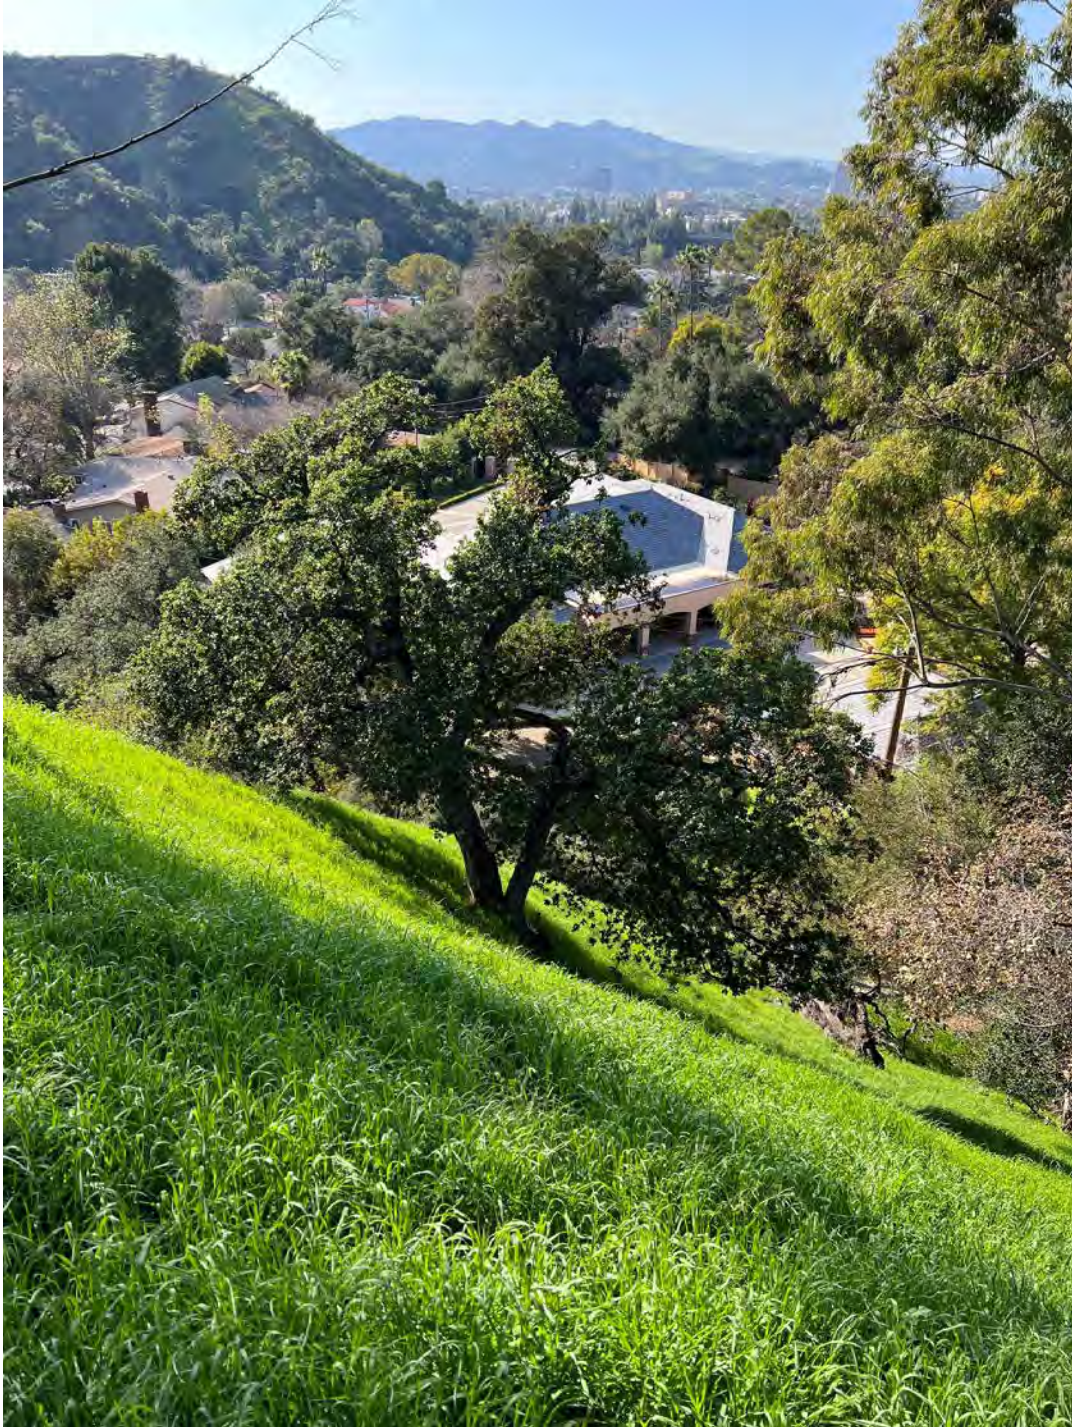
**Tree #4.**

This is the only live indigenous tree that was surveyed.

Two stems emerge from the main trunk flare, and they respectively have 11 and 19 inches DBH. The combined DBH is 22 inches.

The height of the crown is about 20 feet. Crown density is acceptable, and **foliage** looks healthy with no signs of disease.

There is no **included bark** at the **crotch** of the main stems and **scaffold branches**, an indication that the union is strong and not prone to failure. There are some decay cavities on the smaller main stem.

The overall **vigor** of this tree is acceptable.

On a 0 to 5 scale (0 being dead and 5 being excellent), the **condition rating** for this tree is 3 (Average).

This tree is in conflict with the proposed dwelling; therefore, it should be removed.

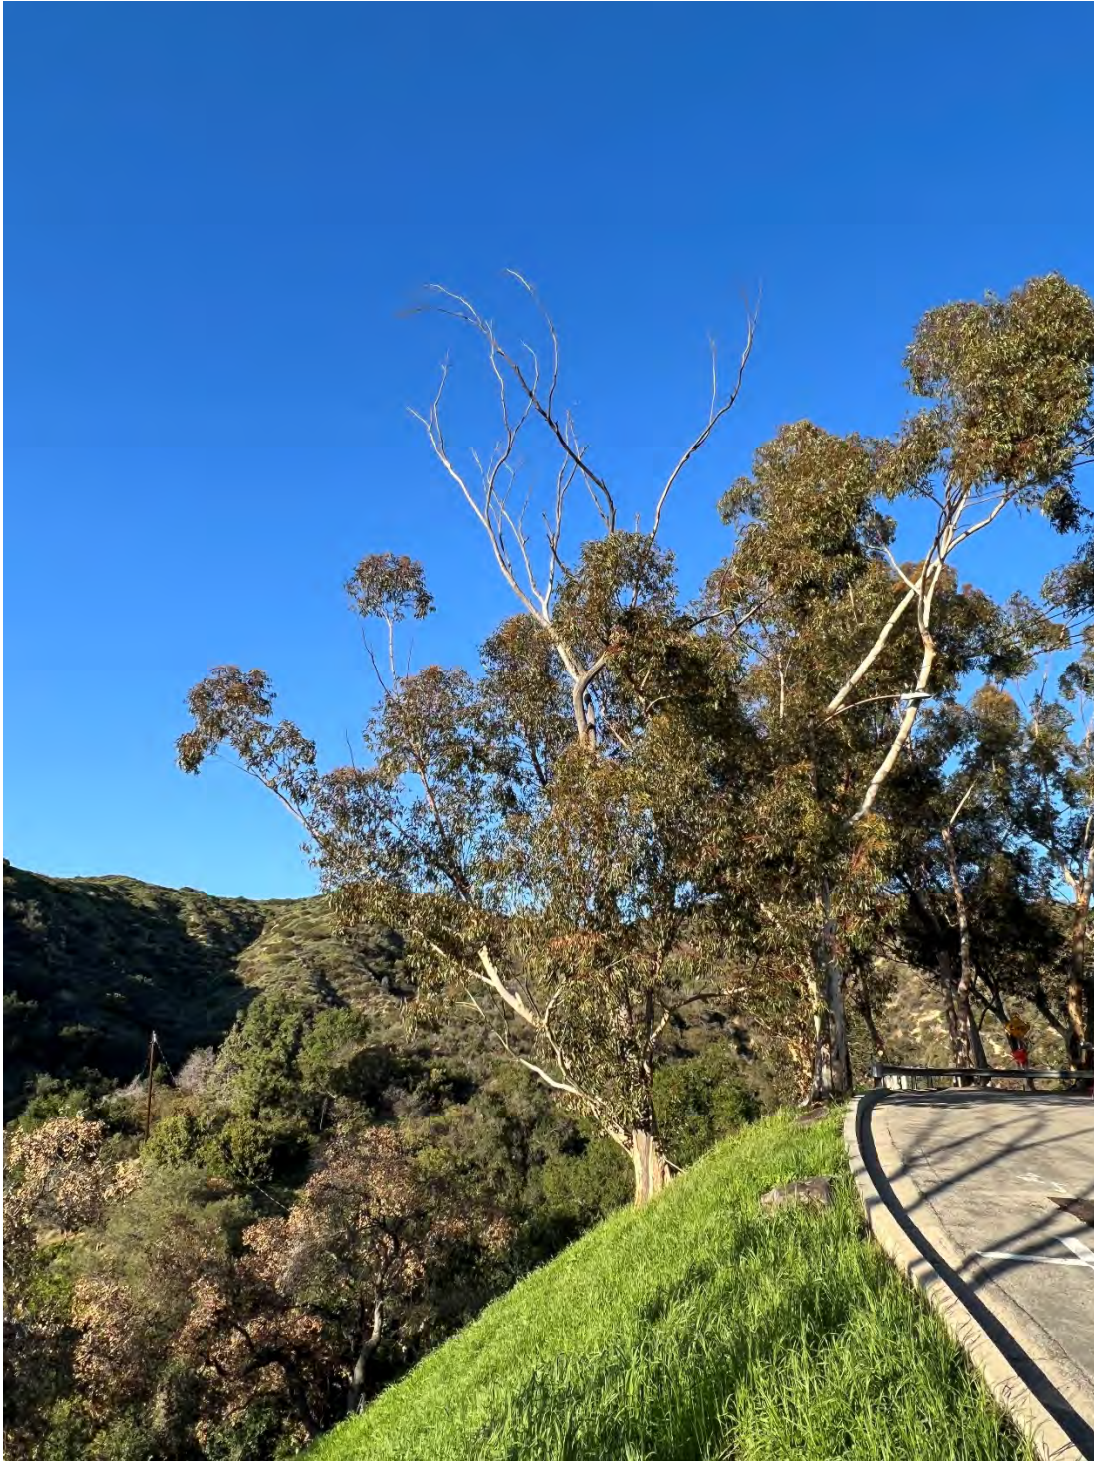
As indicated earlier, other than the four indigenous oak trees on site, there are also two Gum trees. One of them is completely dead, and stumps of other Gum trees in that vicinity indicate that other Gum trees have been removed from the site.

Other live Gum trees are also found toward the north side, these are identified as G2, G3, G4 and G5, and they actually are outside the property lines, and eventually could be removed because of future street improvements. The characteristics of these five trees are included in the tree inventory.

**The Gum trees seen from the south side.**

The only tree that must be protected during the construction activities, is Tree G2, one of the Gum trees that is close to the northeast corner of the proposed house. Because it is a City of Glendale street tree, Urban Forestry will decide to have it removed for the future sidewalk, or the best plan for its preservation.
