**INDIGENOUS TREE REPORT
FOR
RESIDENTIAL CONSTRUCTION**

**3213 MILLS AVENUE
GLENDALE, CA 91214
(APN:5607-016-017)**

June 23, 2025

**Arsen Margossian, MS, Consulting Arborist
Bardez Landscape Services, Inc.**

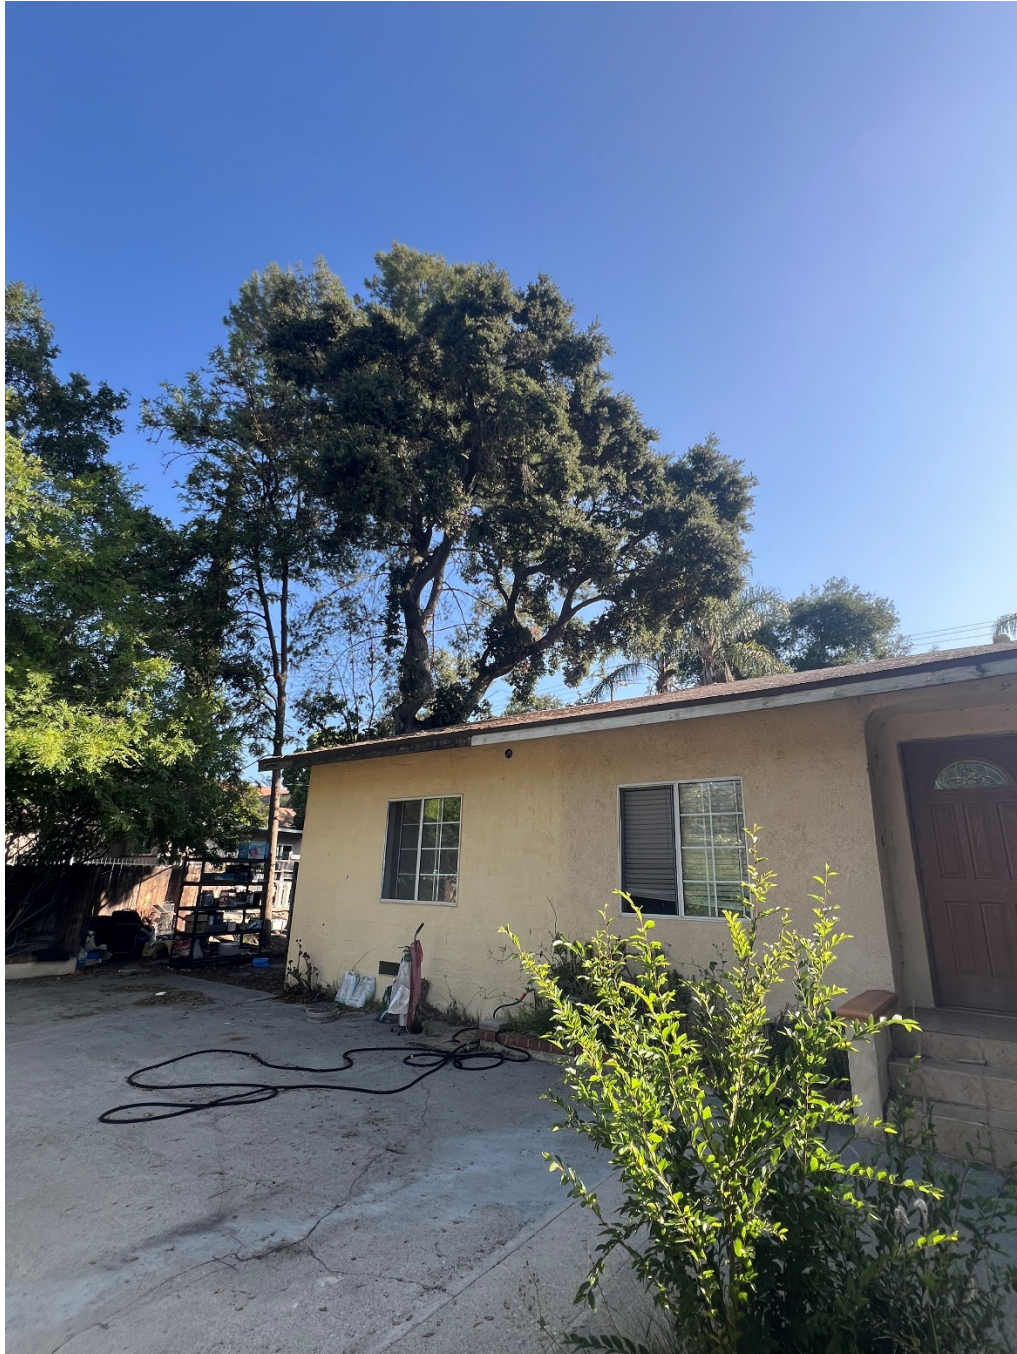
It has a single slightly west-leaning trunk, with a DBH of 24 inches. It divides to two main stems at about fifteen feet from grade; one extends eastward, and the other continues upward.

Many of the main scaffold branches of the tree have been cut in the past almost to an elevation of 25-30 feet, and the resulting crown of the tree is above that height and is uneven.

Because of the presence of a mature pine tree on its northwest side, the crown of the tree is almost completely toward the east side. While branches extend by 18 feet toward the east and north sides, they reach only 11 feet toward the south side and no significant-size branches are seen toward the west side.

Foliage is of acceptable density, but signs of scorch are visible throughout the crown. No signs of other disease or infestation are visible. No decay cavities are also present on the main trunk and main branches.

This tree is of average vigor, and on 0 to 5 grading (0 being dead and 5 being excellent), the condition rating of this tree is 3 (Average.)

The oak tree seen from the southeast side.

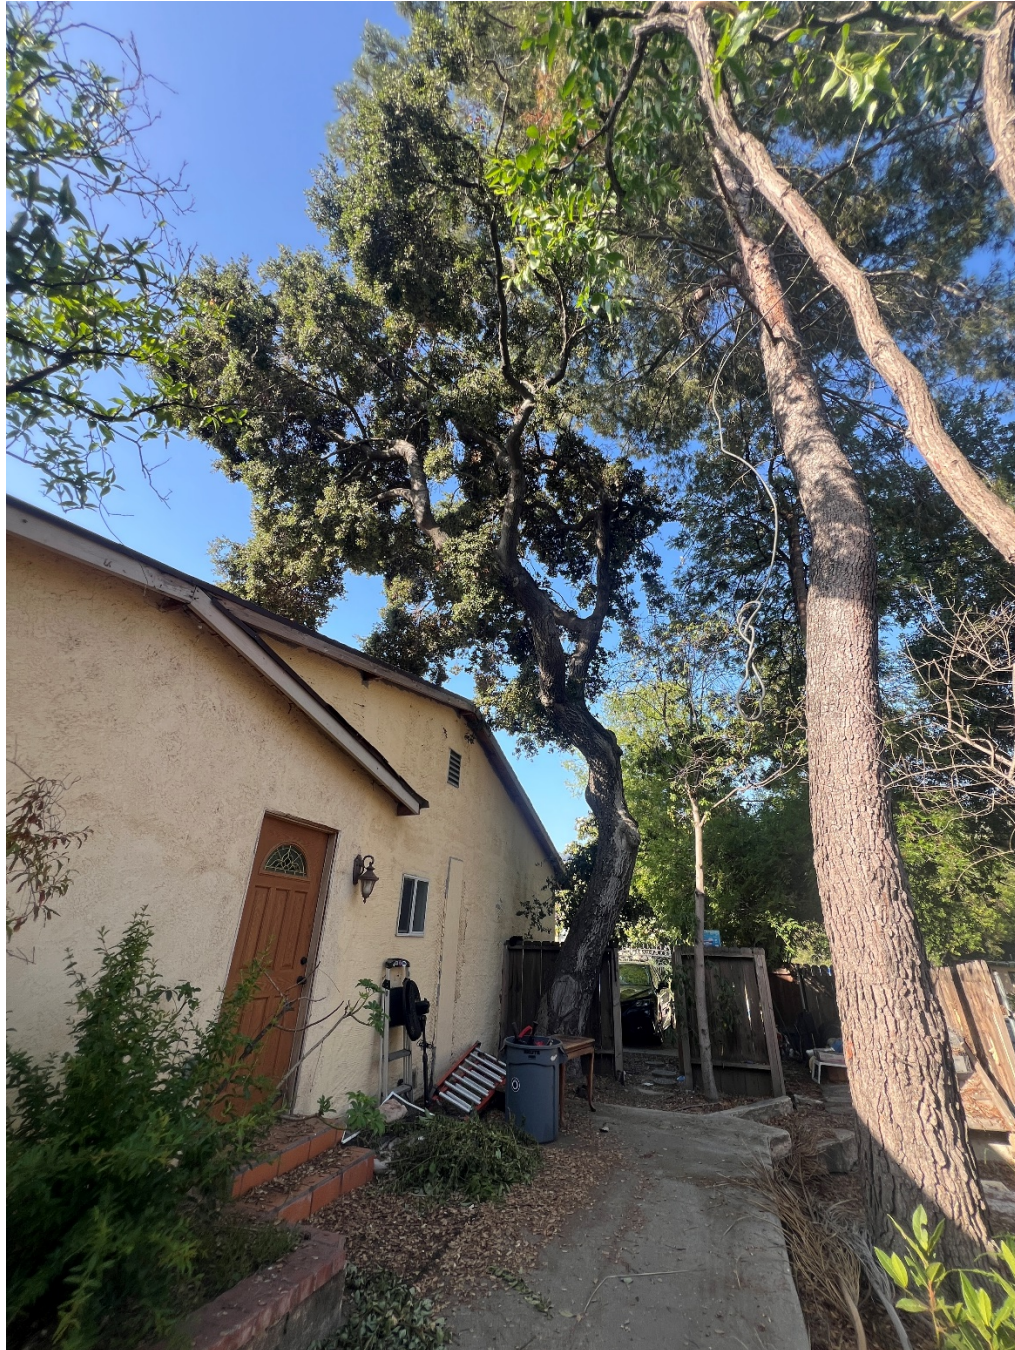
The oak tree seen from the north side.

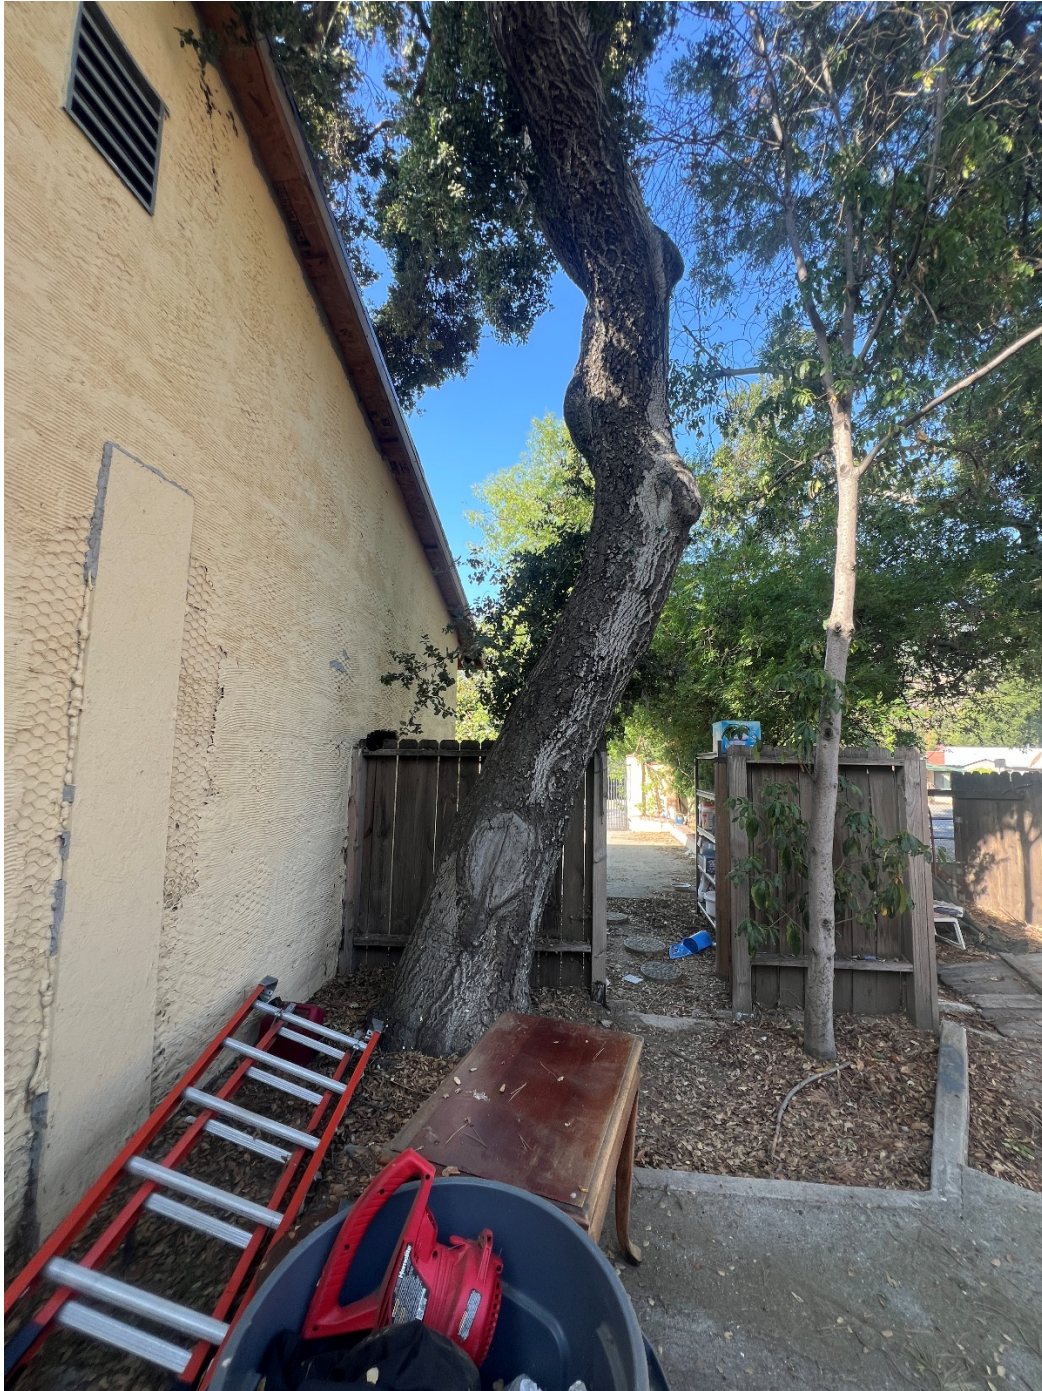
View of the main trunk of the oak tree.

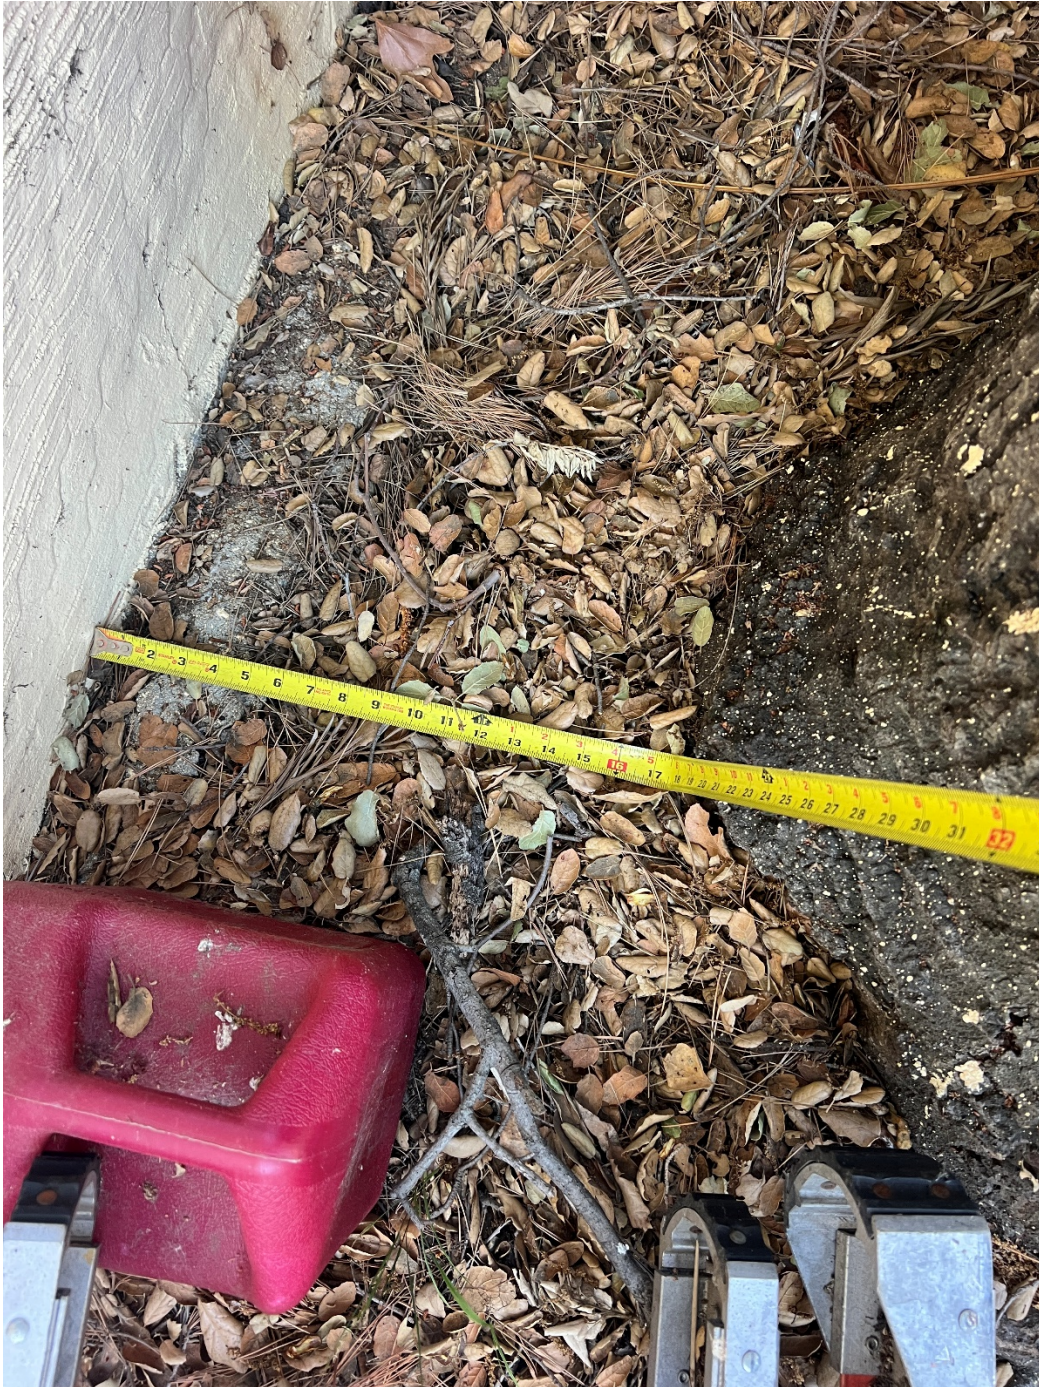
As measured, that wall is only 17 inches from the trunk base of the oak tree. Apparently, the oak tree has not been impacted by the foundation work for that wall, either because there were no roots toward that side, or because roots were somehow not severed when trenching for the foundation.

Distance of seventeen inch from the existing wall to the oak tree trunk edge.

The area of the foundation across from the oak tree trunk must be dug manually, to expose without damaging any roots that possibly would be present in that area. All demolition and excavation must be performed under the direct supervision of the Arborist of Record (AOR), who should be making the decision as to how to preserve or severe certain roots. During construction, the oak tree must be mulched and irrigated regularly, to compensate for any root loss.

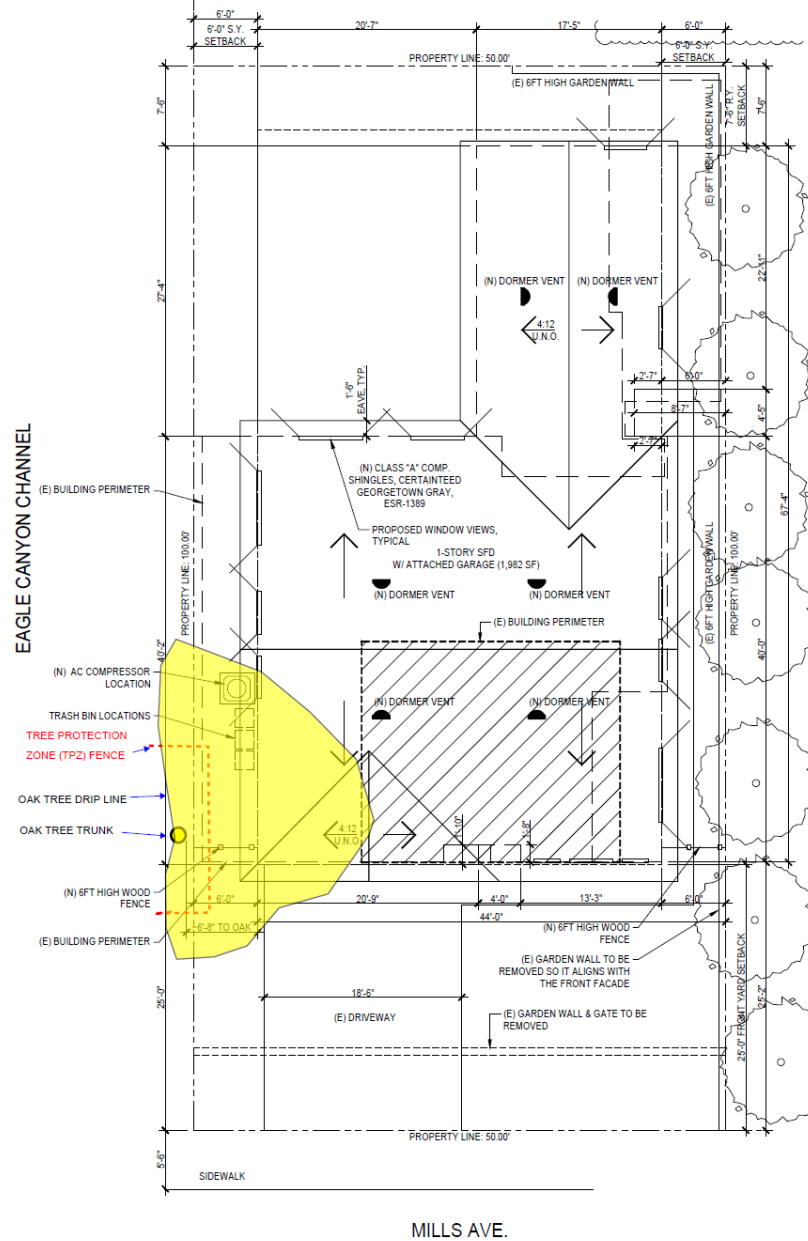
01 PROPOSED SITE PLAN
SCALE: 1/8" = 1'-0"

At present, it is being proposed to build the new residence away from the trunk of the oak tree, which as planned, its trunk edge will be six feet and eight inches from the residence wall.
