November 4, 2021
W&G #S21288

FIELD INVESTIGATION REPORT

Silver Spurs Stables
1900 Riverside Drive
Glendale, CA 91201

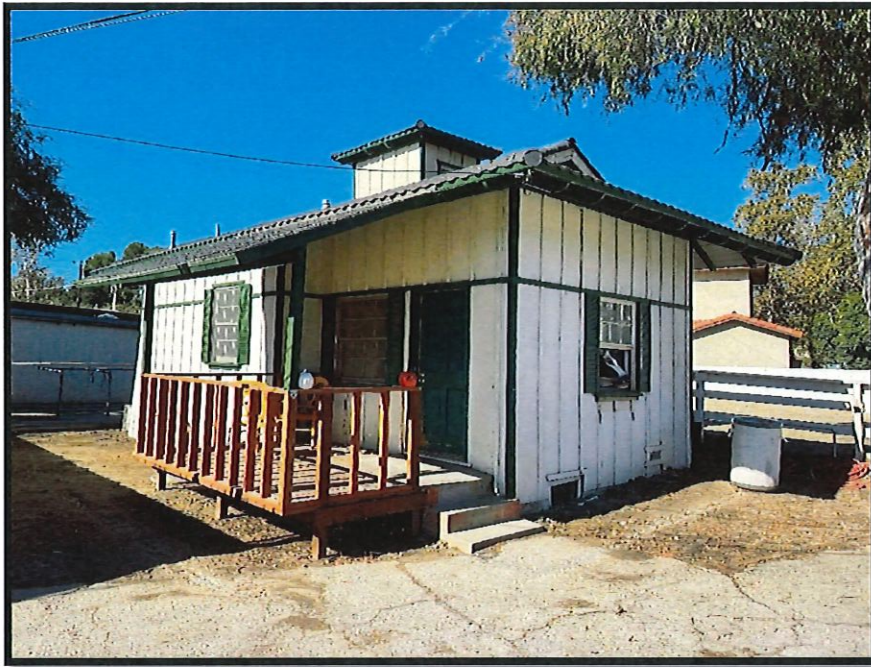
Photo #1 Building A-Wood Framed Residence Structure

Building A – A one story residence type V framed residence supported over a raised foundation (see photo #1).

1. The exterior walls appear to be supported on a continuous concrete footing. The footings consist of a concrete stem.
2. The building shows no signs of deterioration.

1. Review anchorage of building to footings.
2. If required anchor building to foundation stem walls.

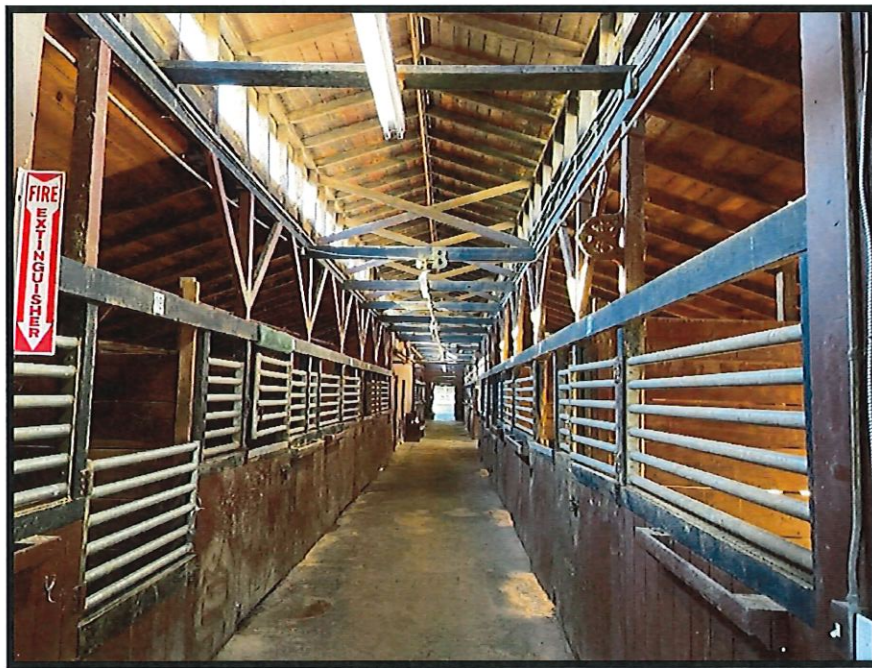
Photo #2 Building B Eastside Stable

Building B - Two one story wood framed horse stable structures built in the 1930's. Both structures are long and narrow and consist of a central hallway with horse pens on each side of the hall. The larger eastside building has a continuous monitor down the middle of the structure (photo #2). The smaller westside building has a shed roof (photo #3). The roof framing consists of 1x sheathing supported by 2x rafters. The walls are covered with 1x sheathing.

1. Roof is to be sheathed with plywood.
2. Scab new 2x rafters to undersized existing 2x4 rafters.
3. Add shear panels to all exterior walls and selected interior cross walls.
4. Provide a new foundations to all continuous walls, posts and added shear panels.
5. Remove and replace all deteriorated wood framing.

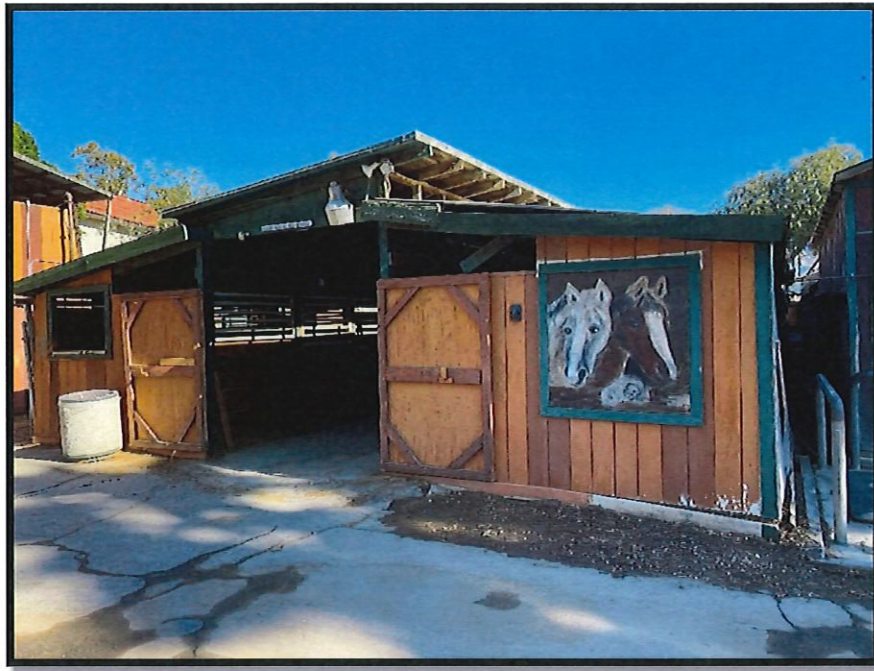
Photo #3 Building B Westside Stable

1. The exterior walls appear to be not supported on a continuous footings but are supported on a sill plate on the soil.
2. The interior posts each side of the hall appear to be supported on the soil only with no signs of footings.
3. The roof diaphragms are not supported or minimally supported laterally or longitudinally by shear walls and there are no signs of foundation anchor bolts.
4. The wood framed wall on the west side of the structure is supporting two to three feet of soil.

1. Roof is to be sheathed with plywood
2. Scab new 2x rafters to undersized existing 2x4 rafters.
3. Add shear panels to all exterior walls and selected cross walls.
4. Provide new foundations to all continuous walls, posts and shear panels.
5. Remove soil at west wall and regrade.
6. Remove and replace all deteriorated framing.

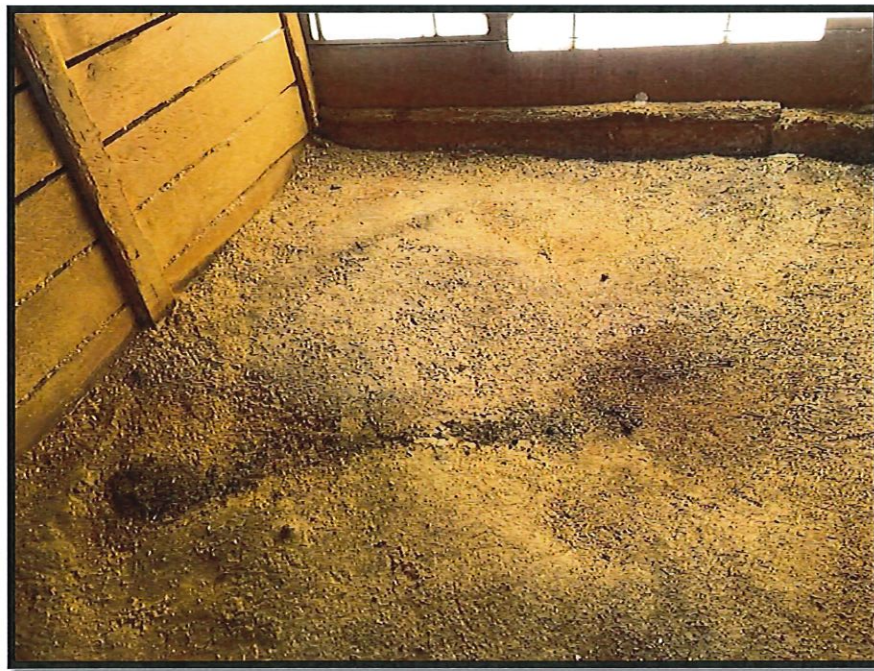
1. The exterior walls appear to be supported on a continuous concrete footing. In some areas the top of the footings are flush with the interior and exterior grades which does not protect the walls and posts which makes them susceptible to dry wrought (see photo #4).
2. The interior posts each side of the hall appear to be supported on the soil only with no signs of footings.
3. The roof diaphragms are not supported laterally or longitudinally by shear walls and there are no signs of foundation anchor bolts (see photo #5).

Photo #4-Continuous footing at longitudinal wall

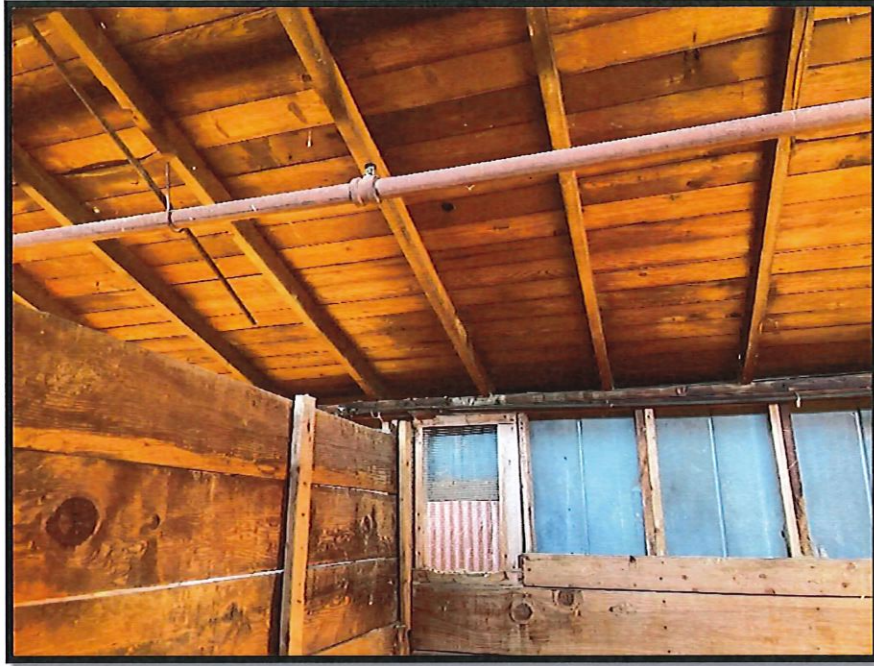
Photo #5 Typical Longitudinal wall at Eastside Stable

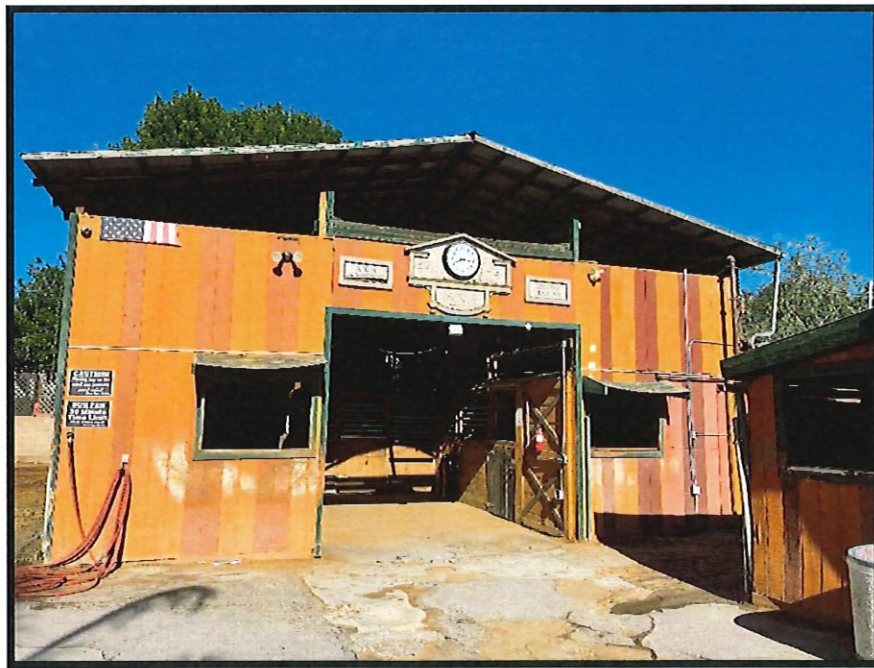
Photo #6 Barn East Elevation

Building D – A tall one-story barn structure consisting of a wood framed roof supporting corrugated steel roof sheets and 1x exterior sheathing.

1. The exterior walls appear to be not supported on a continuous-footings but are supported on a sill plate on the soil.
2. The interior posts each side of the hall appear to be supported on the soil only with no signs of footings.
3. The roof diaphragm, which consists of inadequate corrugated steel sheets, is not minimally supported laterally and longitudinally by shear walls and there are no signs of foundation anchor bolts.
4. The north wall of the structure is supporting approximately 3 ft. of soil.

1. Roof is to be sheathed with plywood
2. Scab new 2x rafters to undersized existing 2x4 rafters.
3. Add shear panels to all exterior walls and selected cross walls.
4. Provide new foundations to all continuous walls, posts and shear panels.
5. Remove soil at north wall and regrade.
