November 18, 2021
W&G #S21288

FIELD INVESTIGATION REPORT

Silver Spurs Stables
1900 Riverside Drive
Glendale, CA 91201

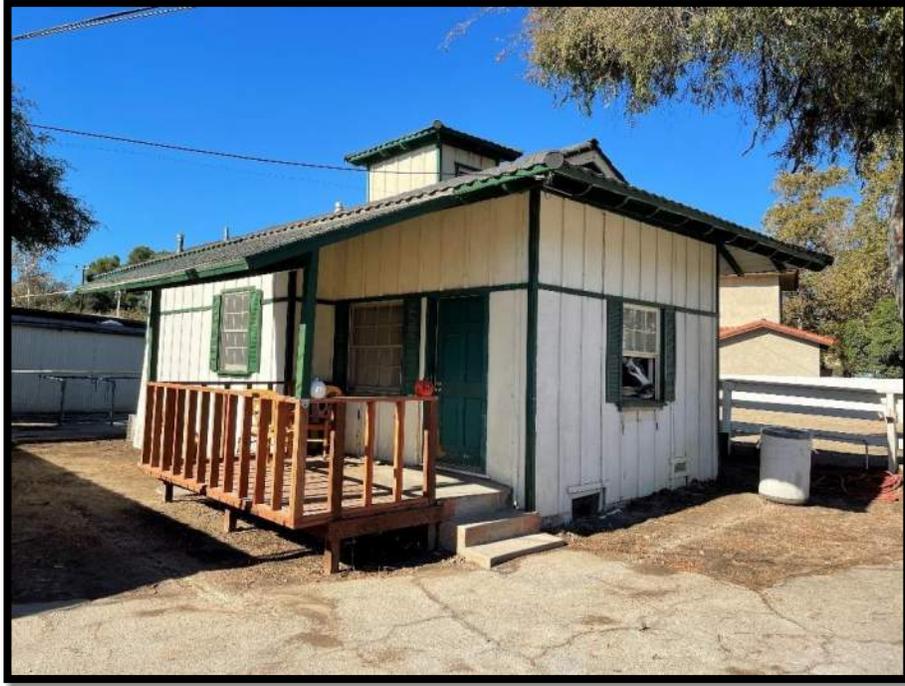
Building A – A one story residence type V framed residence built in 1942 and supported over a raised foundation (see photo #1).

1. The foundation consists of a typical raised floor system with exterior walls are supported on a continuous concrete footing. The raised floor consists of plywood sheathing over 2x6 floor joists that span approximately 8 ft. and a 4x girder running through the middle of the structure.
2. The building siding and framing shows signs of dry wrought deterioration where grade is too close to sill plate.
3. Roof framing consists of 2x6 rafters spanning 7 ft to a 1x ridge board. There are only minimal collar ties running transversely across the building.
4. The building sill plate is anchored to the foundation stem with anchor bolts.

Photo #1 Building A-Wood Framed Residence Structure

1. Provide a retrofit foundation sill anchors at the top of the foundation stem wall.
2. Strengthen roof framing by addition collar ties from top plate to top plate at a minimum of 24"o.c.
3. Remove and replace deteriorated siding and sill plates.
4. Provide plywood shear panels to seismically retrofit the building. Retrofit consists of a continuous load path from roof diaphragm to shear walls to foundation stem. These items include continuous blocking between rafters and floor joists, framing anchors at blocking and holdowns at ends of plywood sheathed shear panels.
5. Regrade surrounding area to provide proper distance from grade to foundation sill.
6. Add foundations at the east side porch to support posts as seen in photo #1. Posts are to be knee braced to add lateral support for porch extension.

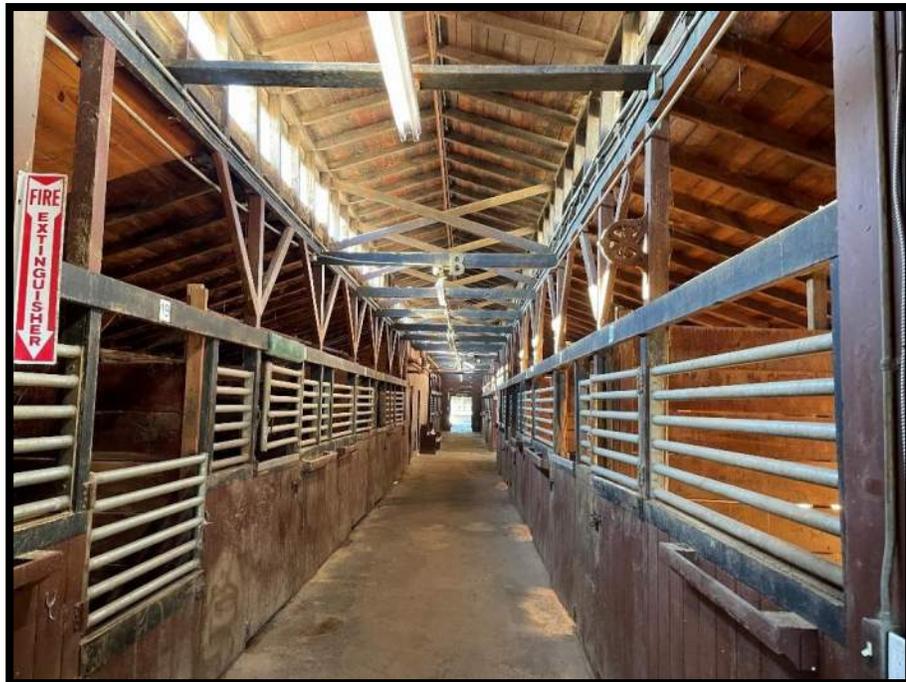
The structure is a type V framed long narrow building approximately 28 ft. in width and consists of a central hallway with horse stables on each side of the hall. There is a continuous monitor over the hallway (photo #2). Roof framing consists of 1x straight sheathing supported by 2x4 rafters spaced at 24"o.c.

4. The roof diaphragms are not supported laterally or longitudinally by shear walls and there are no signs of foundation sill anchor bolts (see photo #6).
5. Roof framing appears to be undersized based on the spans (photo #7).
6. There is no lateral transfer from monitor diaphragm structure to the lower roof (photo #2).

Photo #2 Building B Central Stable

1. Entire roof is to be sheathed with plywood.
2. Scab new 2x rafters to undersized existing 2x rafters.
3. Add continuous collar ties between monitor cripple wall plates and sheath cripple walls with plywood to create a continuous load path from roof diaphragm to foundations. This will include continuous blocking between rafters with added framing anchors at each block.

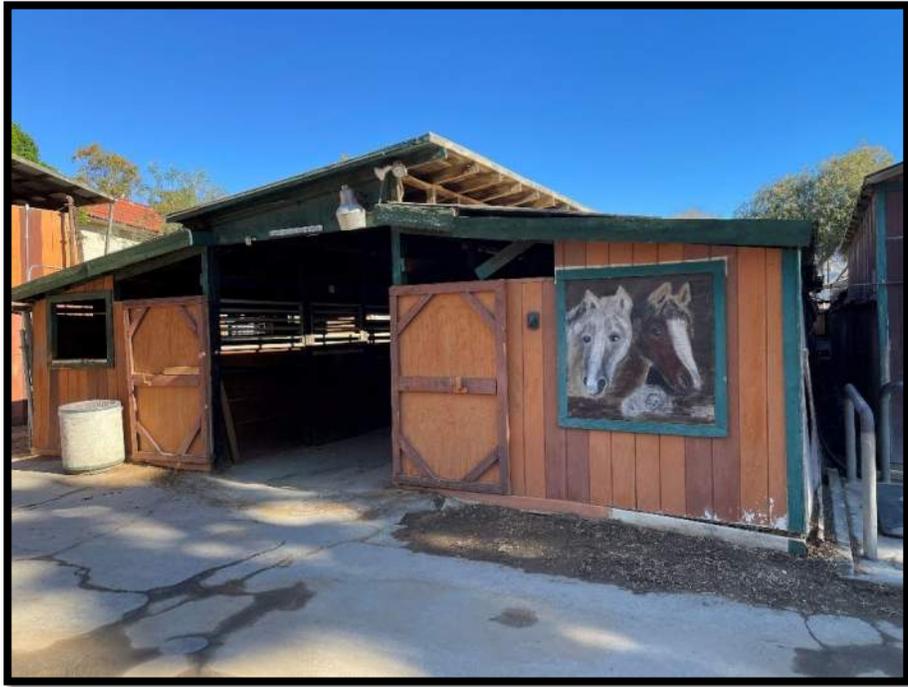
The westside building has a shed roof (photo #3 & #4). The roof framing consists of 1x sheathing supported by 2x rafters. The walls are covered with 1x sheathing.

1. The exterior walls appear to be not supported on a continuous-footings but are supported on a sill plate on the soil with no anchor bolts.
2. The interior posts each side of the hall appear to be supported on the soil only with no signs of footings.
3. The roof diaphragms are not supported or minimally supported laterally or longitudinally by shear walls.
4. The wood framed wall on the west side of the structure is supporting two to three feet of soil.
5. The roof framing is undersized with 2x6 rafters spanning over 10 ft. and spaced at 3 ft. o.c.
6. There are no wall top plates per normal type V construction (photo #4).

Photo #3 Building B Westside Stable

1. Entire roof is to be sheathed with plywood
2. Scab new 2x rafters to undersized existing 2x4 rafters.

3. To seismically retrofit the structure, add shear panels to all exterior walls and selected cross walls. The seismic retrofit consists of a continuous load path from roof diaphragm to shear walls to foundation stem. These items include continuous blocking between rafters, framing anchors at all blocking and holdowns at ends of plywood sheathed shear panels.
4. The existing stud walls are inadequate and do not meet typical type V framing requirements (no top plates). All of the stud walls are to be removed and reframed.
5. Shore entire building and provide a new-foundations with curbs to all continuous walls, posts and added shear panels.
6. Remove soil at west wall and regrade.
7. Remove and replace all deteriorated framing.

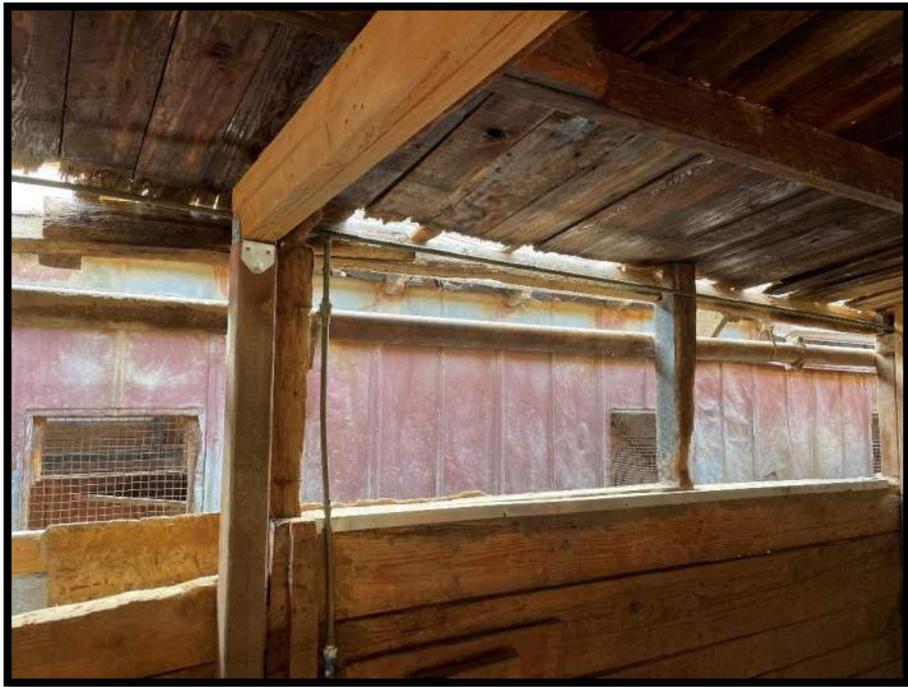
Photo #4 Building B Westside (east wall)

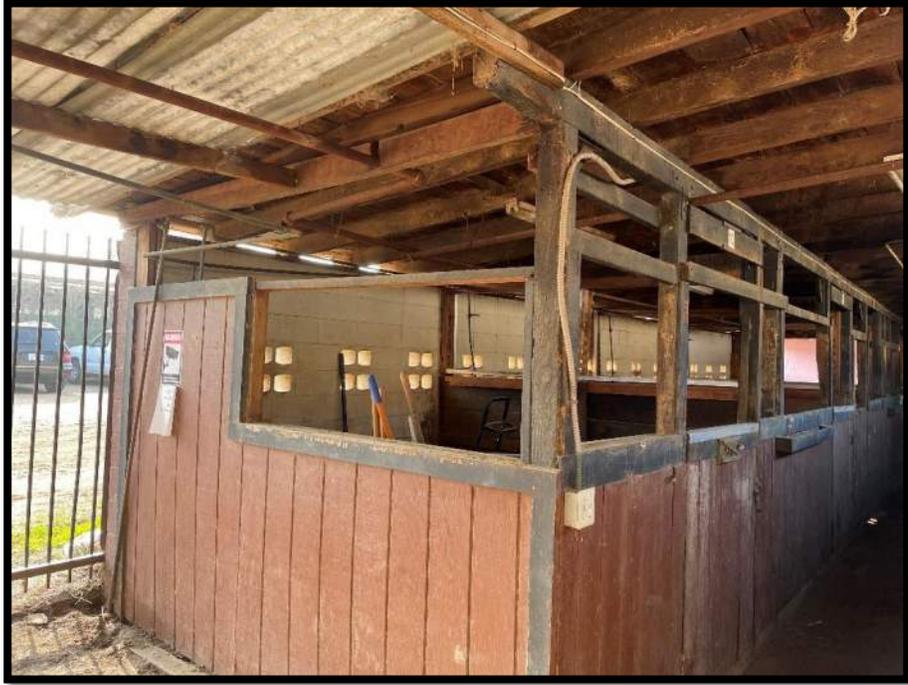
1. The wood stud walls appear to be not supported on a continuous-footings but are supported on a sill plate on the soil with no anchor bolts.
2. The interior posts are supported on the soil only with no signs of footings.
3. The masonry wall on the east wall is not positively anchored to the roof diaphragm (photo #5).
4. The roof diaphragms are not supported or minimally supported laterally or longitudinally by shear walls and there are no signs of foundation anchor bolts.
5. The roof framing is undersized with 2x6 rafters spanning over 15 ft. and spaced at 16"o.c.

Photo #5 Building B Eastside Stable

1. Entire roof is to be sheathed with plywood
2. Scab new 2x rafters to undersized existing 2x6 rafters.
3. To seismically retrofit the structure, add shear panels to all exterior walls and selected cross walls. The seismic retrofit consists of a continuous load path from roof diaphragm to shear walls to foundation stem. These items include continuous blocking between rafters, framing anchors at all blocking and holdowns at ends of plywood sheathed shear panels.
4. The existing masonry wall is to be positively anchored to the roof diaphragm with straps and anchor bolts.
5. Shore entire building and provide a new-foundations with curbs to all continuous walls, posts and added shear panels.
6. Remove and replace all deteriorated framing.

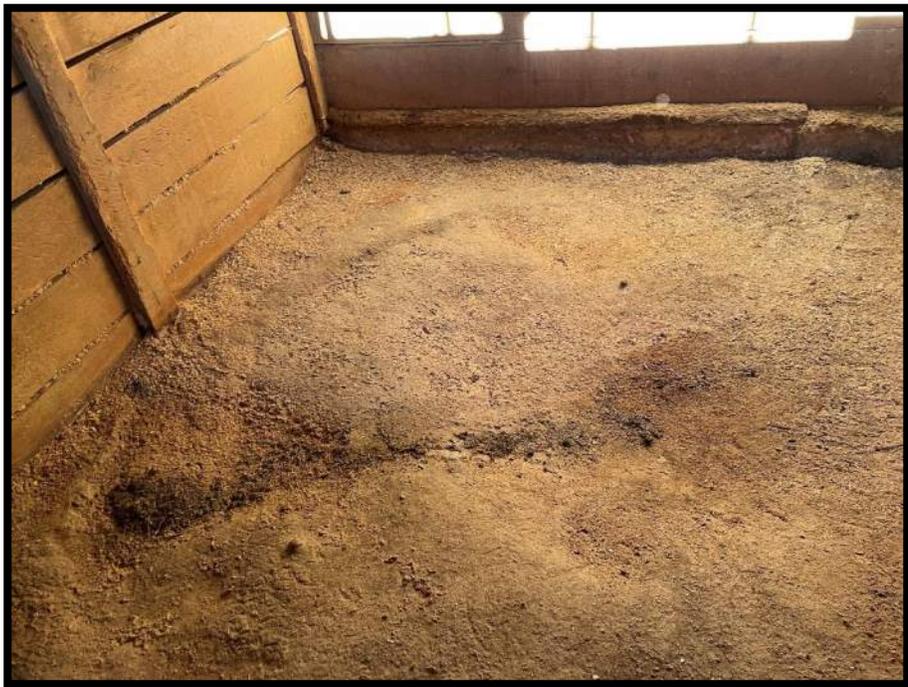
1. The exterior walls appear to be supported on a continuous concrete footing. In some areas the top of the footings are flush with the interior and exterior grades which does not protect the walls and posts which makes them susceptible to dry wrought (see photo #6).
2. Concrete footing shows signs of exposed aggregate and therefore concrete quality is below minimum standard and is deteriorating.
3. The interior posts each side of the hall appear to be supported on the soil only with no signs of footings.

Photo #6-Continous footing at longitudinal wall

5. Shore entire building and provide a new-foundations with curbs to all continuous walls, posts and added shear panels.
6. Remove and replace all deteriorated wood framing.

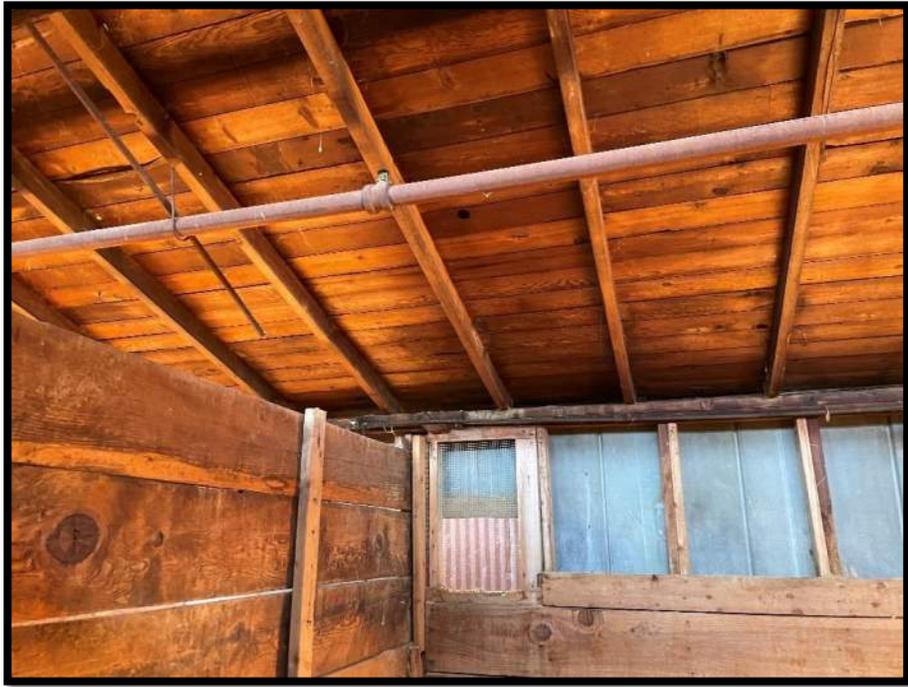
Photo #7 Typical Longitudinal wall at Central Stable

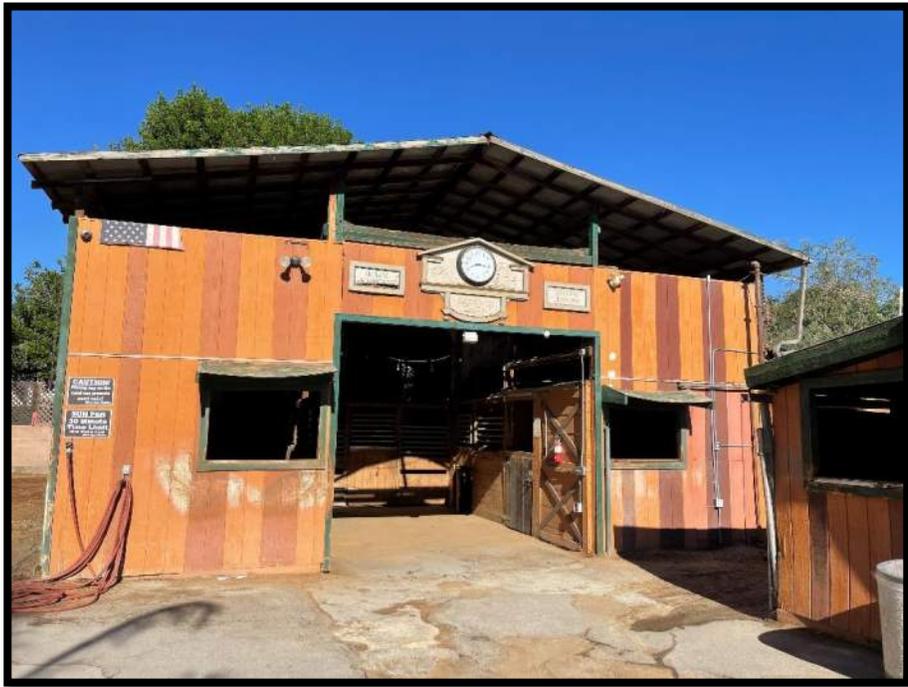
Building D – A tall one-story barn structure approximately consisting of a wood framed roof supporting corrugated steel roof sheets and 1x exterior sheathing and 2x Rafters. The original portion of the building is approximately 28'x31' in plan dimensions with additions on the north and east sides (photo #8).

1. The exterior walls are supported on a continuous-footings but there are only minimal sill anchor bolts found.
2. The interior posts each side of the hall appear to be supported on the soil only with no signs of footings.

3. The roof diaphragm, which consists of inadequate corrugated steel sheets, is not minimally supported laterally and longitudinally by shear walls.
4. The north wall of the structure is supporting approximately 3 ft. of soil.

5. The tall east and west wall studs are undersized based on their spans.
6. Roof framing (2x4 rafters spanning 9 ft. and spaced at 24"o.c.) are undersized.

7. The east and west walls studs are not continuous to the top of the gable roof but are interrupted by 2-2x plates at the 10 ft. height. This condition creates a hinge point in the wall and therefore the wall is inadequate for wind loading.

8. The foundation sill plates are not redwood or pressure treated material and therefore are susceptible to deterioration.

Photo #8 Barn East Elevation

1. Entire roof is to be sheathed with plywood
2. Scab new 2x rafters to undersized existing 2x4 rafters and add roof beams as required.

7. To seismically retrofit the structure, add shear panels to all exterior walls and selected cross walls. The seismic retrofit consists of a continuous load path from roof diaphragm to shear walls to foundation stem. These items include continuous blocking between rafters, framing anchors at all blocking and holdowns at ends of plywood sheathed shear panels.
3. Shore entire building and provide a new-foundations with curbs to all continuous walls, posts and added shear panels with proper anchor bolts and sill material.
4. Reframe tall and east and west walls with continuous larger studs.
5. Remove soil where finish grade is too close to foundation sill plates.
