Indigenous Tree Report

PREPARED FOR RAYMOND MUNRO

PROPERTY LOCATED AT: 910 LAIRD STREET, GLENDALE CA 91206

October 26, 2017

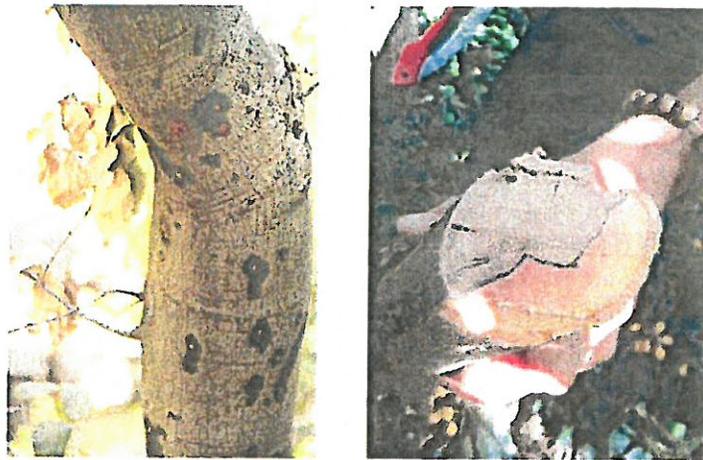
Note: Signs of ISHB were seen on the property. I recommend regularly inspecting the trees for early signs of this destructive beetle. Polyphagous shot hole borer (*Euwallacea* spp.) and other invasive shot hole borers and the fungus *Fusarium euwallaceae* are an insect/fungal disease complex that attacks over 260 species of trees. Polyphagous means glutton in Latin. The insect is an ambrosia beetle the size of a sesame seed that carries the fungus and farms it in tree hosts. It prefers California sycamore, willow, maple, oak and box elder. It will attack other trees if the preferred hosts are unavailable. The insects reproduce as much as 3x per season. The fungus clogs the nutrient and water transport systems of the plant. If insect populations are high, trees can be damaged or killed.

LEFT: DAMAGE FROM PSHB/FUSARIUM ON COAST LIVE OAK; RIGHT: DAMAGE TO WOOD FROM *FUSARIUM EUWALLACEA*

At this time, management options are still under investigation. The recommended treatments are to chip, grind or heat the infested material to reduce the emergence of the beetle. Preventative systematic insecticides have been tried with varying success (personal observation).

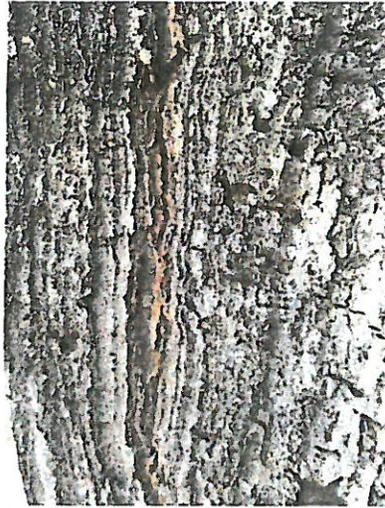
*SYCAMORE BORER DAMAGE ON OAK
PHOTO TAKEN BY REBECCA LATTA 2013.*

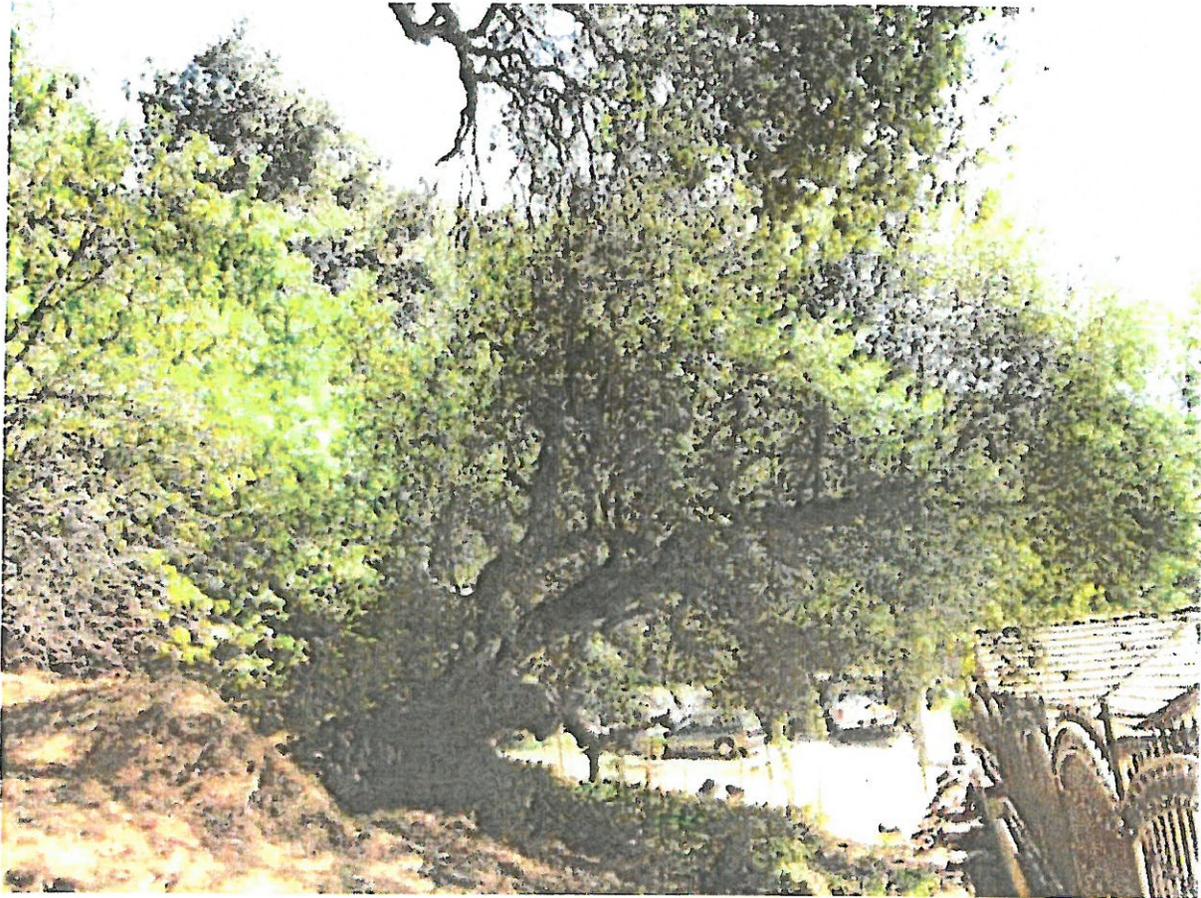
OAK #4 – UPROOTED AND REESTABLISHED IN A NEW POSITION

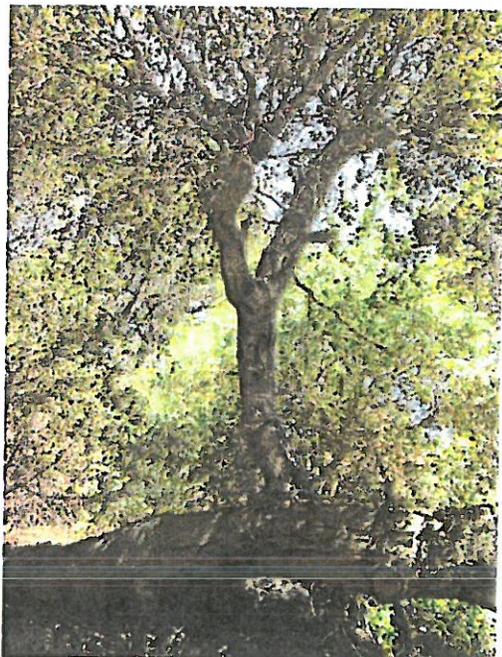
UPRIGHT SPROUT ON OAK #4

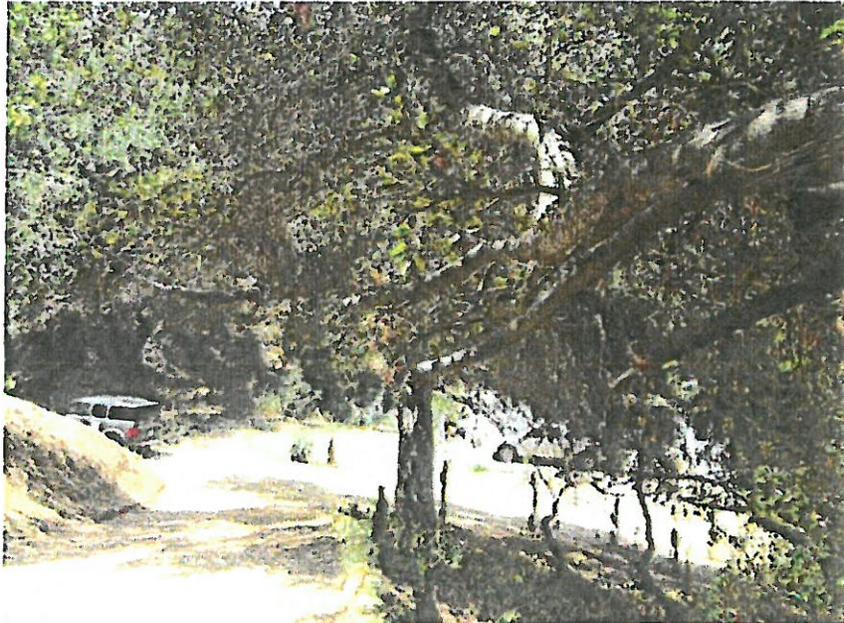
OAK #5 – PHOTO TAKEN IN 2013, STUB CUTS HAVE BEEN CLEANED UP (2015)

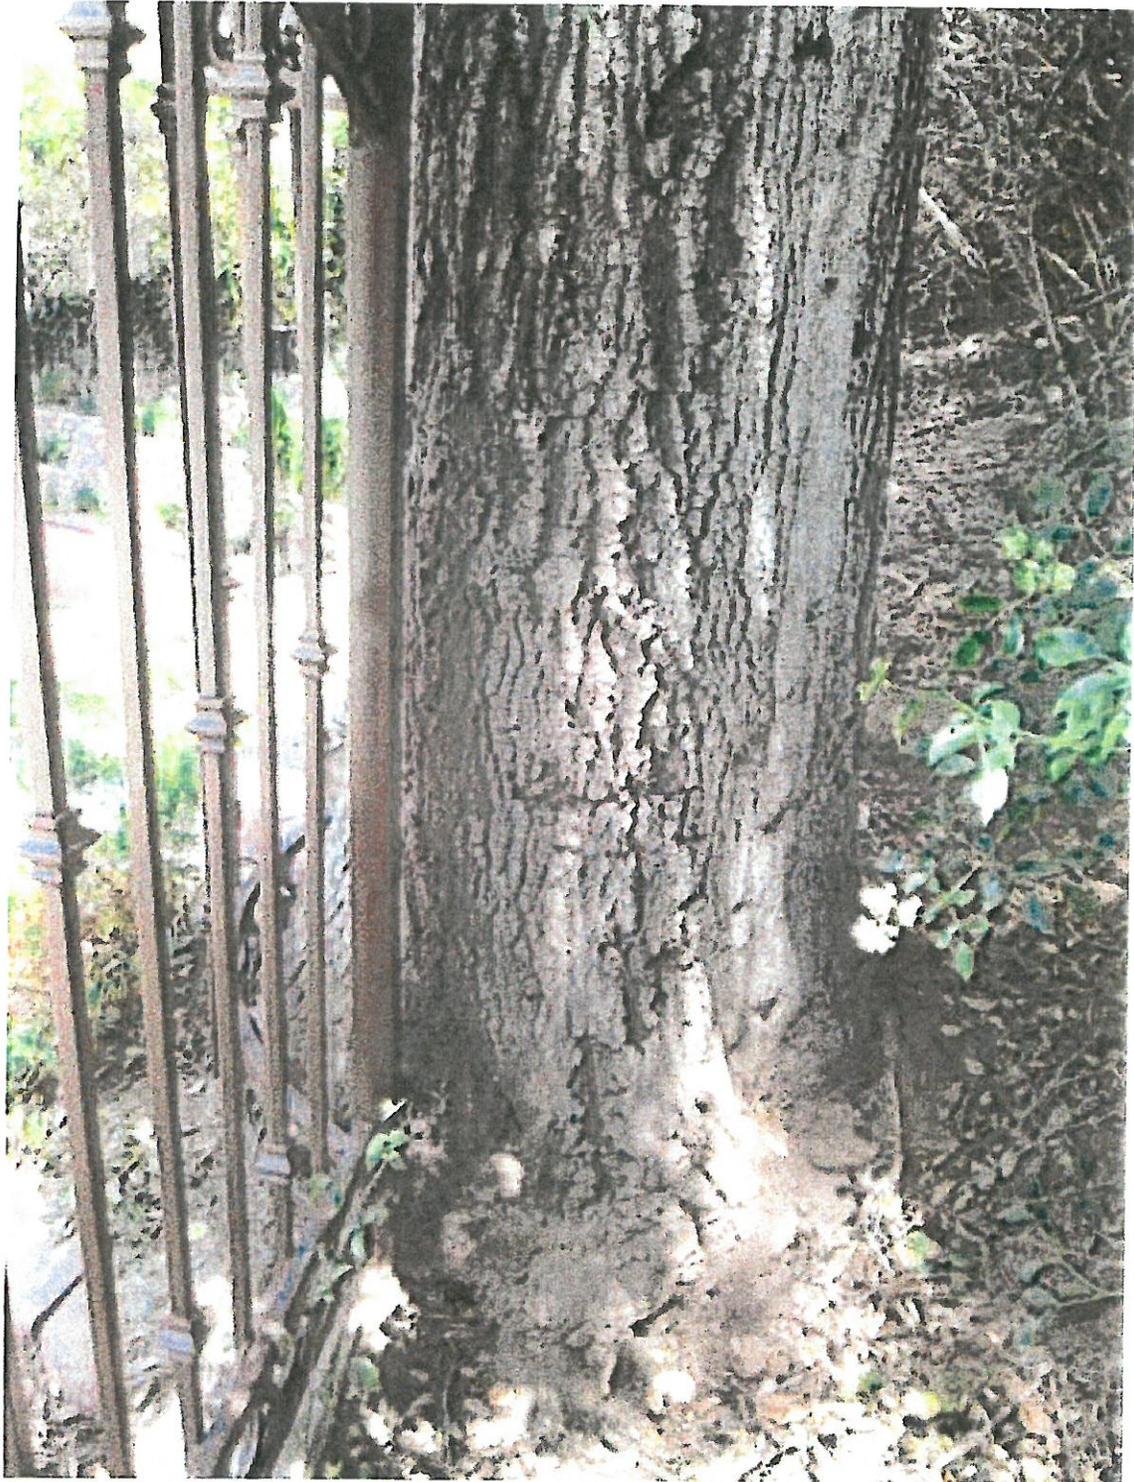
OAK #10 – DAMAGED BY NEW FENCE (2013) BELONGING TO NEIGHBOR

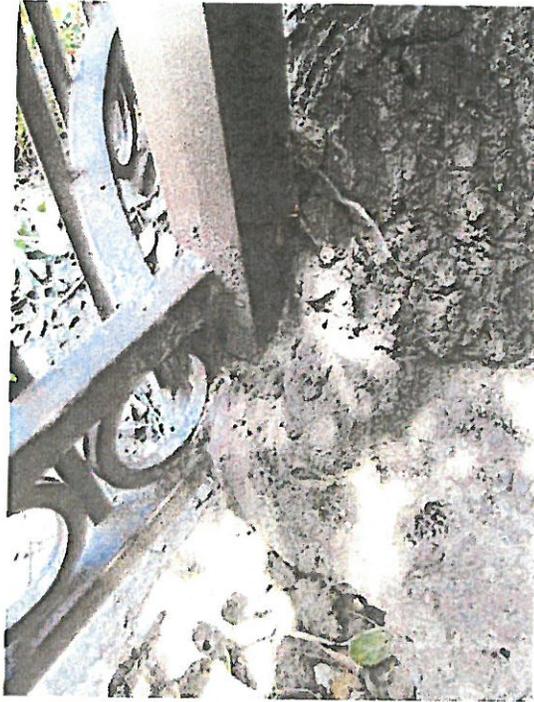
CLOSE UP OF DAMAGE TO OAK #10 FROM FENCE

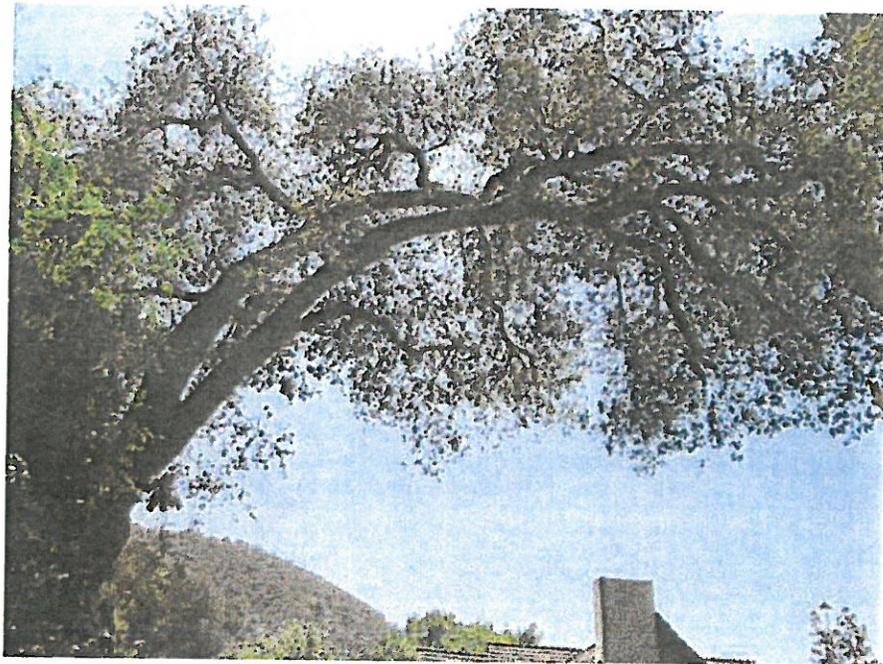
OAK #10 HANGING OVER ADJACENT PROPERTY LOOKING SW

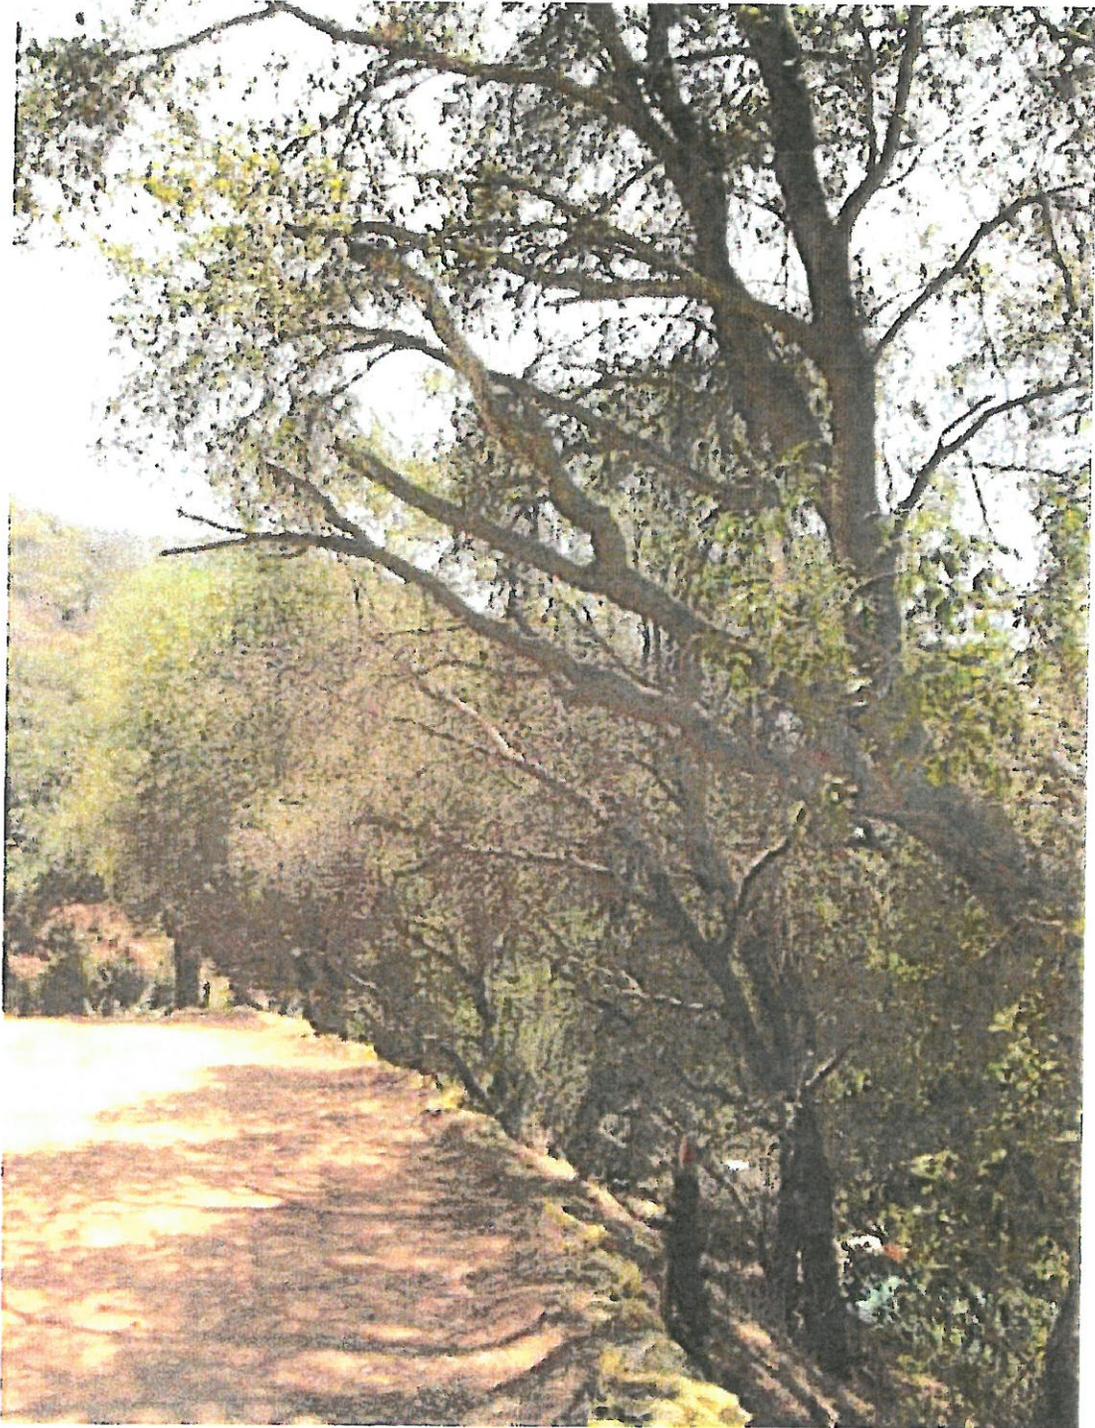
LOOKING SOUTH TO OAKS, 12, 11, 9 AND 5 (PHOTO TAKEN IN 2013, TREES HAVE MOSTLY RECOVERED AND STUBS HAVE BEEN REMOVED)

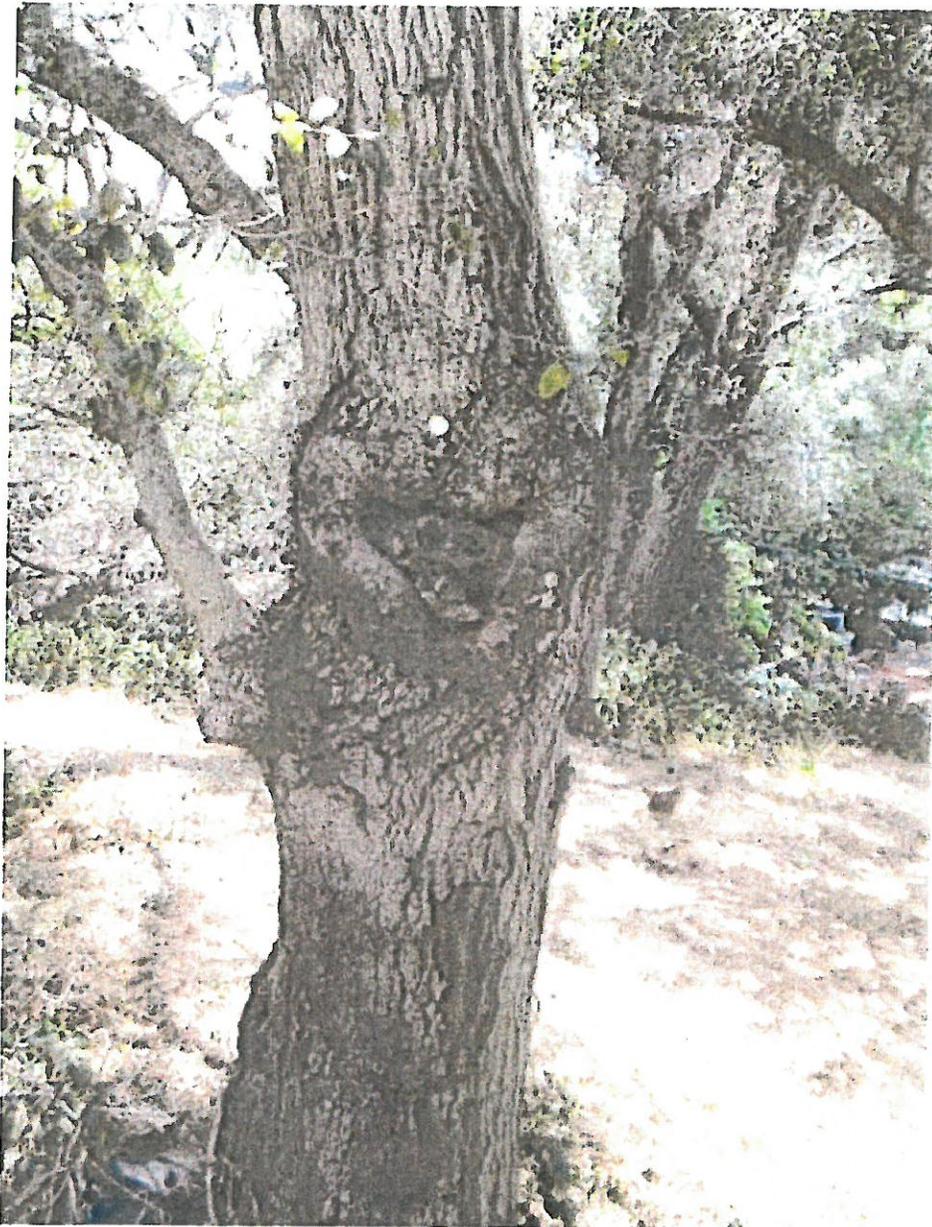
CLOSE UP OF OLD BRANCH FAILURE ON OAK #12

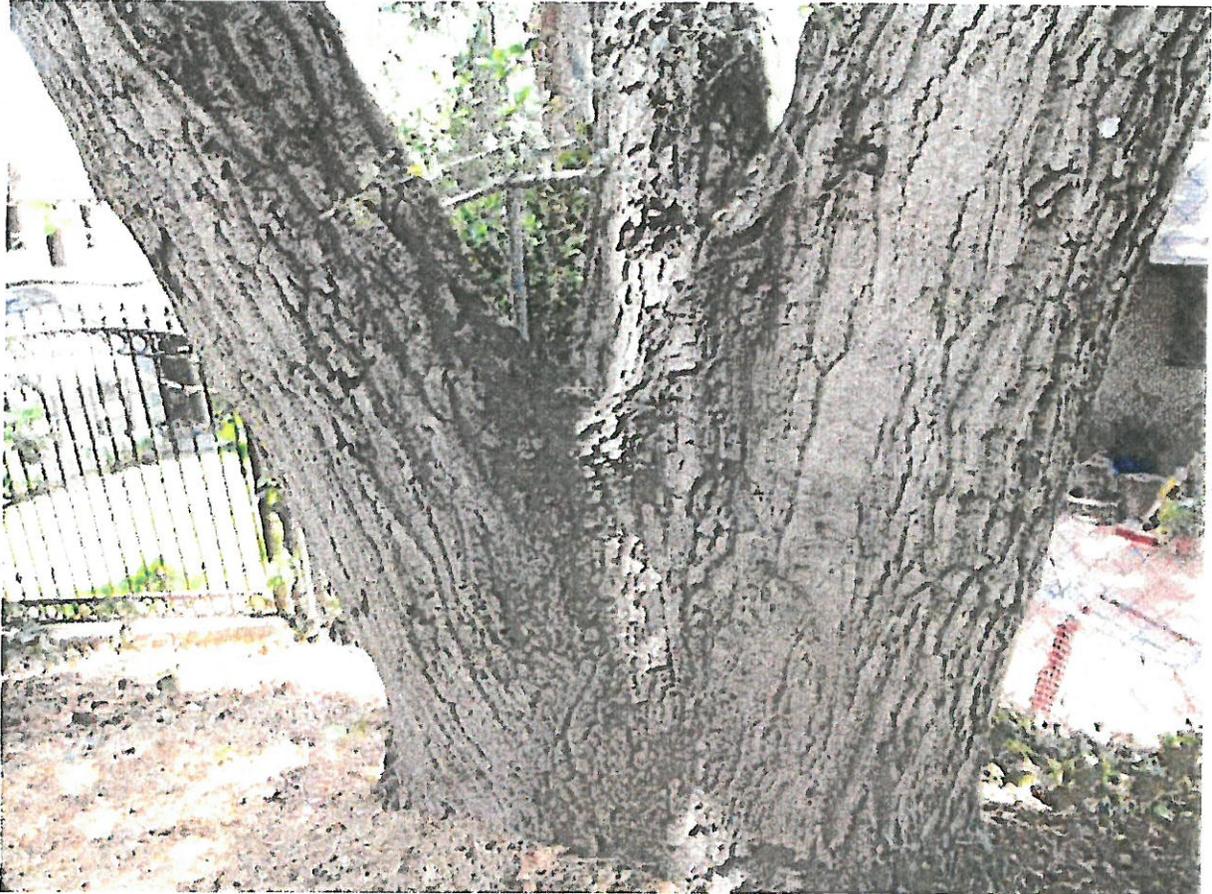
THE BASE OF TREE #16 – CO-DOMINANT TRUNKS

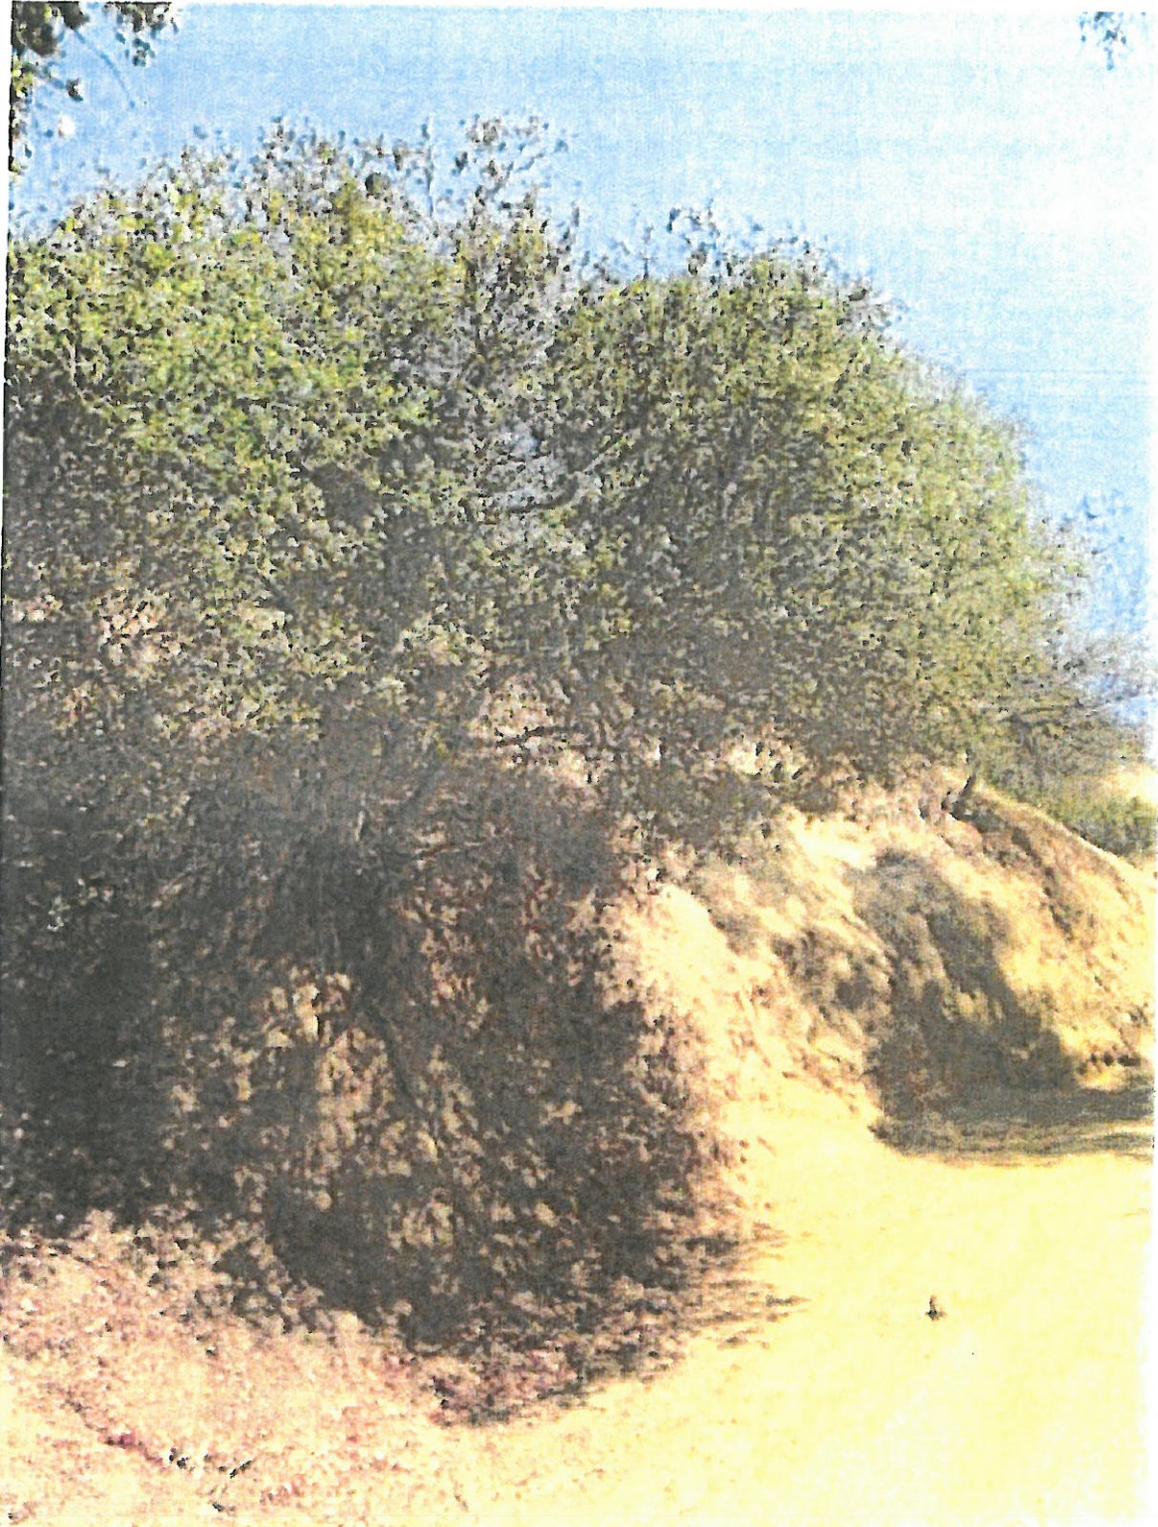
SCRUB OAK #18 – NATIVE WOOD RAT NEST AT BASE (PROTECT)

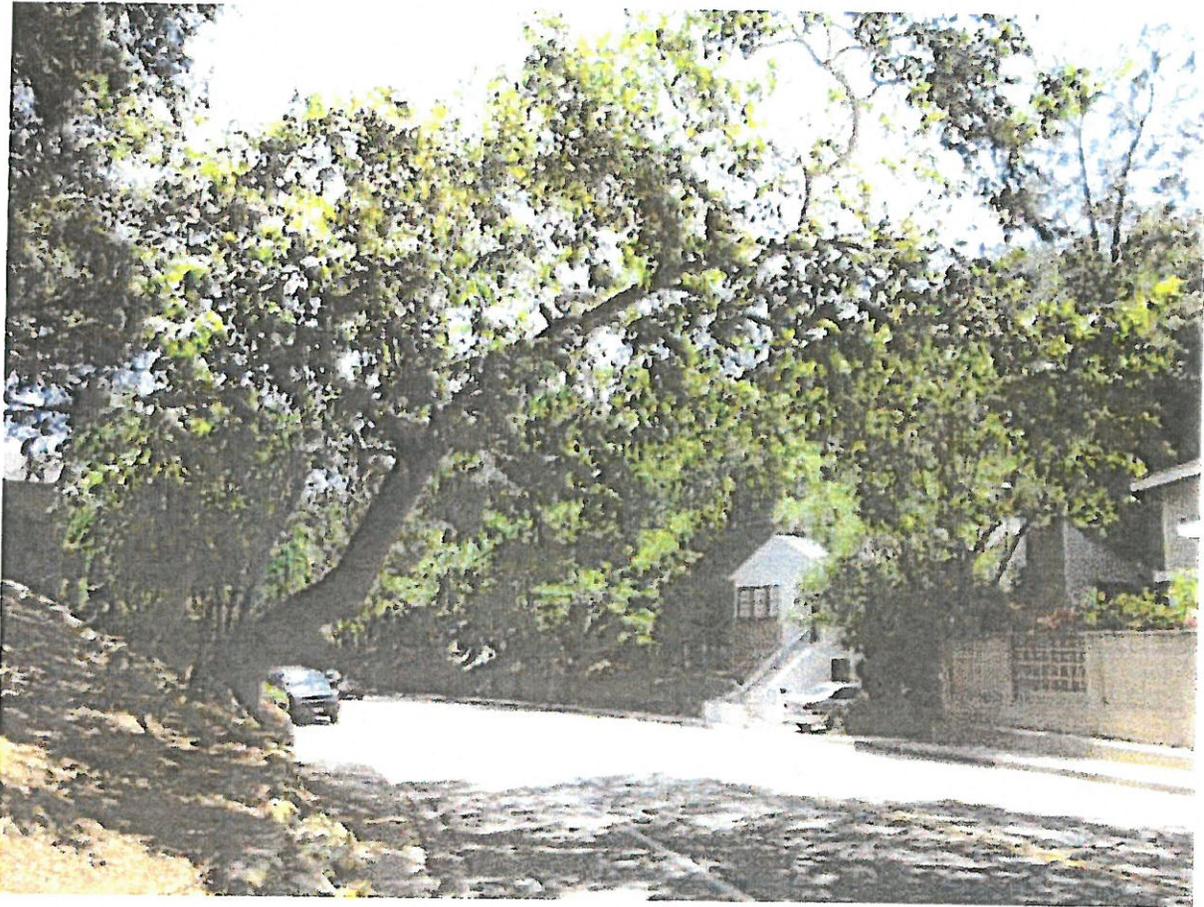
CALIFORNIA SYCAMORE #24 OVER STREET ON CHEVY CHASE
