Rockhaven Sanitarium

Status of the Preservation and Reuse of Rockhaven

August 20, 2024

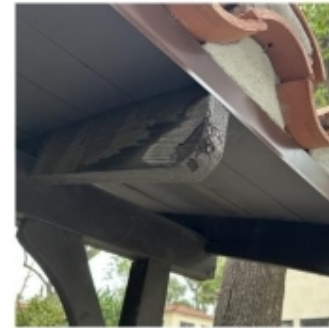
Peeling paint and splitting at wood posts, joists, and beams.

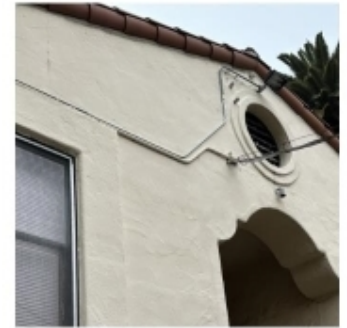
Misc conduit & wiring mounted across facade, connected to contemporary light fixtures.

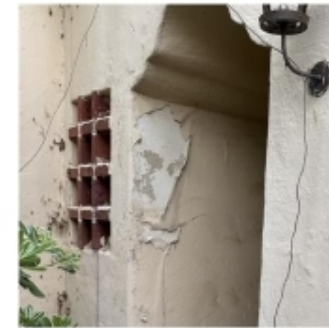
Hairline cracks and peeling paints at painted stucco facades.

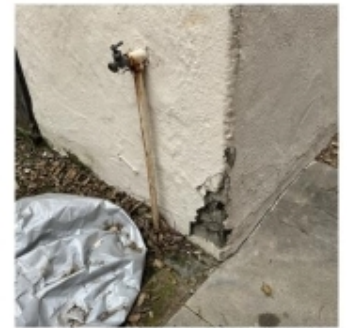
Localized spalling at painted stucco facades.

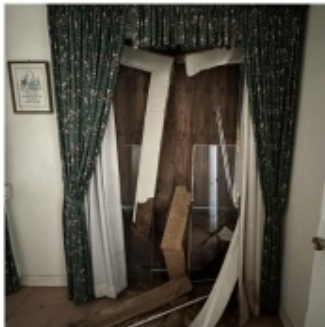
Heavily damaged door opening.

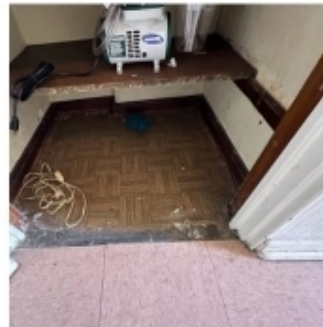
Multiple layers of vinyl flooring throughout; requires asbestos abatement.

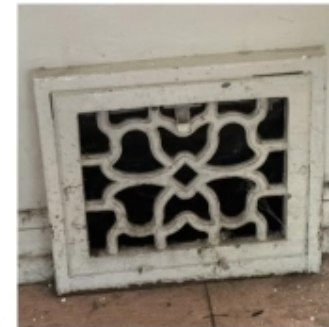
Original cast iron vent covers to be restored and possibly reused.

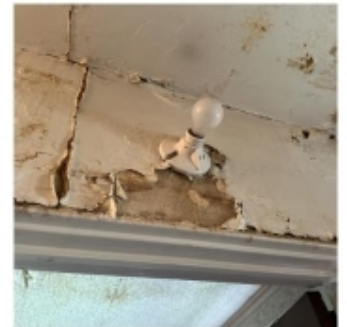
Water damage at ceilings and walls.

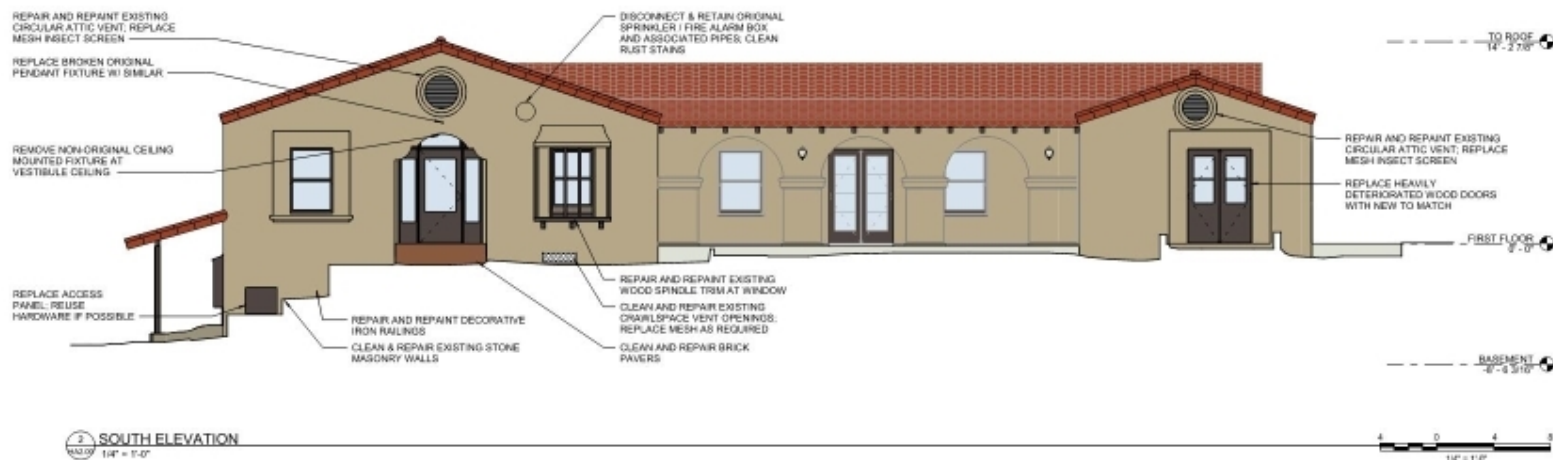
South & West Facades

Repair Exterior Elevations

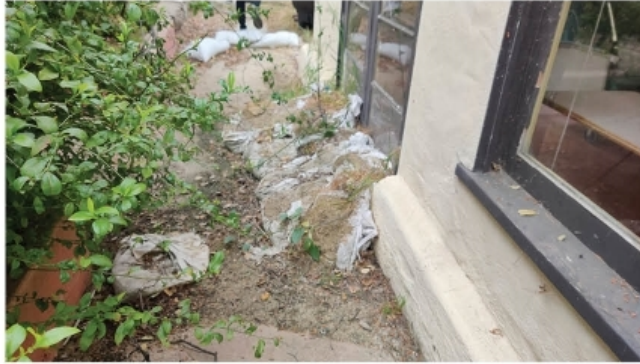
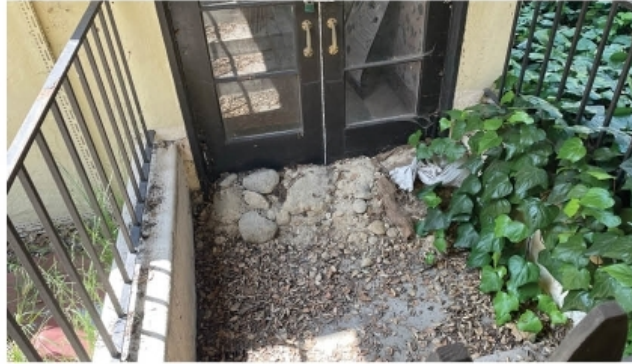
Site Resiliency to Natural Hazards

- Address site's poor drainage
- Protect all buildings from future deterioration from surface run off

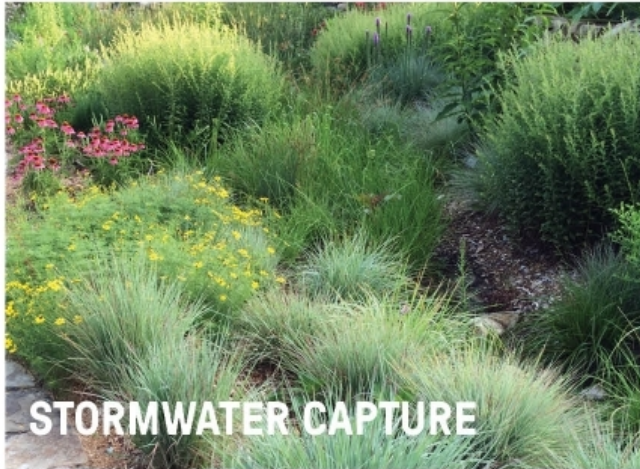
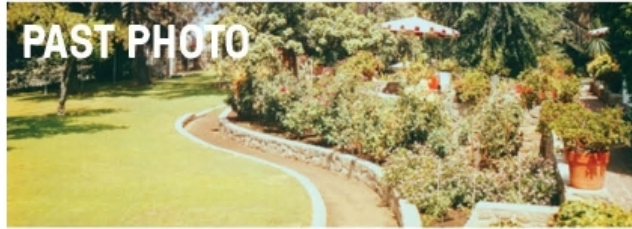
Site Sustainability

- Storm-water capture
- LID Compliance
- Balance selection of drought tolerant planting versus Historic Character
