**A RESOLUTION OF THE CITY COUNCIL OF THE CITY OF GLENDALE, CALIFORNIA,
APPROVING A RESPONSE TO THE JUNE 21, 2022 LOS ANGELES COUNTY CIVIL
GRAND JURY REPORT ENTITLED “WATER, WATER EVERYWHERE LEAKING
FROM THE PIPES” AND DIRECTING THE CITY MANAGER, OR HIS DESIGNEE, TO
SUBMIT SAID RESPONSE TO THE CIVIL GRAND JURY**

City of Glendale Response to June 21, 2022 Los Angeles County Civil Grand Jury Report Entitled “Water, Water Everywhere Leaking from The Pipes”

An Asset Management Planning Tool for Water Utilities

Utah State University
Buried Structures Laboratory
Steven Folkman, Ph.D., P.E.

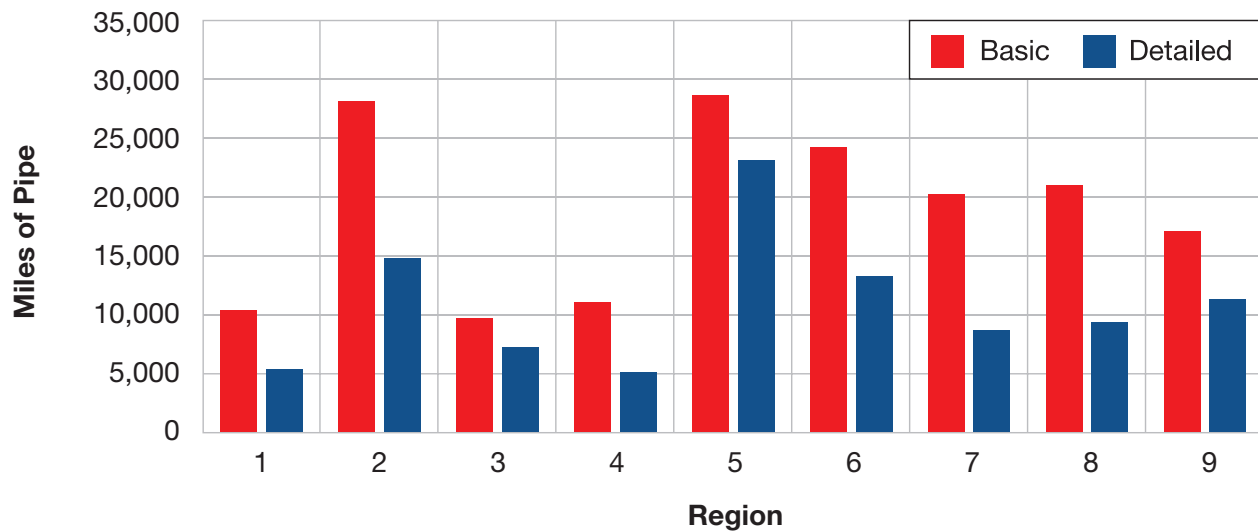
FIGURE 2: LENGTH OF PIPE FROM EACH REGION THAT RESPONDED TO THE BASIC AND DETAILED SURVEYS

Based on miles of pipe shown in Figure 2, the basic survey got the most miles of pipe from Regions 2 and 5. Figure 3 shows that the peak number of respondents came from Region 6.

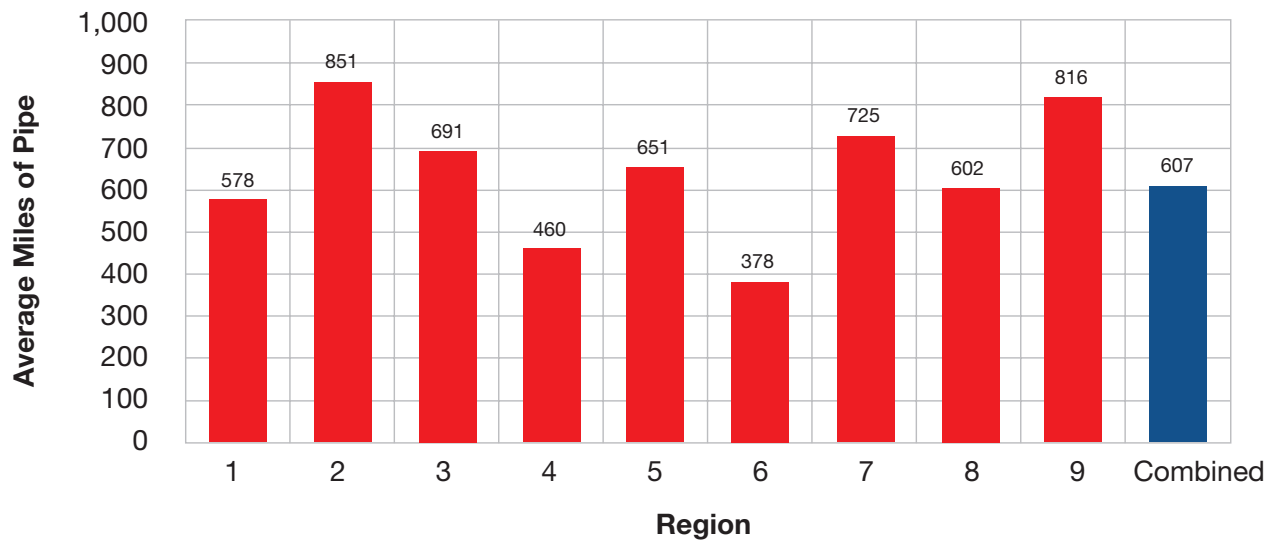
FIGURE 4: AVERAGE MILES OF PIPE FROM EACH REGION RESPONDING TO THE BASIC SURVEY

Figure 4 shows the average miles of pipe per utility for the basic survey by region. Region 2 had the highest average pipe length of 851 miles and Region 6 had the smallest with 378 miles. Overall, based on the basic survey, an average utility participant had 607 miles of pipe and served 186,752 people. For comparison, the 2012 survey results reported an average utility had 626 miles of pipe and served 164,325 people, which are similar results. The 2012 survey had 188 respondents covering 117,603 miles of pipe with failure data and thus the 2018 basic survey had a 49% increase in respondents and 45% more miles of pipe. This increase in survey coverage increases the statistical validity of this study.

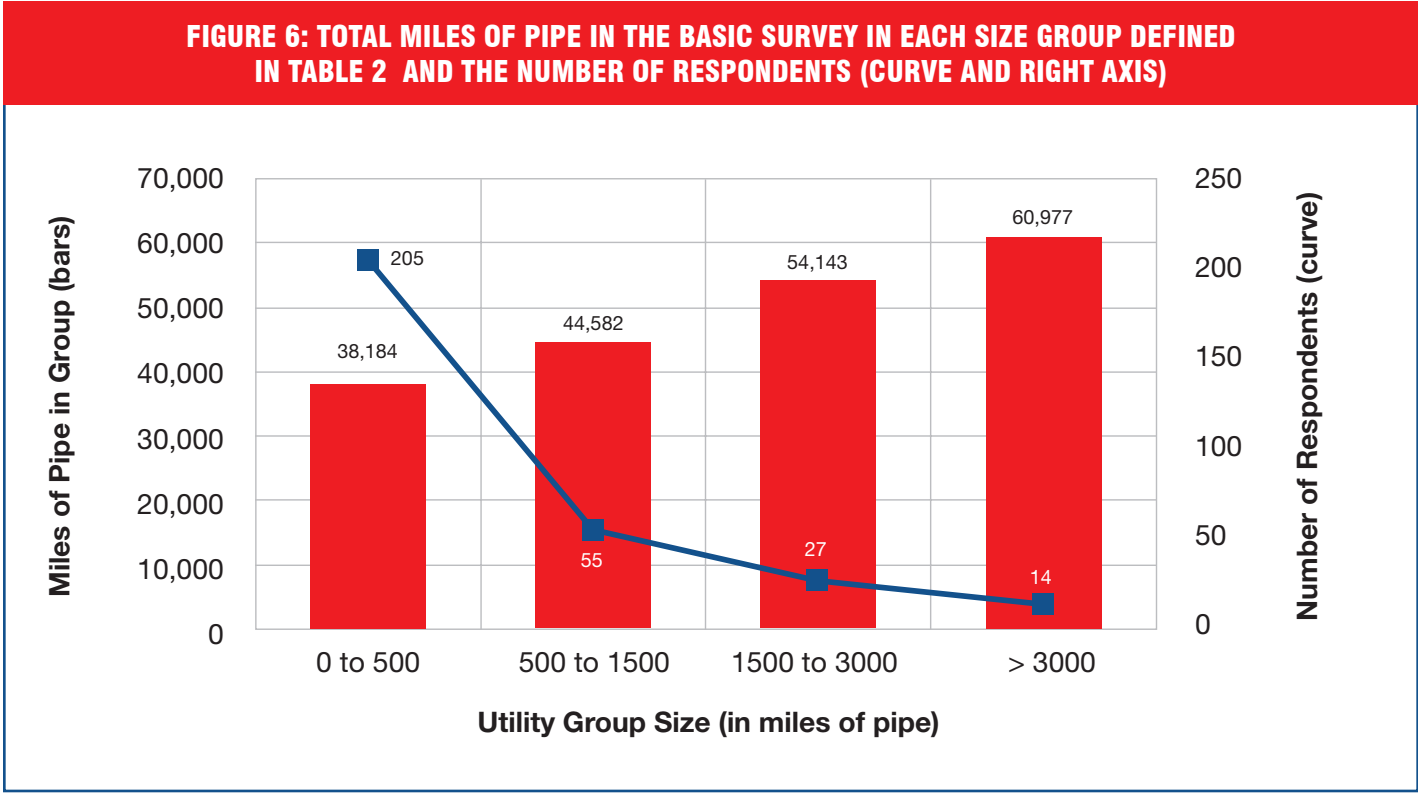
Four categories of utility size were used as shown in Table 2 and each survey participant was allocated to one of the categories based on the miles of installed water mains. Figure 6 shows the distribution of total miles of pipe from the basic survey based on these categories (bar graph) along with the number of respondents (line graph with right axis). Respondents covered the range from very small to very large with each group from Table 2 well represented. In terms of total length of pipe from each of the size groups in Table 2, this survey has reasonable uniform distribution of pipe length from small to large utilities.

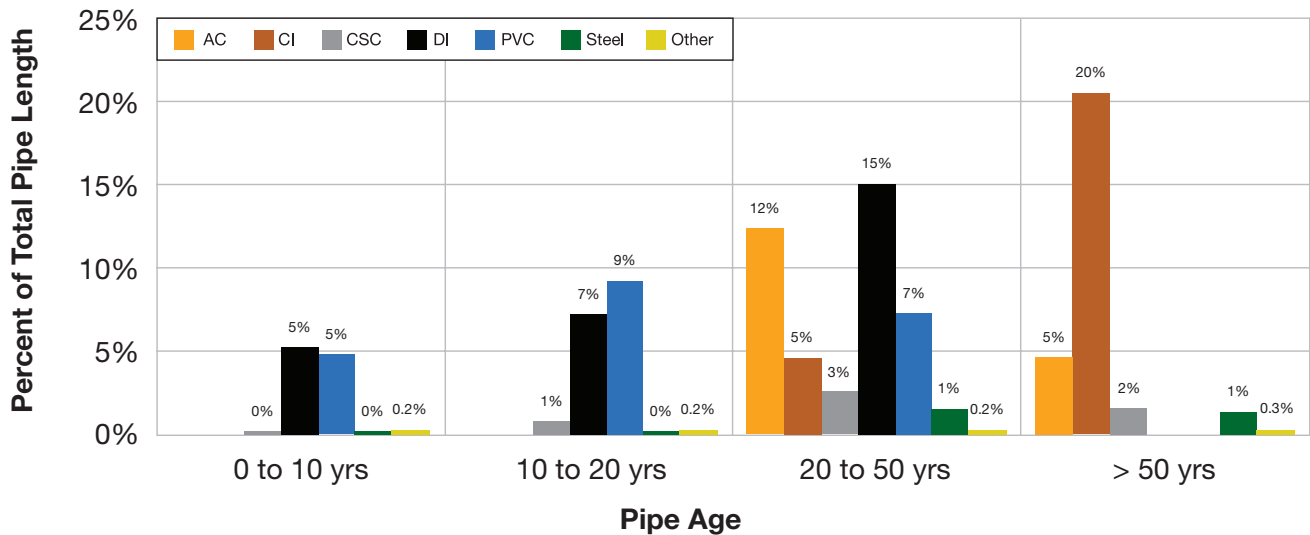
FIGURE 14: PERCENT OF TOTAL LENGTH OF PIPE BY AGE FROM THE DETAILED SURVEY

Figure 14 shows the age distribution as a percentage of total length of all pipe materials. For example, cast iron pipe older than 50 years is 20% of all installed pipe. For ages between 0 to 10 years, ductile iron (DI) and PVC both have about 5% of the total installed length. The most common pipe materials installed during the last 10 years are DI and PVC.

Comparing this 2018 survey with the 2012 survey in Table 5 shows that overall, break rates increased by 27%. The change is primarily due to failures in asbestos cement (AC) and cast iron (CI) pipes with increases of break rates by over 40%. As Figure 14 shows, AC and CI pipe represent the largest percentage of oldest pipe currently installed and thus are nearing the end of their useful lives. Many studies show that water-main failure rates generally increase exponentially over time (Kleiner, 2002). One could envision a rapid increase in break rates in the future as illustrated in Figure 21. Certain utilities could experience the need to rapidly accelerate the rate at which they are replacing CI and AC water mains. If a break rate doubles, the economic impact is significant; one would need to double the number personnel repairing the breaks along with supplies while loss of treated water increases, and societal impacts could be devastating.

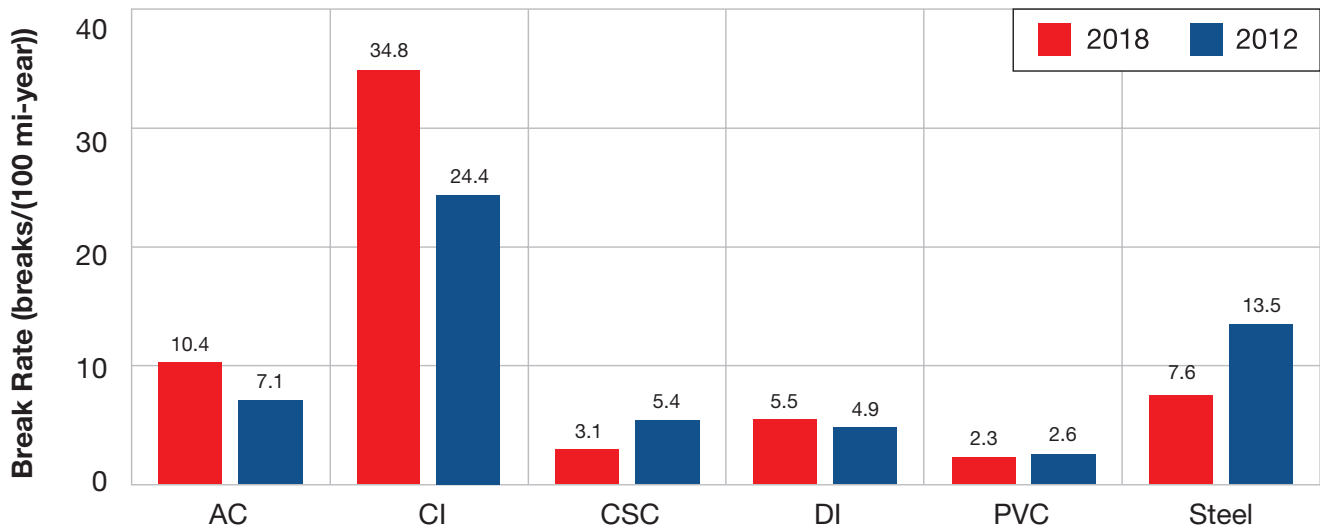
FIGURE 22: COMPARISON OF BREAK RATES OF THE 2018 AND 2012 SURVEYS

Figure 22 compares the break rates of the 2012 and 2018 surveys. Since over 90% of installed pipe consists of AC, CI, DI, and PVC, the break rates for those material types will be most accurate. From 2012 to 2018, Figure 22 shows a small decrease in break rates for PVC and a small increase for DI pipe. The overall consistency of those values demonstrates they are accurate. Again, the increase in break rates for AC and CI pipes is a very significant observation.

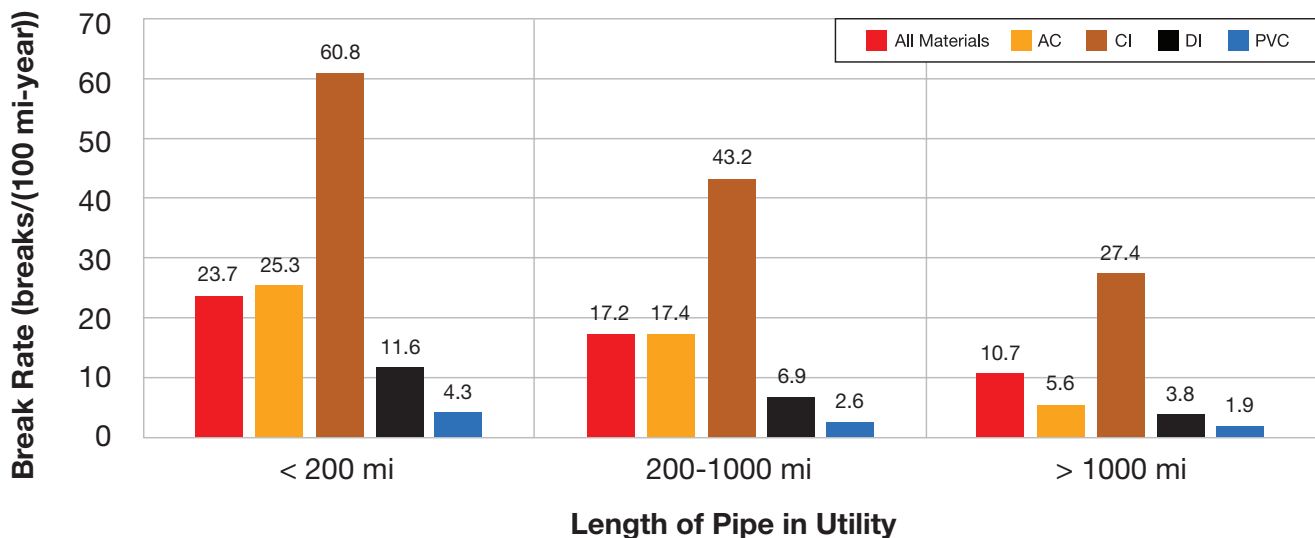
FIGURE 23: BREAK RATES BY UTILITY SIZE FROM THE BASIC SURVEY

The size of a utility can affect break rates. Three sizes of utilities are considered here based on the length of pipe; small with less than 200 miles, intermediate with 200 to 1000 miles, and large with over 1000 miles. Figure 23 illustrates the overall break rate (for all pipe materials) and then separated by the four most common pipe materials in these three utility sizes. The large utilities consistently had lower break rates than intermediate and smaller utilities. This is likely due to better funding and larger staffs for engineering design, monitoring and information gathering, installation oversight, and repair of water mains. It is very significant that small utilities consistently have break rates at least double that of a large utility.

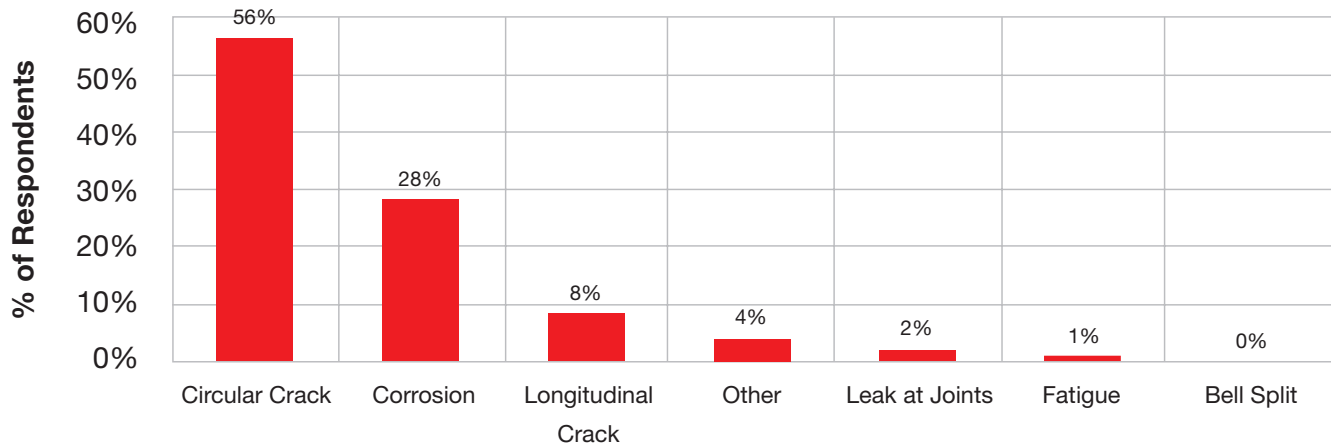
FIGURE 27: PERCENT OF RESPONDENTS SELECTING A MOST COMMON FAILURE

The detailed survey requested participants to select the most common failure mode from the following: corrosion, bell split, circumferential crack, longitudinal crack, leakage at joints, fatigue, or other. Figure 27 illustrates that 56% of the respondents identified a circumferential crack as the most common followed by corrosion at 28%. These are the typical failure modes of CI and AC pipe.

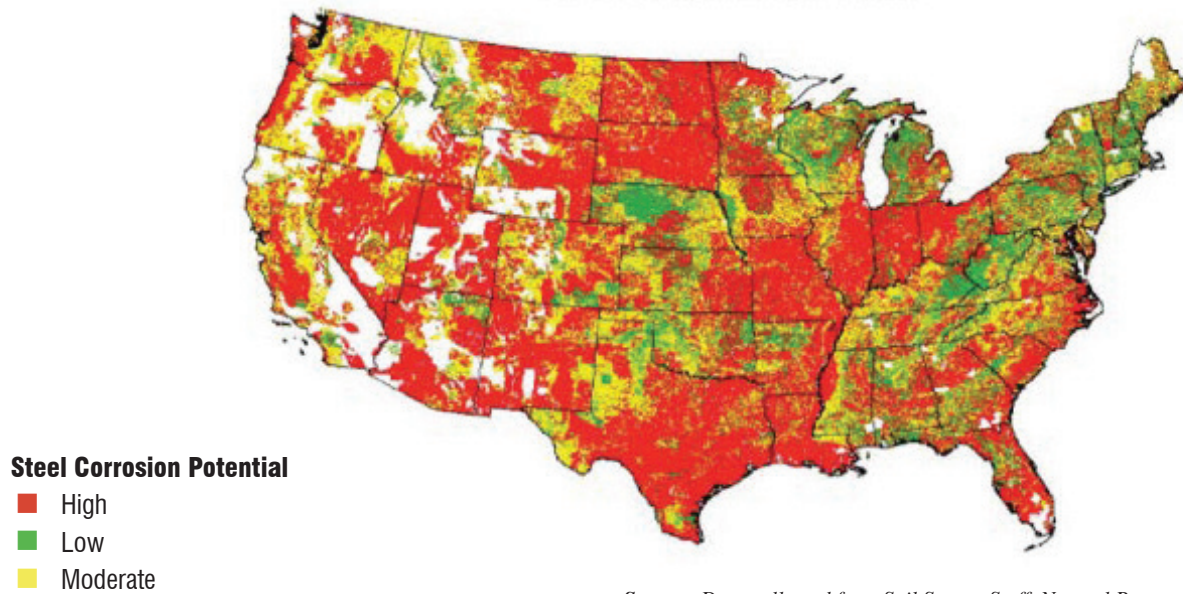
FIGURE 30: US CORROSIVE SOILS MAP (CONUS POTENTIAL FOR STEEL CORROSION)

Source: Data collected from Soil Survey Staff, Natural Resources Conservation Service, U.S. Department of Agriculture Soil Survey Geographic Database.

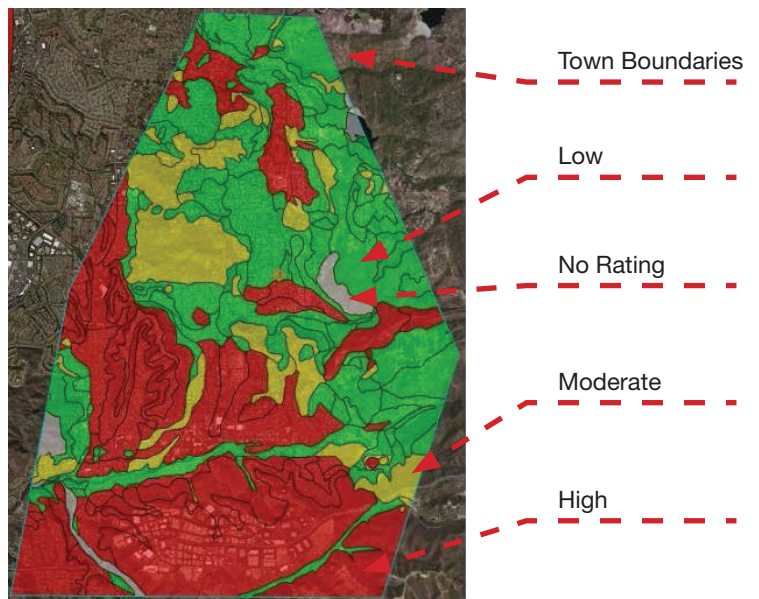
FIGURE 31: CORROSIVE SOIL RISK PLOT

Soil risk can change over a distance of a few blocks. This is illustrated in Figure 31 which shows a screen capture of soil risk colors inside the boundaries of a town in California. This town has all three regions present; low (green), moderate (yellow), and high (red). Soil analysis data is not available in regions with a light gray color.

It was desired to relate water main break rates to soil corrosivity. Since most cities have a combination of low, moderate, and high regions, a numerical ranking was developed that provided an overall level of soil corrosiveness. To do that, pictures of each area served by the utilities in the basic survey were created. Next a program was developed that counted the number of reddish, greenish, and yellowish pixels in each photo. To provide a numerical ranking, pixels that were low risk were given a value of 1, moderate pixels were given the value 2, and high risk pixels were given the value 3. The pixel values were summed and then divided by the total number of red, yellow, and green pixels. The computed value is called a corrosion index. Cities with a corrosion index near 1 have low corrosion risk while those close to 3 have high corrosion risk. For the area in Figure 31, the computed corrosion risk was 2.1 or slightly above a moderate level.

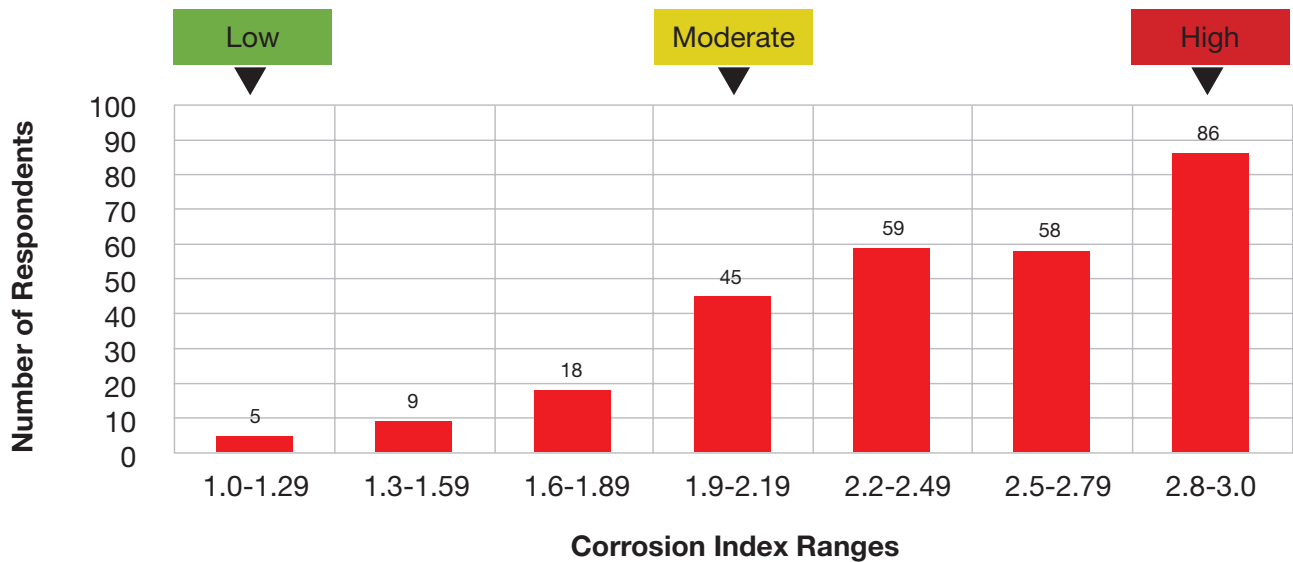
FIGURE 32: NUMBER OF UTILITIES VERSUS THEIR CORROSION INDEX

Corrosion index values were computed for 281 cities in the US. Some US cities had little or no data for the soil inside their boundaries preventing computation of a corrosion index. For analysis, the corrosion index values were broken down into seven ranges and the number of utilities in each range is plotted in Figure 32. The average corrosion index for all the US utilities in the basic survey was 2.4 or close to midway between moderate and high corrosion risk. That is, most utilities in the US have a moderate to high soil corrosion risk which is consistent with the detailed survey report that showed 75% of utilities have one or more areas with corrosive soils.

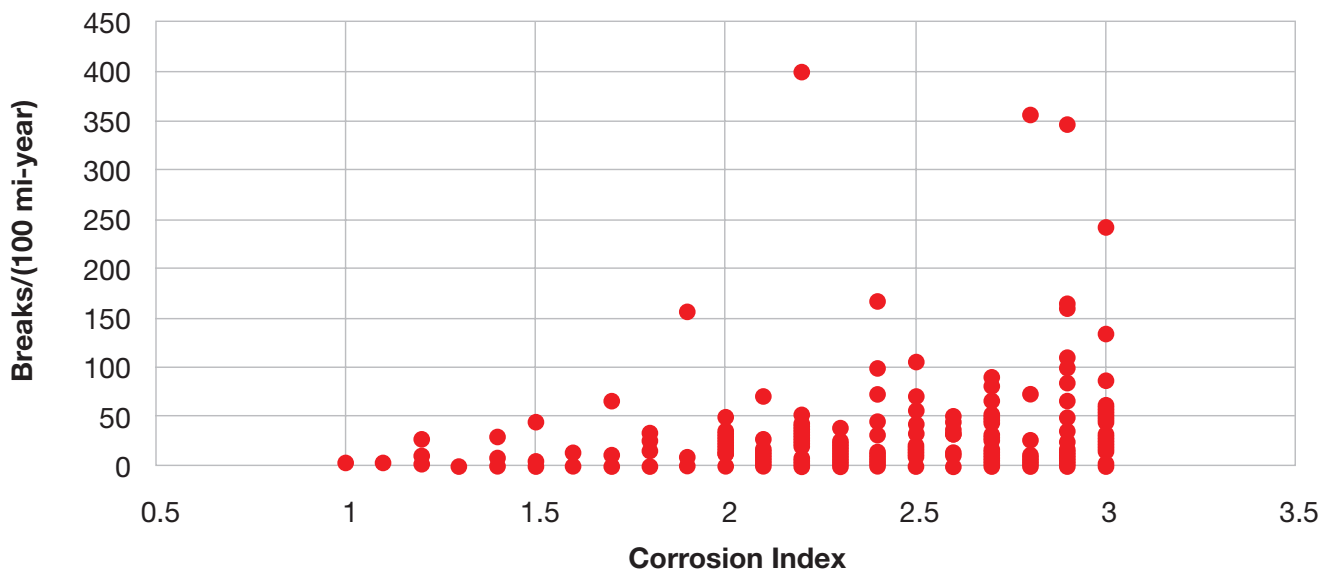
FIGURE 33: INDIVIDUAL UTILITY BREAK RATES FOR CAST IRON PIPE VERSUS THEIR CORROSION INDEX

It is reasonable to expect break rates would increase when pipe is installed in corrosive soils. To examine this, plots were made of a utility's corrosion index versus break rate. Figure 33 illustrates this for cast iron pipe. There is a trend of higher break rates with increasing corrosion index, but the wide scatter in the data makes analysis difficult. The high break rates in Figure 33 are associated with small utilities that have a small amount of pipe. Consider a utility with 1 mile of cast iron pipe with 2 breaks during the past year. That would translate to a break rate of 200 breaks/(100 miles)/year. If that utility had no breaks the following year, the break rates drop to zero.

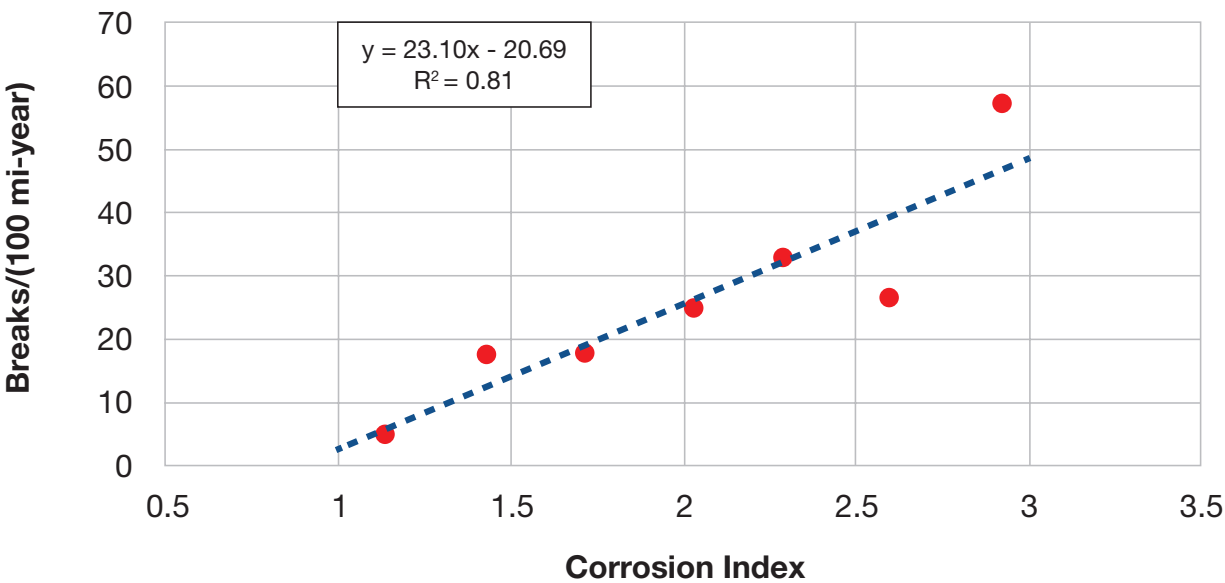
FIGURE 34: CAST IRON PIPE BREAK RATE VERSUS CORROSION INDEX

To get a realistic estimate of break rates, we need to add the number of breaks of a pipe type from several utilities and divide by the sum of the length of that pipe type to compute break rates. The corrosion index data was broken down into the same seven categories used in Figure 32. The results are listed in Table 7. The break rates versus corrosion index data are plotted in Figure 34 for cast iron pipe and Figure 35 for ductile iron pipe. The figures also contain a regression equation fit and a correlation coefficient. Correlation coefficients close to 1.0 indicates an excellent correlation and zero indicate no correlation. Both cast and ductile iron results in reasonably good fits to the data.

Using the equations in Figure 34 with $x=1$ for a low corrosion risk and $x=3$ for a high corrosion risk, one can show that a cast iron pipe in a high corrosion soil is expected to have over 20 times the break rate of one in a low corrosion soil. Similarly, ductile iron pipe in a high corrosion soil has over 10 times the break rate than one in a low corrosion soil. Very poor correlations were found for the other material types in this survey.

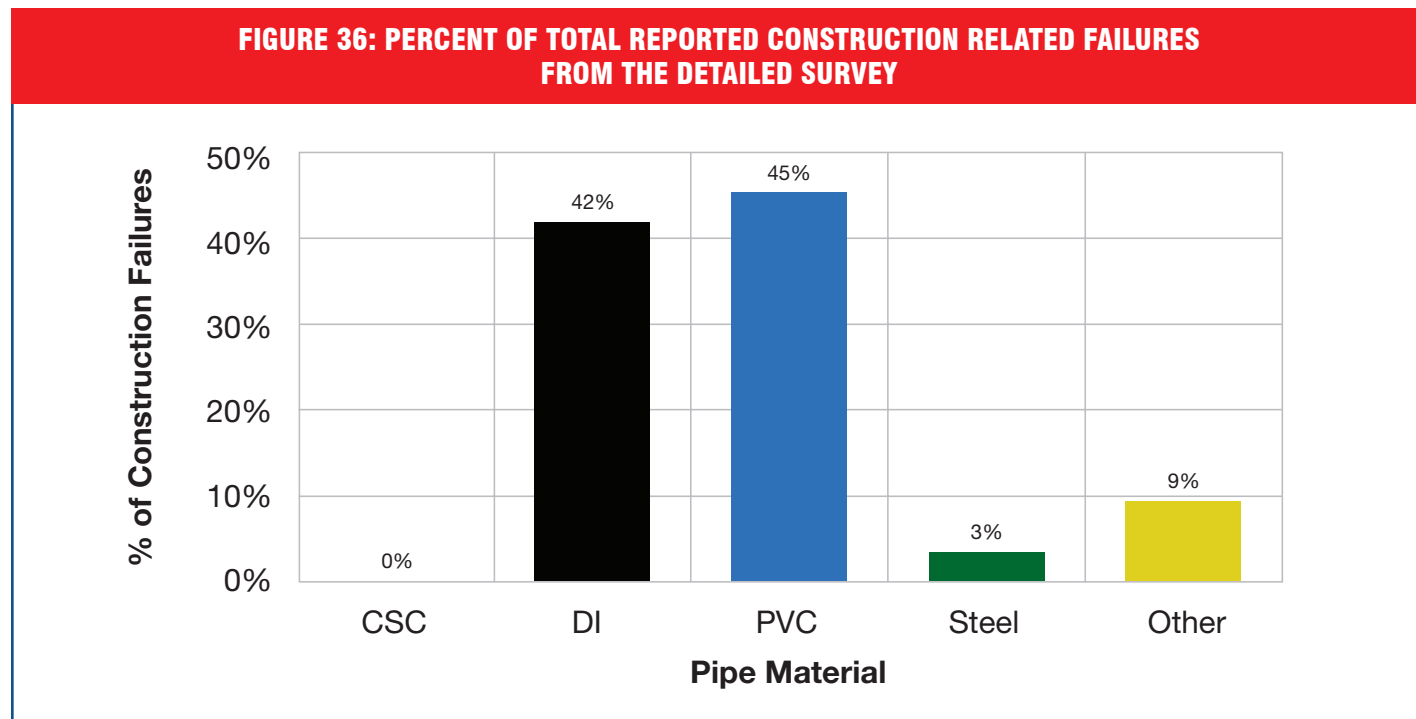
The detailed survey asked respondents to report failures related to construction activities. Figure 36 illustrates the percentage of total construction failure related to a particular pipe material. Ductile iron and PVC pipes have the majority of construction related failures at a nearly equal frequency. Figure 14 shows that DI and PVC are the two pipe materials that are also most commonly being installed today. This points to the need to improve construction practices for underground infrastructure regarding installation, location services and inspection.
