Water Main Break Rates In the USA and Canada: A Comprehensive Study

An Asset Management Planning Tool for Water Utilities

Utah State University
Buried Structures Laboratory
Steven Folkman, Ph.D., P.E.

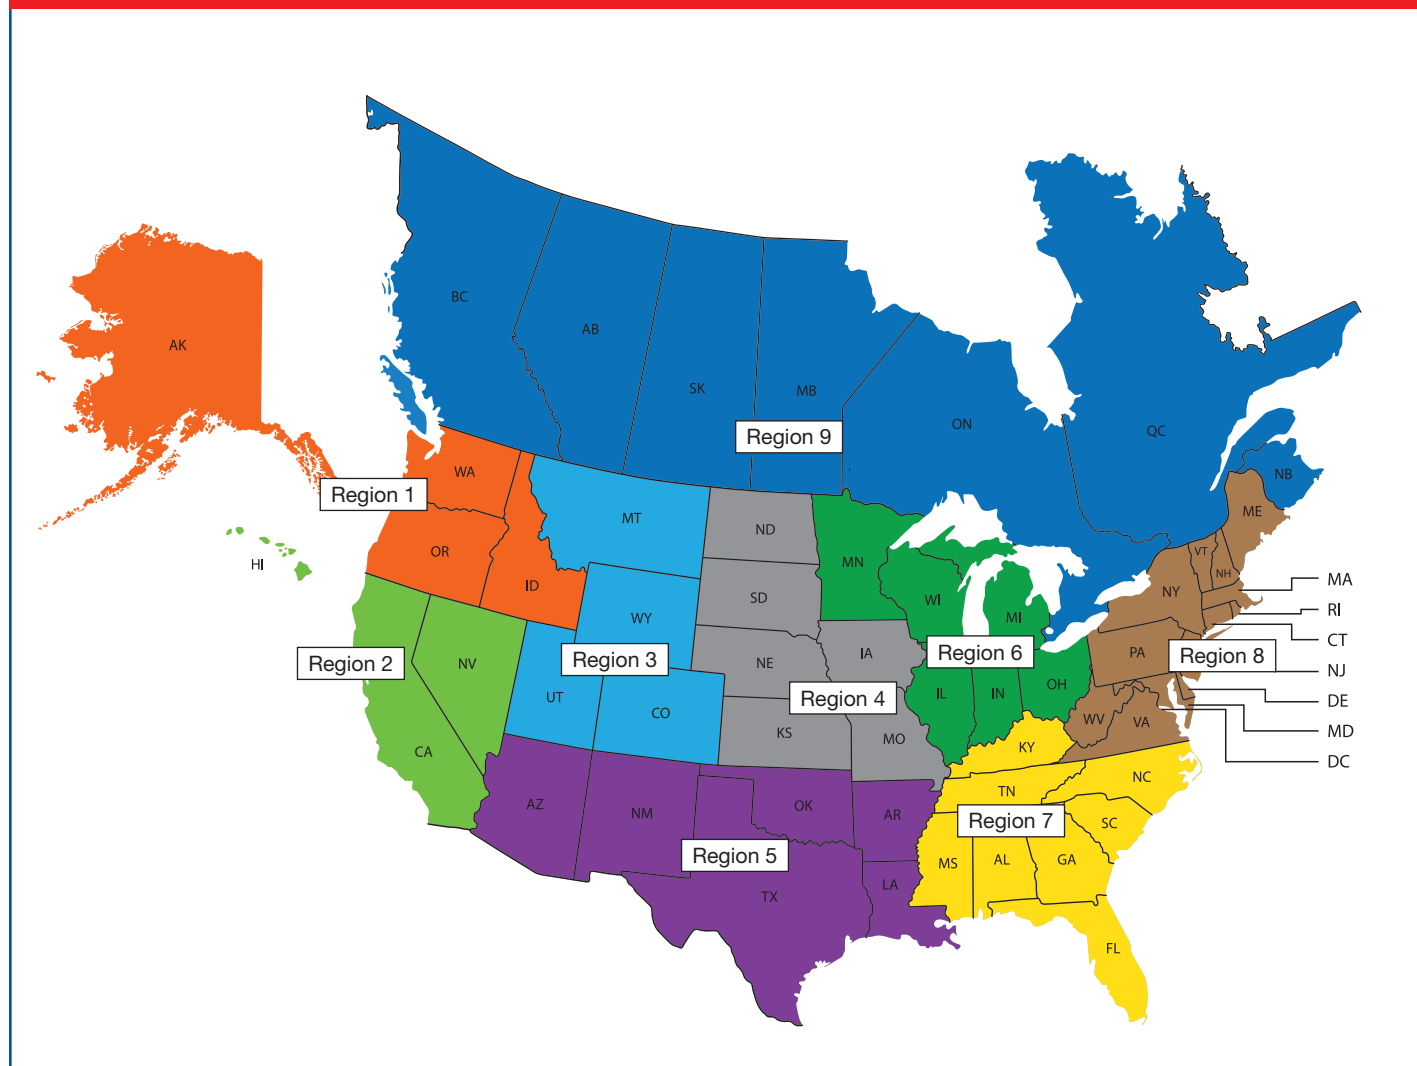
FIGURE 1: REGIONS USED TO REPORT SURVEY RESULTS

In total, 281 utilities participated in the surveys and provided failure data. To examine regional variations, nine survey regions in the United States and Canada were selected. The regions defined in the study are used here to indicate the wide geographical distribution of the respondents. Table 1 lists the number of respondents with failure data, the miles of pipe, and the population served in the basic and detailed surveys from each region. Figure 1 illustrates the locations of the nine different regions used in this report. Respondents were asked to report the length of water supply mains in their system but not to include sewer or force mains or lines with a diameter less than 3 inches. Figure 2 illustrates the miles of water main pipe that were reported in the basic and detailed surveys on a regional basis. A total of 170,569 miles and 98,097 miles of pipe was reported by respondents in the basic and detailed surveys, respectively. Figure 3 illustrates the number of respondents from each region. There were 26 additional respondents to the basic survey that could not provide failure data and these are not included in the miles of pipe or populations served in Table 1. The respondents are distributed across a large survey area. The basic survey

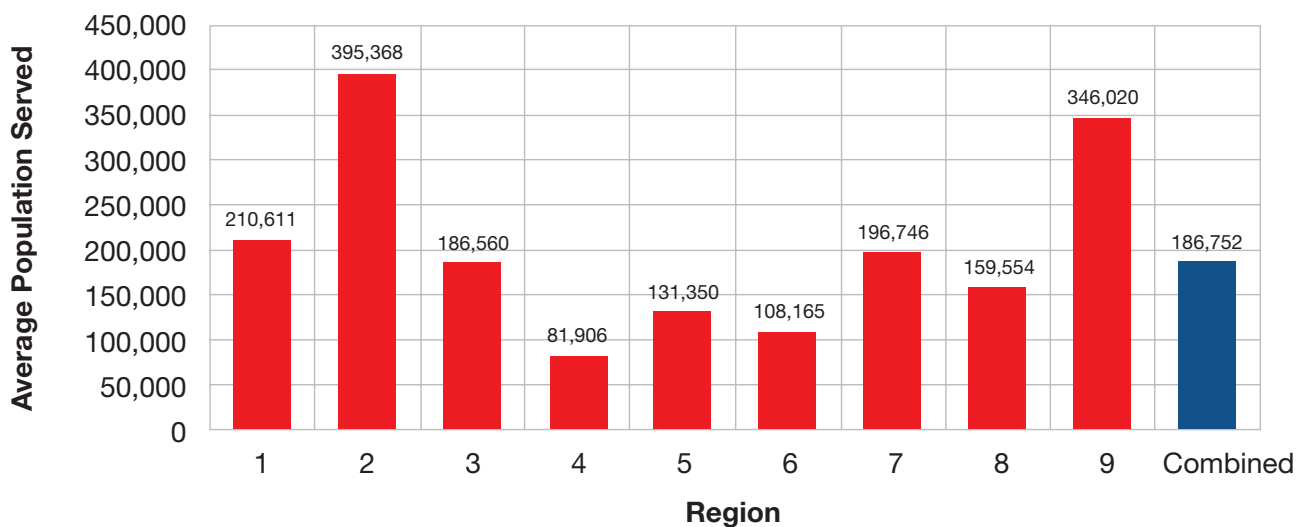
FIGURE 5: AVERAGE POPULATION SERVED FROM EACH REGION RESPONDING TO THE BASIC SURVEY

Figure 5 shows the average population served per utility for each region in Figure 1. The average population served per utility for the entire basic survey was 186,752.

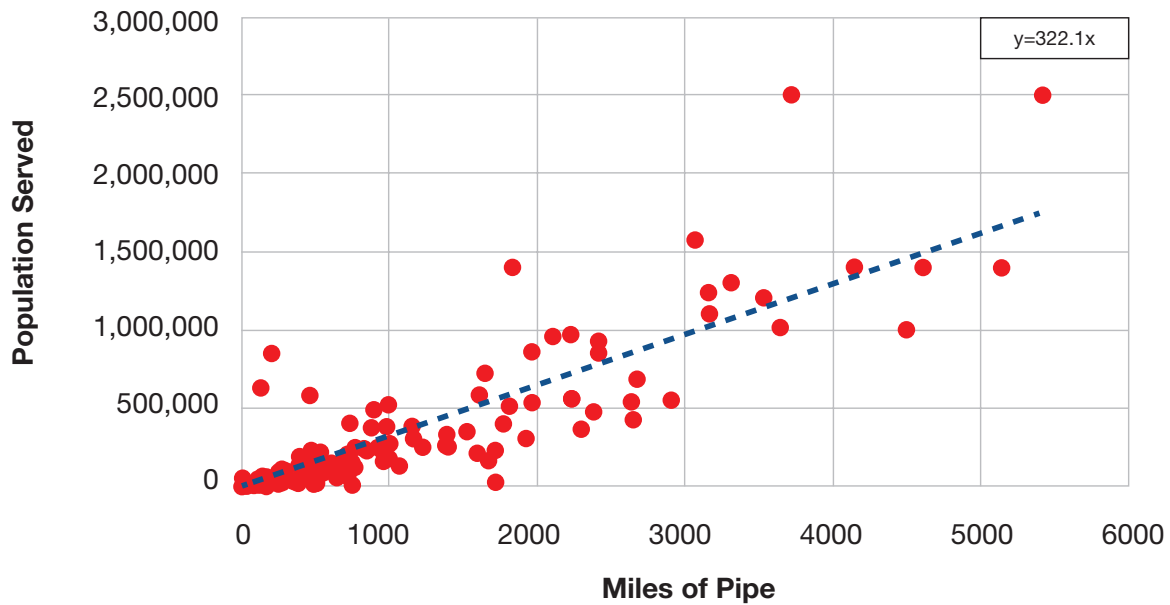
FIGURE 7: POPULATION SERVED RELATIVE TO TOTAL MILES OF PIPE FROM THE BASIC SURVEY

Figure 7 illustrates the relationship between the population served by the utilities participating in the basic survey and the number of miles of water main pipe. The trend line and equation are a best fit to the data. The slope of this line indicates that there are on average 322 people served for each mile of water main installed. Figure 7 tends to be biased by the points most distant from the origin. Figure 8 utilizes the data in Table 1 to compute average population served per mile of pipe for each region. We see that this produces an overall average of 308 people served per mile. More rural areas such as Regions 3, 4, and 5 have lower population to miles of pipe ratios as expected. Utilities that were exclusively transmission systems were excluded. This compares with a commonly used estimate of 325 people per mile (Eidinger, 2001). The 2012 survey reported this value as 264 people served per mile. Pipe breaks in utilities with a higher count of people per mile would have a greater impact on the community.

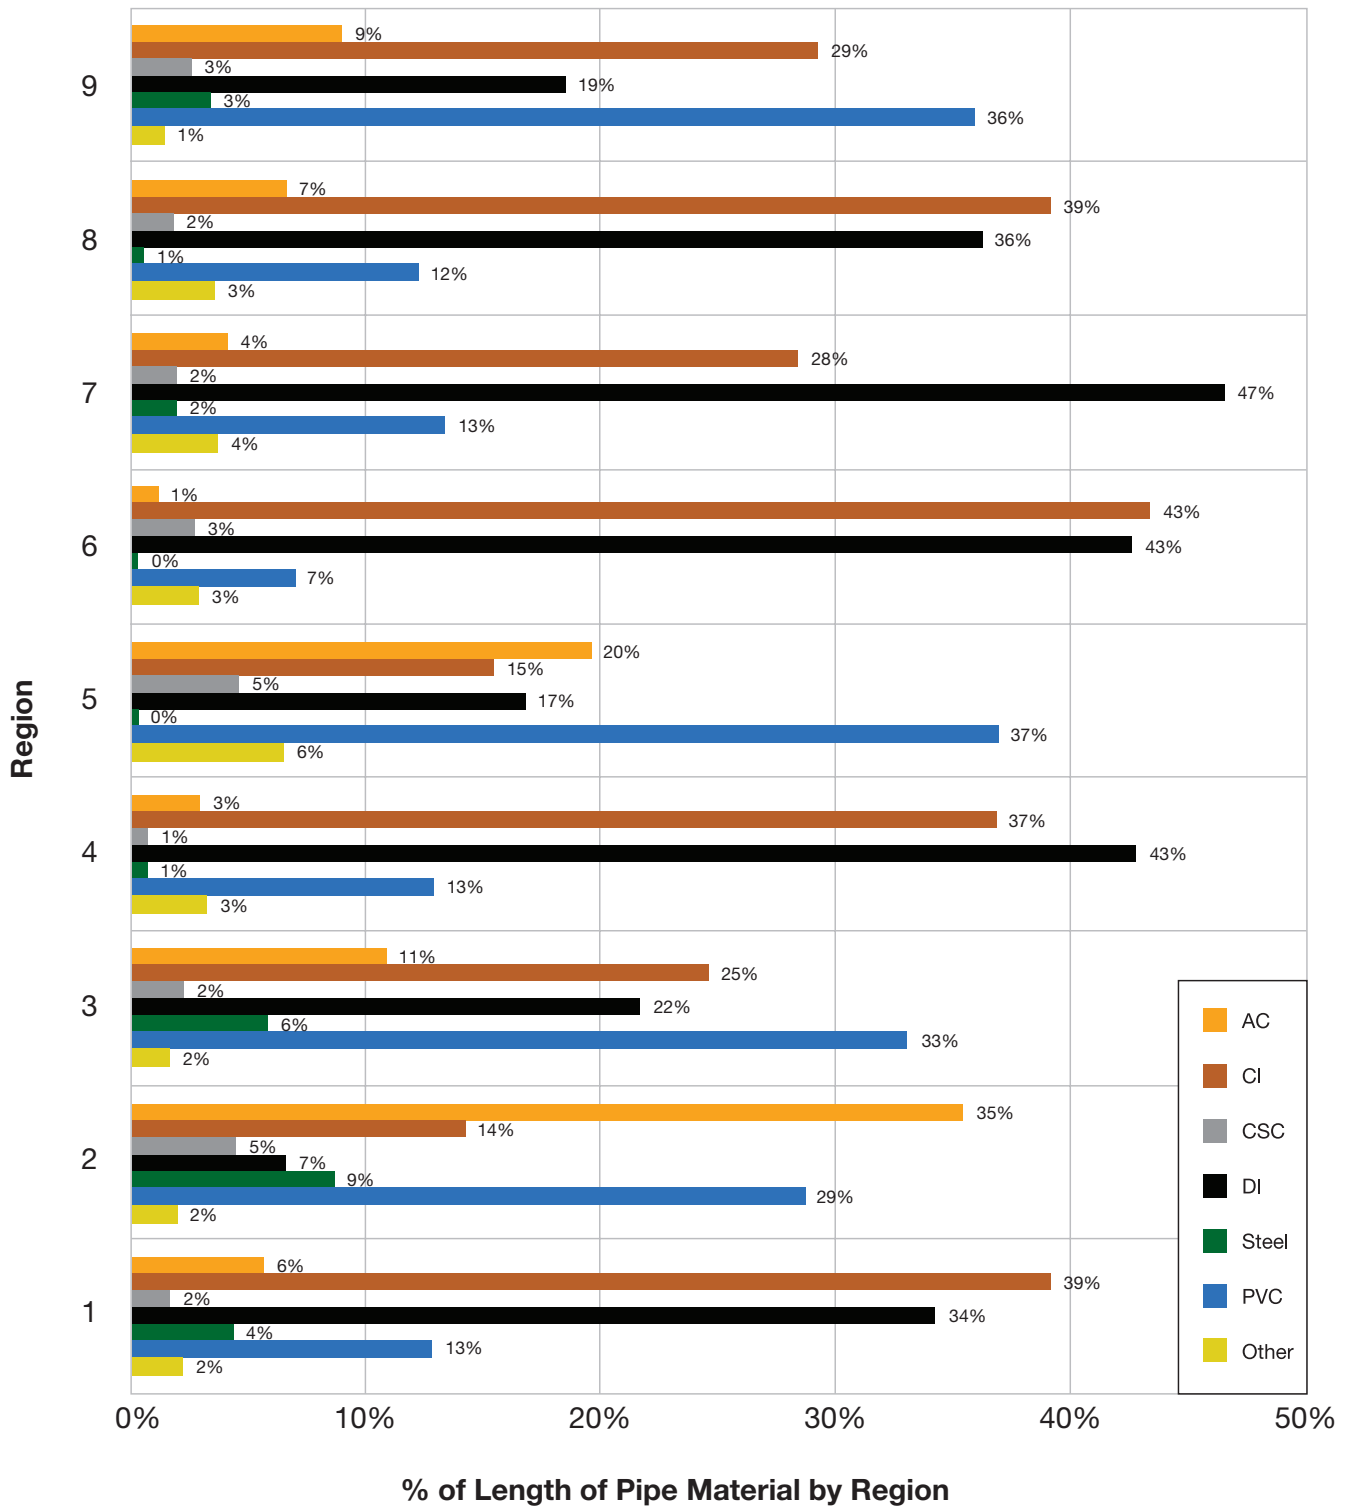
FIGURE 11: REGIONAL PERCENTAGE OF LENGTH OF PIPE BY MATERIAL TYPE (BASIC SURVEY)

Figure 11 illustrates the regional distribution of pipe material usage as a percentage of the total length in that region. It is interesting to note the significant differences in regional pipe material utilization. Cast iron (CI) and ductile iron (DI) pipe represent approximately 86% of the water mains in Region 6 and over 75% in Regions 4, 7, and 8. PVC has a leading role in Regions 3, 5 and 9 and is slightly behind asbestos cement (AC) pipe in Region 2. AC pipe has a significant presence in Regions 2 and 5. Region 2 is unique in that it is the only region where AC pipe is the most common material. This suggests that the selection and use of pipe materials are based on historical preference versus comparative cost analysis or environmental conditions. Since CI and AC pipes are no longer manufactured in the US and Canada, the use of these materials in water systems should be decreasing with time as they are replaced. By applying asset management best practices, life cycle cost analysis should be used to do a comparative total cost of ownership evaluation of what pipe material should replace the CI and AC pipes.

Water main pipe material usage varies significantly over geographic regions (see Figure 11). This suggests that the selection and use of pipe materials are based on historical preference versus comparative cost analysis or environmental conditions. The upper northwest and eastern half of the USA (Regions 1, 4, 6, 7, and 8 as illustrated in Figure 1) have either cast iron or ductile iron pipe for much of the installed pipe length. Regions 3, 5, and 9 have more PVC pipe than any other material. The most common pipe material in Region 2 is asbestos cement and it is unique in that respect.

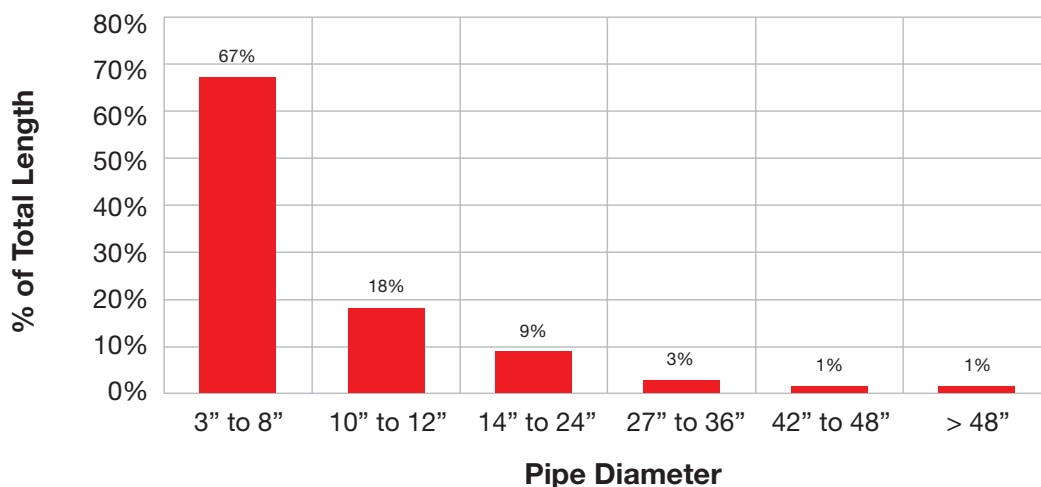
FIGURE 15: PERCENT OF TOTAL LENGTH OF PIPE BY AGE FROM THE DETAILED SURVEY

The detailed survey respondents were also asked to break down the fraction of total installed pipe length by six pipe diameter categories. Figure 15 illustrates the percentage of water main that fit into each size range. Figure 15 indicates that approximately 67% of the installed pipe is 8 inches or less in diameter. The 2012 survey found that 66% of the pipe was 8 inches or less in diameter showing good agreement. Earlier studies assumed 73% of water pipes were 10 inches or less in diameter (Stone et al., 2002). Figure 16 illustrates the diameter distribution for each material type. Figure 16 shows that large diameter transmission pipes are dominated by steel and concrete pipe materials with 18% of all concrete pipe and 14% of all steel pipe having a diameter greater than 48-inches. Figure 17 illustrates the percent of total length of all pipe materials broken down by material type and diameter. Figure 17 illustrates that cast iron pipe from 3 to 8 inches in diameter represents over 19% of the installed pipe.

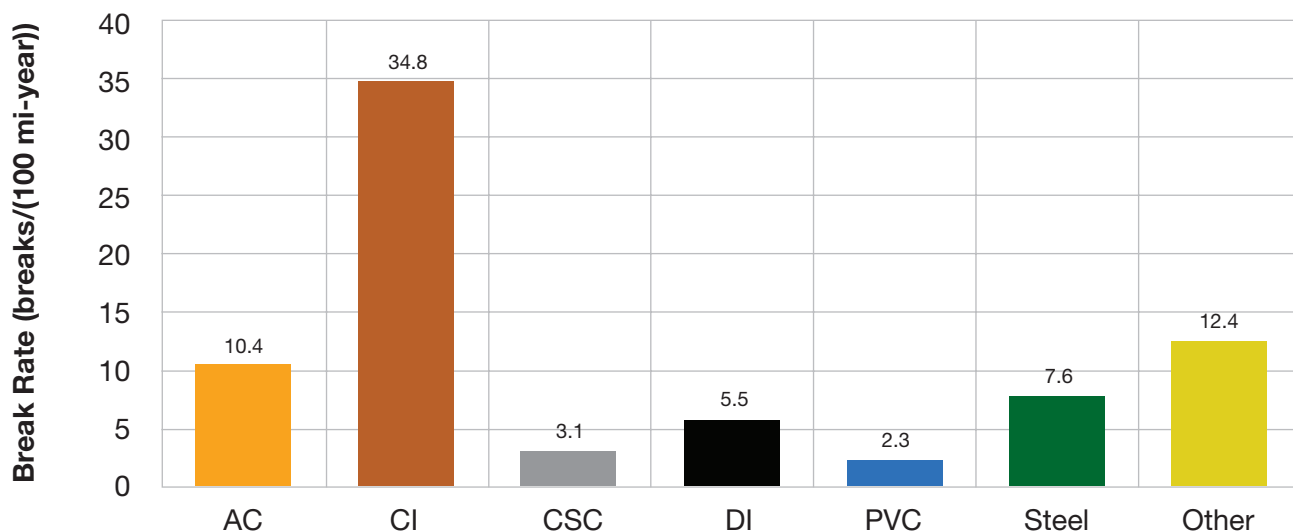
FIGURE 20: BREAK RATES OF EACH PIPE MATERIAL FROM THE BASIC SURVEY

Comparing this 2018 survey with the 2012 survey in Table 5 shows that overall, break rates increased by 27%. The change is primarily due to failures in asbestos cement (AC) and cast iron (CI) pipes with increases of break rates by over 40%. As Figure 14 shows, AC and CI pipe represent the largest percentage of oldest pipe currently installed and thus are nearing the end of their useful lives. Many studies show that water-main failure rates generally increase exponentially over time (Kleiner, 2002). One could envision a rapid increase in break rates in the future as illustrated in Figure 21. Certain utilities could experience the need to rapidly accelerate the rate at which they are replacing CI and AC water mains. If a break rate doubles, the economic impact is significant; one would need to double the number personnel repairing the breaks along with supplies while loss of treated water increases, and societal impacts could be devastating.

When failure rates of cast iron, ductile iron, PVC, concrete, steel, and asbestos cement pipes were compared, PVC had the lowest overall failure rate. This was also the case in the 2012 survey and is confirmed by other industry sources. A lower failure rate contributes to a lower total cost of ownership and helps confirm the performance and longevity of PVC pipes. PVC is not subject to corrosion, unlike ferrous and concrete steel cylinder pipes.

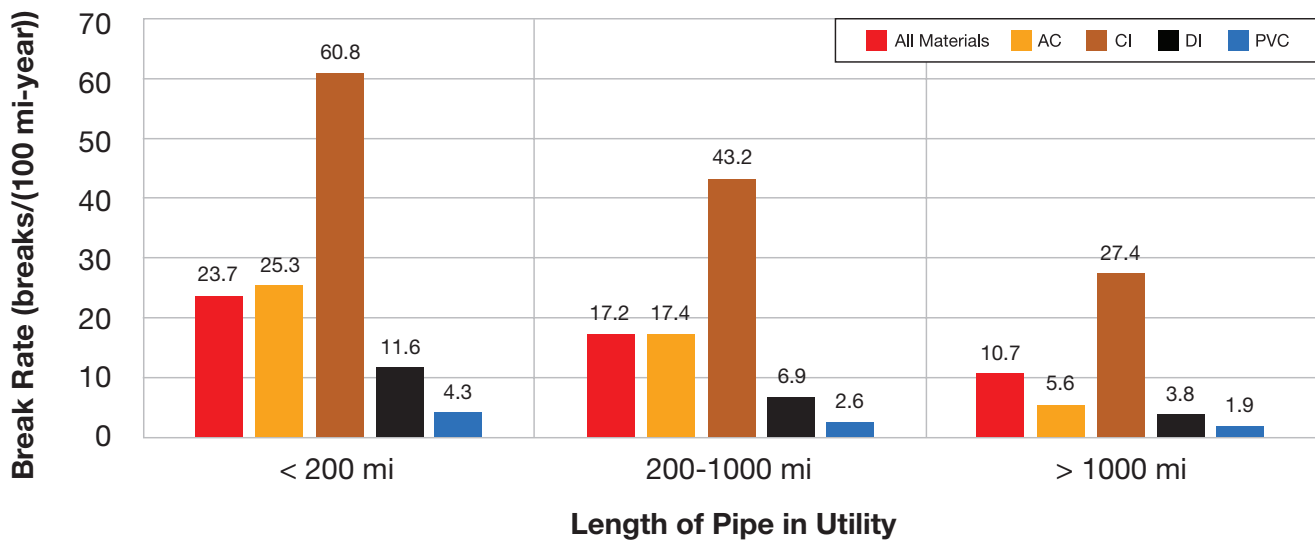
FIGURE 23: BREAK RATES BY UTILITY SIZE FROM THE BASIC SURVEY

The size of a utility can affect break rates. Three sizes of utilities are considered here based on the length of pipe; small with less than 200 miles, intermediate with 200 to 1000 miles, and large with over 1000 miles. Figure 23 illustrates the overall break rate (for all pipe materials) and then separated by the four most common pipe materials in these three utility sizes. The large utilities consistently had lower break rates than intermediate and smaller utilities. This is likely due to better funding and larger staffs for engineering design, monitoring and information gathering, installation oversight, and repair of water mains. It is very significant that small utilities consistently have break rates at least double that of a large utility.

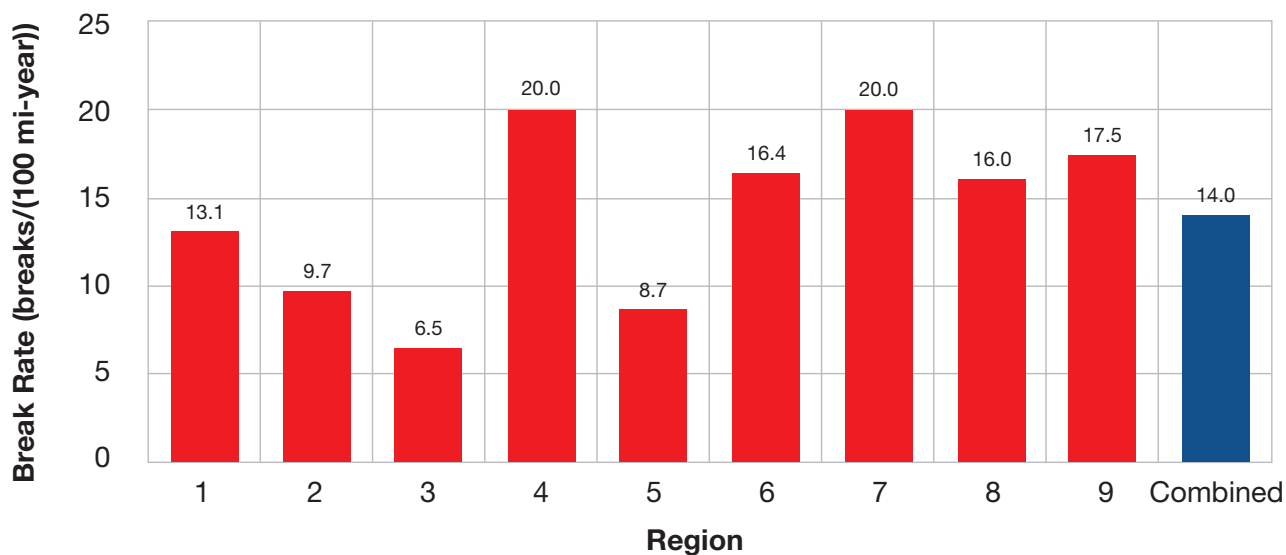
FIGURE 24: OVERALL BREAK RATES BY REGION FROM THE BASIC SURVEY

Figure 24 illustrates the overall break rate broken down by region. Clearly not all regions are experiencing the same failure rate. In Table 1, the number of respondents for each region is reported. It was desired to separate US and Canadian break rate data. This is illustrated in Figure 25. Canada can have very corrosive soils (Seargeant, 2013) and this is reflected in the high break rates of cast and ductile iron pipes in Figure 25. Seargeant reported that the highly corrosive soil in Edmonton necessitated a transition from cast iron to asbestos cement pipes in 1966 and then to PVC starting in 1977. The transition to PVC has produced a dramatic reduction in water main break rates for the city.

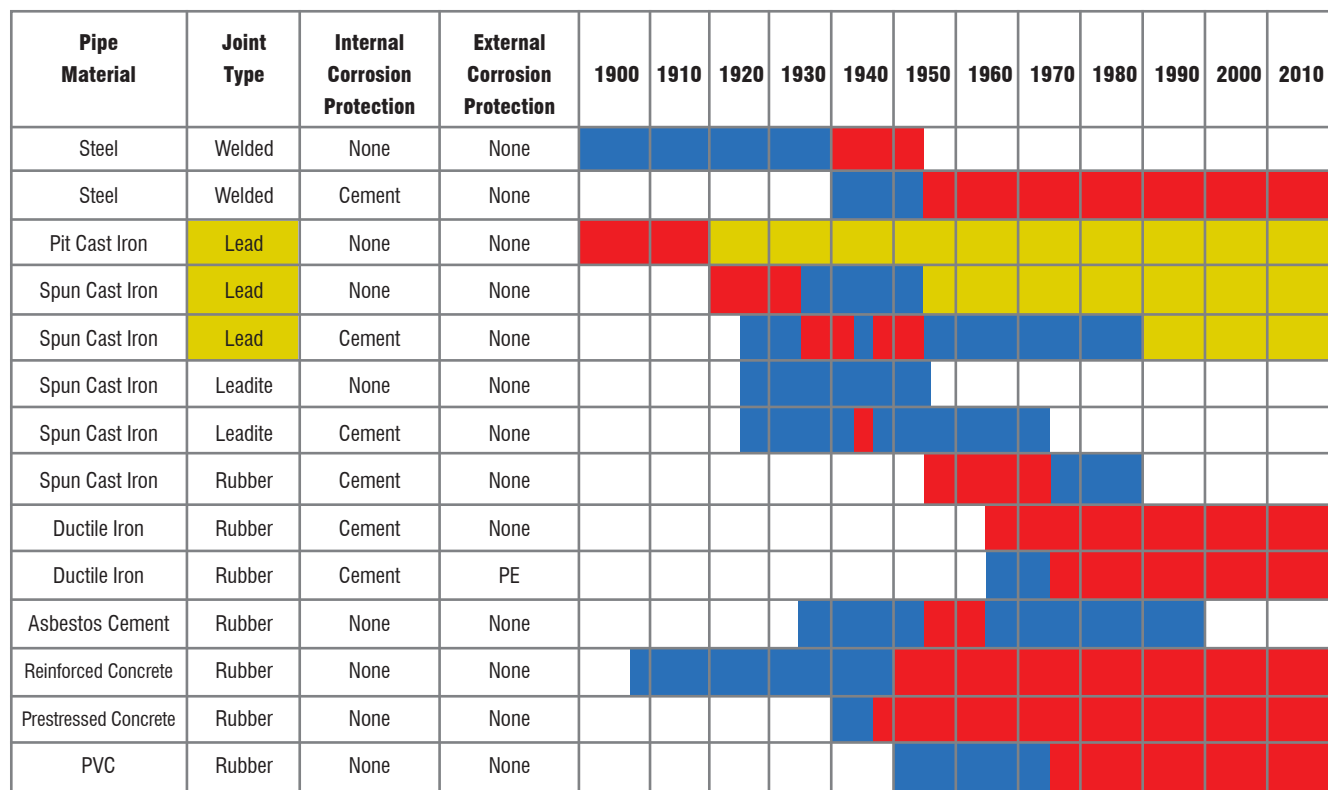
FIGURE 29: TIMELINE OF PIPE TECHNOLOGY IN THE US IN THE 20TH CENTURY

As mentioned in section 3.0, the survey did not track the many subclasses of pipe that have been installed because many utilities do not have that information. Individual utilities should try to add to their database as much as they can about what is referred to as a pipe cohort and other details about their installation. Copeland, et al. (2015) provides a good example of data to record. A pipe cohort is a group of pipes with similar characteristics. This concept is useful in pipe management because defining different pipe cohorts can be helpful in identifying pipes that have different risk characteristics (see Figure 29).

- Pipe Material Availability
- Periods of Active Installation and Widespread Use
- Extended Potential Lead Joint Leaching Periods in Iron Pipes

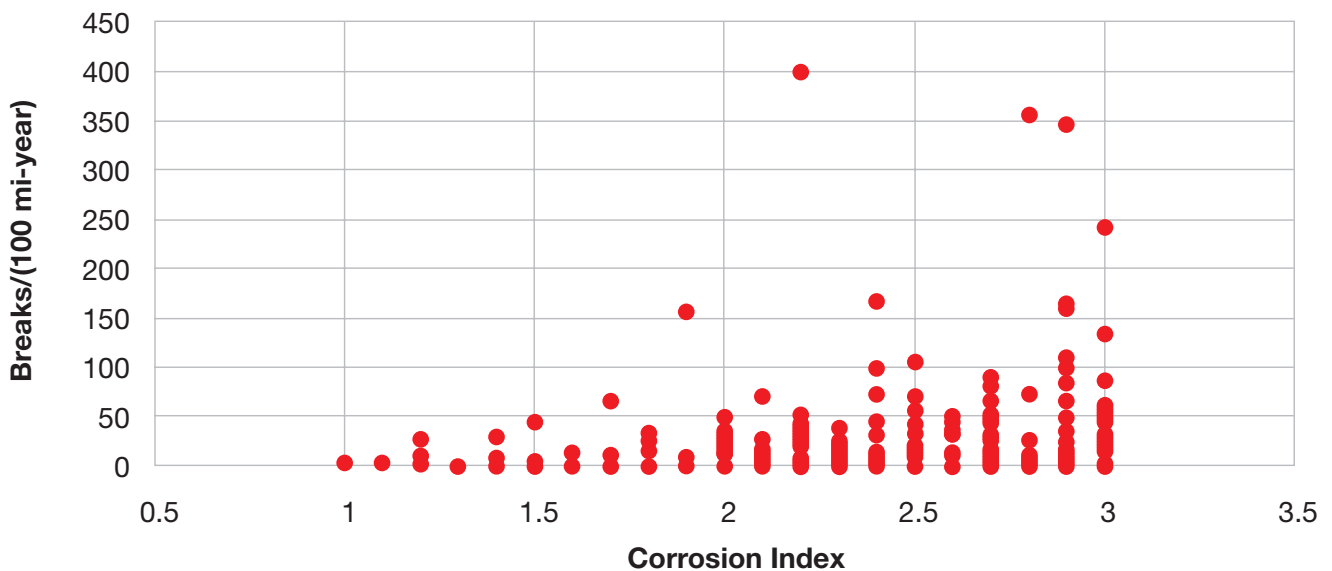
FIGURE 33: INDIVIDUAL UTILITY BREAK RATES FOR CAST IRON PIPE VERSUS THEIR CORROSION INDEX

It is reasonable to expect break rates would increase when pipe is installed in corrosive soils. To examine this, plots were made of a utility's corrosion index versus break rate. Figure 33 illustrates this for cast iron pipe. There is a trend of higher break rates with increasing corrosion index, but the wide scatter in the data makes analysis difficult. The high break rates in Figure 33 are associated with small utilities that have a small amount of pipe. Consider a utility with 1 mile of cast iron pipe with 2 breaks during the past year. That would translate to a break rate of 200 breaks/(100 miles)/year. If that utility had no breaks the following year, the break rates drop to zero.

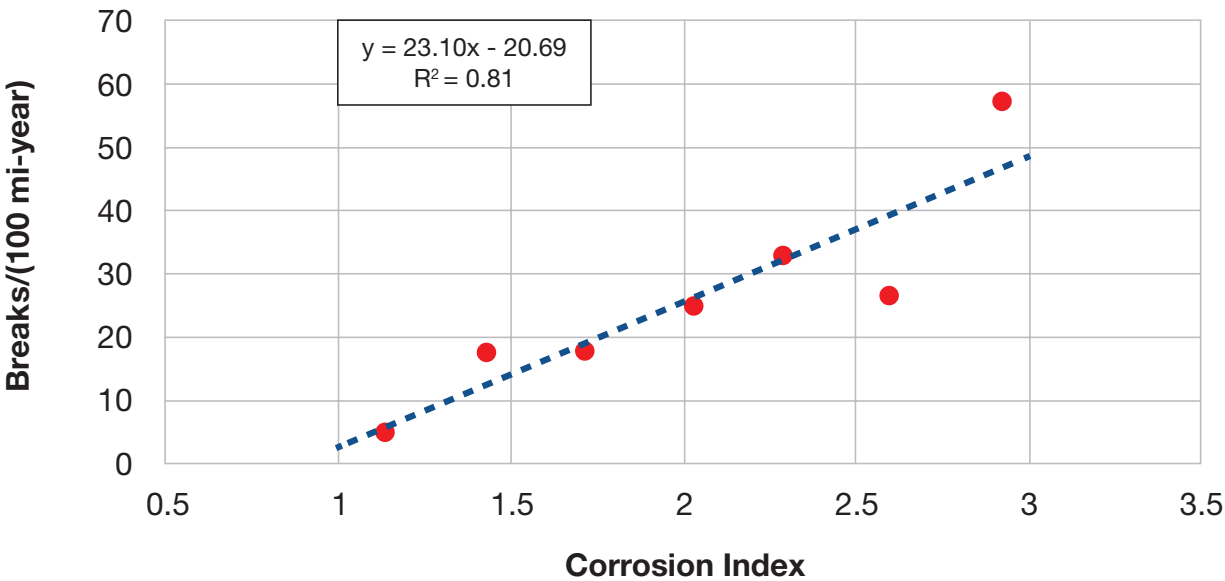
FIGURE 34: CAST IRON PIPE BREAK RATE VERSUS CORROSION INDEX

To get a realistic estimate of break rates, we need to add the number of breaks of a pipe type from several utilities and divide by the sum of the length of that pipe type to compute break rates. The corrosion index data was broken down into the same seven categories used in Figure 32. The results are listed in Table 7. The break rates versus corrosion index data are plotted in Figure 34 for cast iron pipe and Figure 35 for ductile iron pipe. The figures also contain a regression equation fit and a correlation coefficient. Correlation coefficients close to 1.0 indicates an excellent correlation and zero indicate no correlation. Both cast and ductile iron results in reasonably good fits to the data.

Using the equations in Figure 34 with $x=1$ for a low corrosion risk and $x=3$ for a high corrosion risk, one can show that a cast iron pipe in a high corrosion soil is expected to have over 20 times the break rate of one in a low corrosion soil. Similarly, ductile iron pipe in a high corrosion soil has over 10 times the break rate than one in a low corrosion soil. Very poor correlations were found for the other material types in this survey.

12. Cast Iron Pipe Has 20 Times More Breaks in Highly Corrosive Soils Than in Low Corrosive Soils

Analyses of soil corrosivity completed in this study shows that a cast iron (CI) pipe in highly corrosive soil is expected to have over 20 times the break rate of a CI pipe in low corrosive soil. Traditionally, the thickness of the iron pipe wall provided the additional corrosion protection. CI pipes manufactured after World War II have significantly higher failure rates due to thinner walls. The resulting higher main

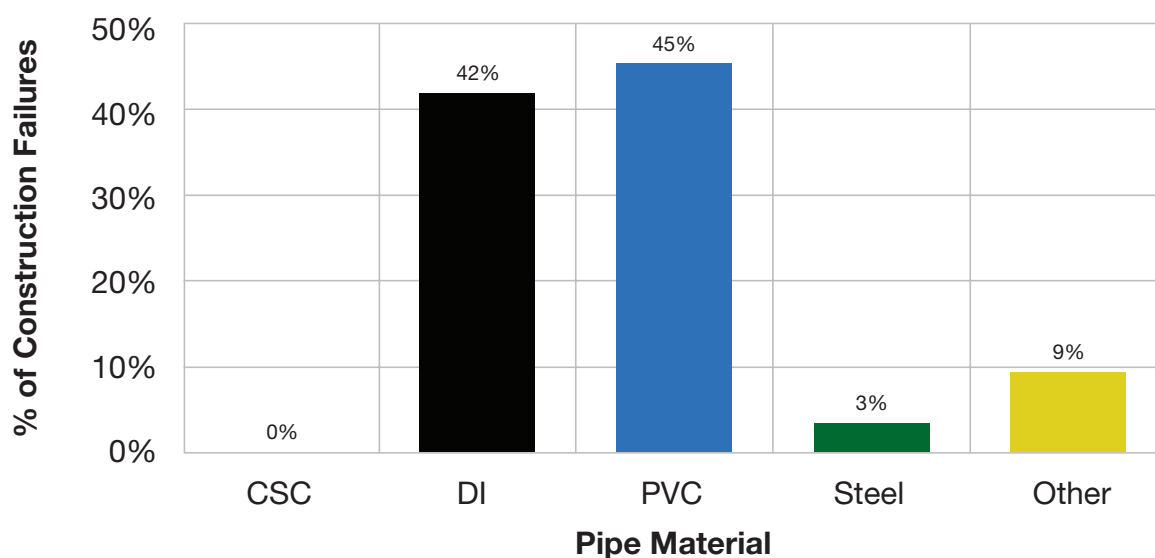
FIGURE 36: PERCENT OF TOTAL REPORTED CONSTRUCTION RELATED FAILURES FROM THE DETAILED SURVEY

The detailed survey asked respondents to report failures related to construction activities. Figure 36 illustrates the percentage of total construction failure related to a particular pipe material. Ductile iron and PVC pipes have the majority of construction related failures at a nearly equal frequency. Figure 14 shows that DI and PVC are the two pipe materials that are also most commonly being installed today. This points to the need to improve construction practices for underground infrastructure regarding installation, location services and inspection.

The detailed survey asked utilities to report the number of failures related to construction activities and identify the pipe material that failed. The vast majority of construction related failures involved either ductile iron (DI) or PVC pipe and the number of failures for each material was essentially identical. Therefore, DI and PVC pipe have an equivalent rate of construction related failures. This points to the need to improve construction practices for underground infrastructure regarding installation, location services and inspection.

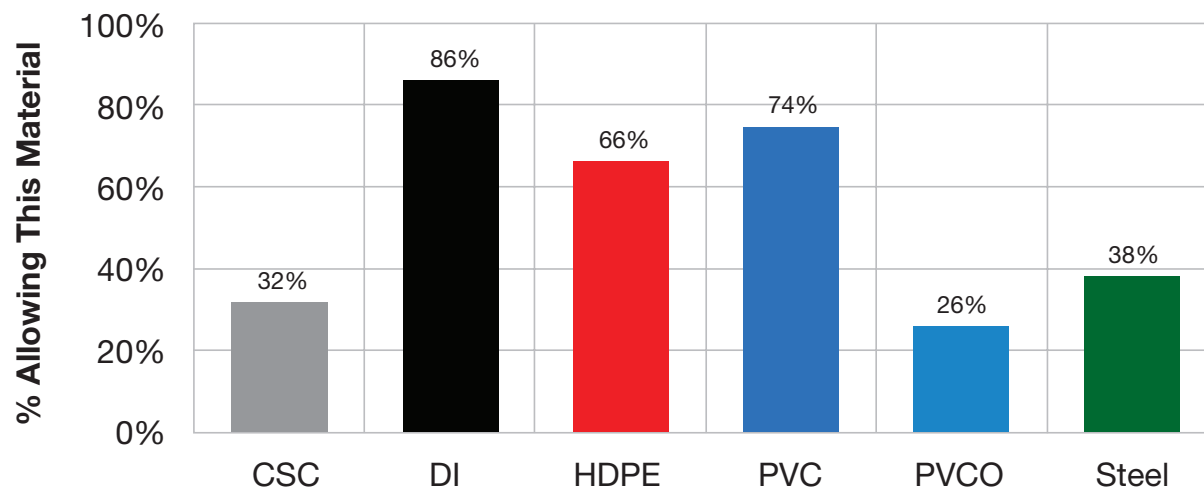
FIGURE 39: RESPONDENTS ALLOWING INSTALLATION OF THESE WATER MAIN MATERIALS

The detailed survey also asked respondents what water main pipe materials are currently approved for use at their utility. Figure 39 illustrates the percentage of respondents that allow a particular pipe material to be installed. HDPE pipe at 66% allowance for use in water systems represents a high degree of acceptance for trenchless applications such as pipe bursting and directional drilling, whereas for open cut installations PVC and ductile iron pipe are the predominantly accepted materials (see Table 10). Figure 40 compares the pipe materials approved for use by utilities in the 2018 survey with the data obtained in the 2012 survey. Figure 40 shows a 23% increase in the acceptance of PVC water pipe by North American utilities since 2012. Specifically, PVC pipe approval among survey respondents increased from 60% of water utilities allowing its use in 2012 to 74% of utilities allowing its use in 2018. The number of utilities approving of ductile iron, concrete steel cylinder, and steel pipes for use in water systems remains essentially the same.
