Indigenous Tree Report

PREPARED FOR RAYMOND MUNRO

PROPERTY LOCATED AT: 910 LAIRD STREET, GLENDALE CA 91206

October 26, 2017

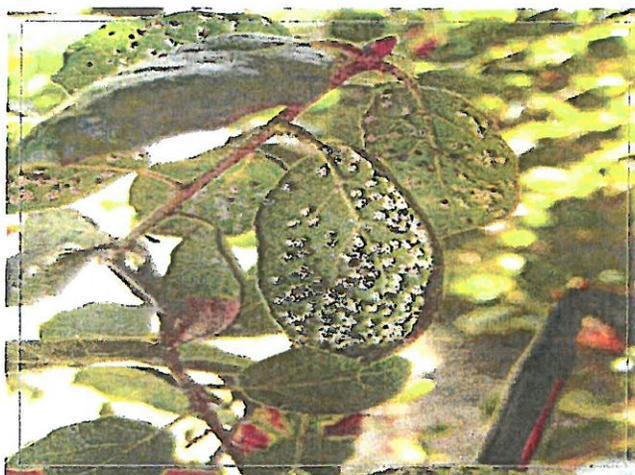
Crown whitefly live on sap. They excrete honeydew that can be sticky or covered with sooty mold. The honeydew can attract ants who discourage predatory insects that might otherwise eat the aphids. These insects are native, naturally occurring and causing only minor aesthetic damage

CROWN WHITEFLY ON COAST LIVE OAK

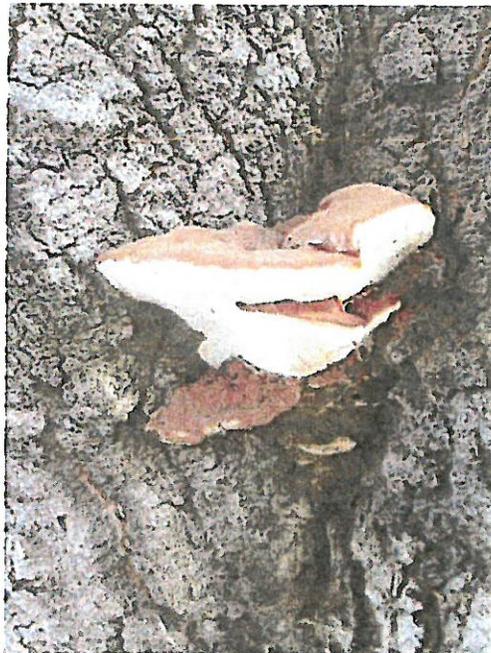
Ganoderma fungus causes a white rot or butt rot of hardwood trees and shrubs. It is common in local oak species. The presence of fruiting bodies usually indicates an advanced level of decay in the wood. The spores can land on open pruning wounds or other damaged plant tissue. Fruiting bodies or conks usually develop near the soil line or in the lower trunk.

GANODERMA CONK IS AN INDICATOR OF HEARTWOOD ROT

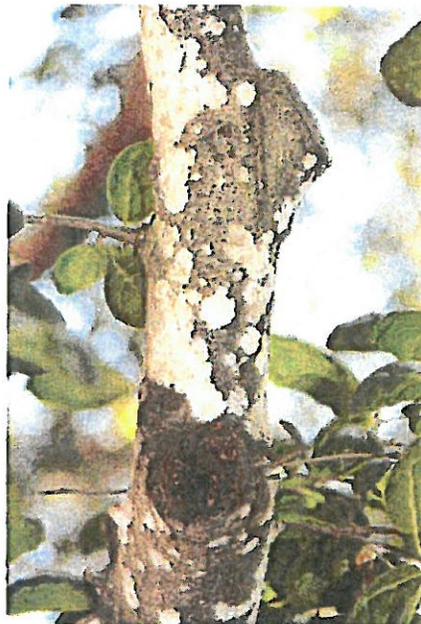
Ehrhorn's scale is a small reddish scale insect that occurs in colonies with the cottony fungus (*Septobasidium canescens*). It manifests itself as gray, pink or white encrustations on the undersides of oak branches. It is my observation that heavy infestations can slow oak growth.

*PHOTO OF EHRHORN'S SCALE TAKEN IN MAY 2014
PHOTO BY REBECCA LATTA

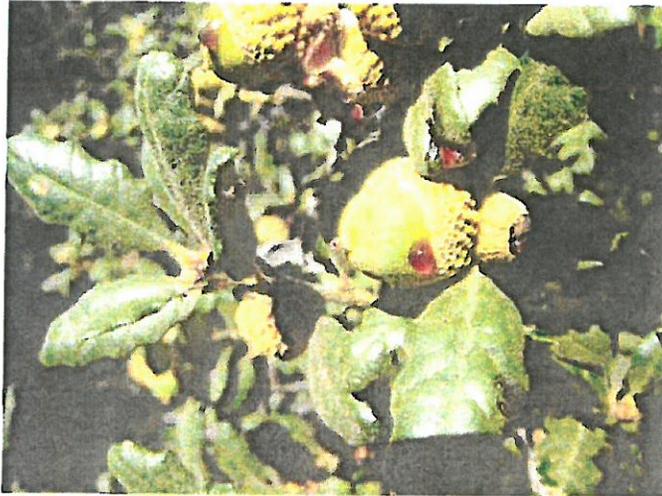
Drippy nut (*Brenneria quercina*) is a disease characterized by dripping, sticky sap oozing from affected acorns and caps. The oozing is caused by a bacterium that enters the acorn when an insect such as a filbert weevil deposits eggs into the acorn. The disease is usually worse in warm weather. Sticky dripping sap can be seen on the ground under the trees.

DRIPPY NUT DISEASE ON SCRUB OAK ABOVE LA CANADA FLINTRIDGE

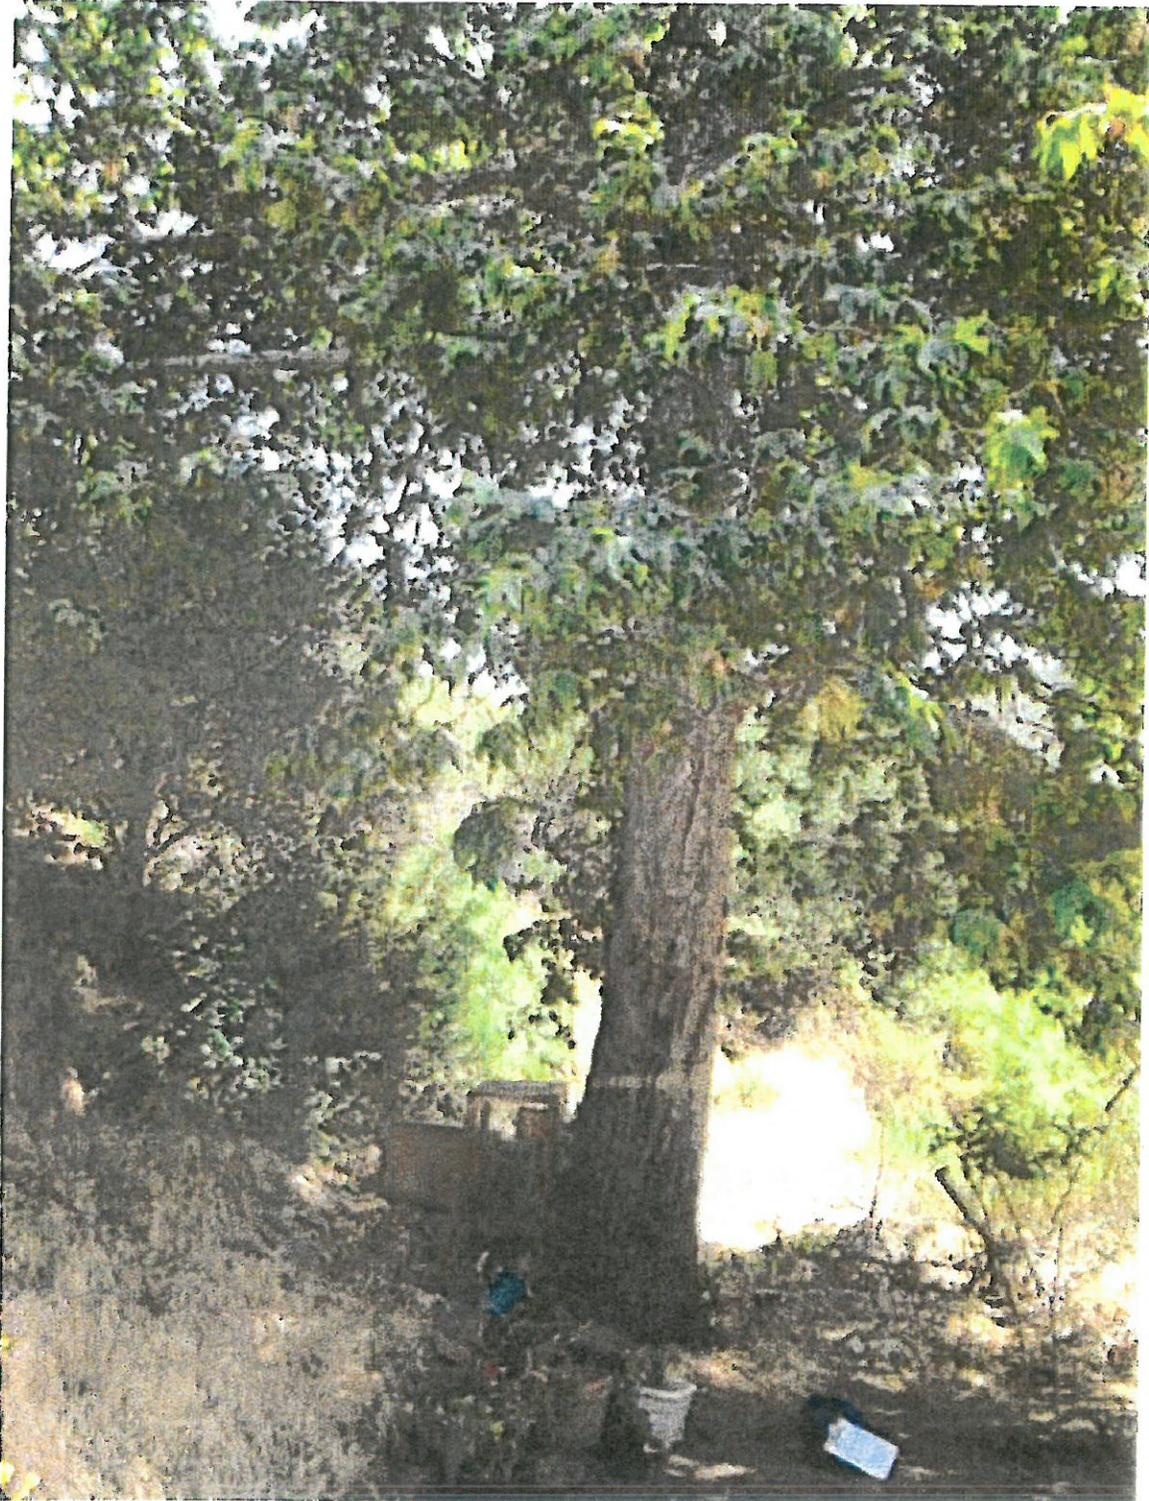
SYCAMORE 1A AT BASE WITH COAST LIVE OAK 1B ON RIGHT

- Sycamore 1a has a long low branch that will interfere with the new structure. I recommend pruning in the winter when the tree is dormant. The canopy impact will be approximately 20-30%. At least 5 feet of clearance may be required near the structure to allow room to work.

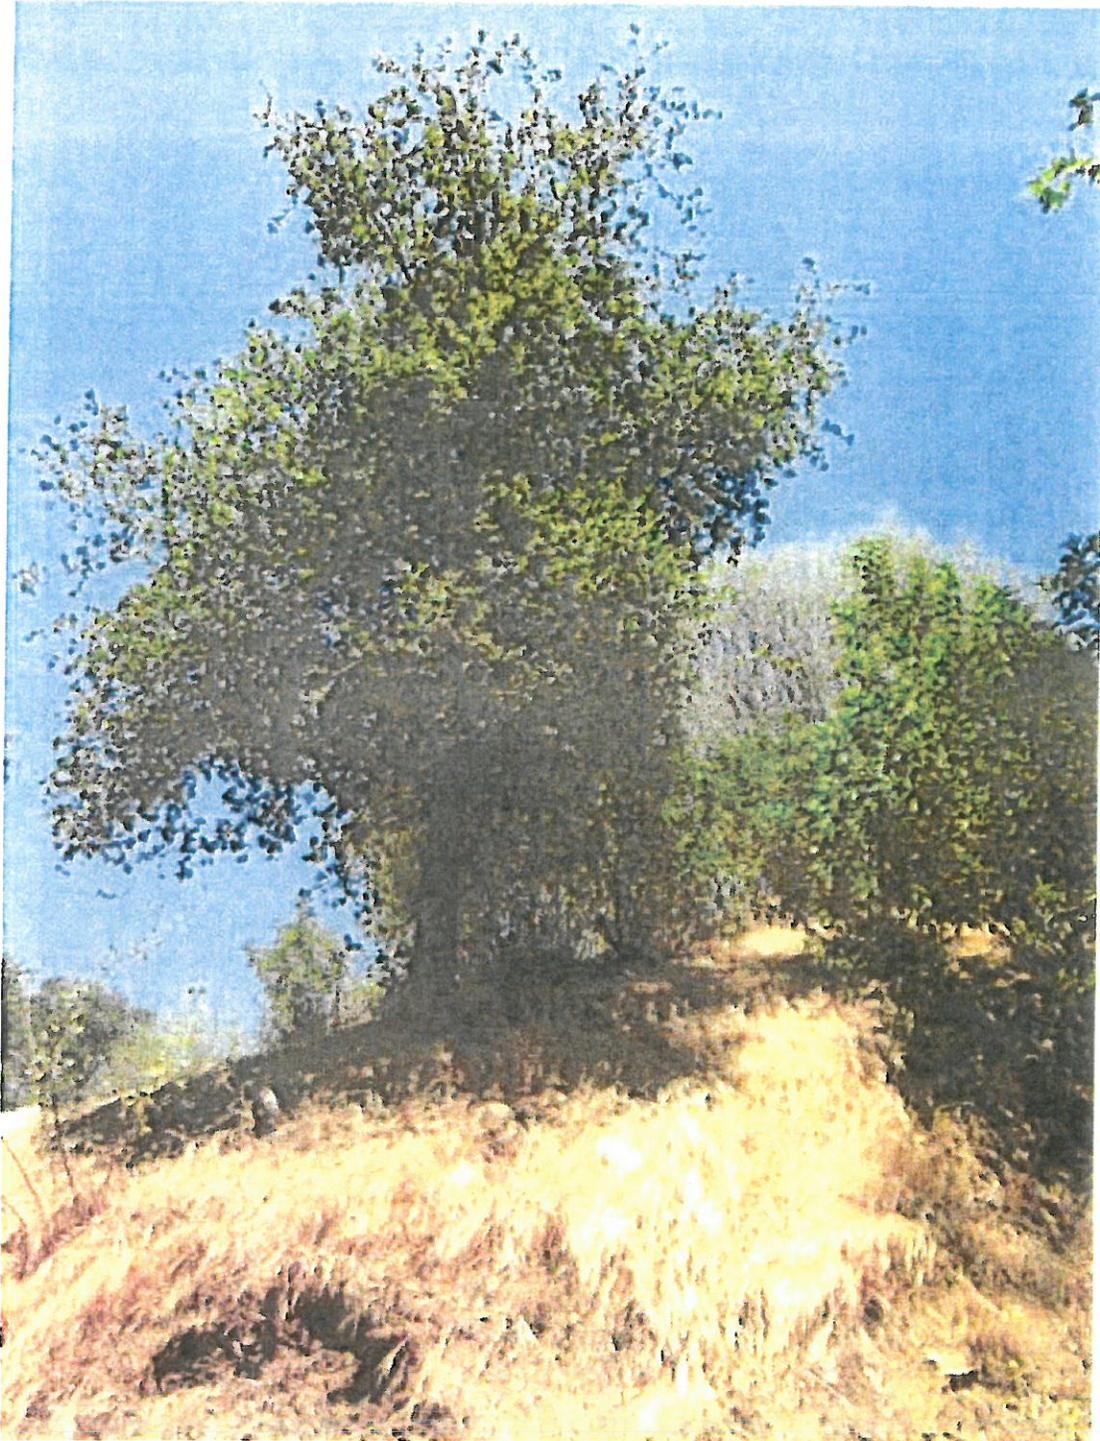
COAST LIVE OAK #2 ON SLOPE

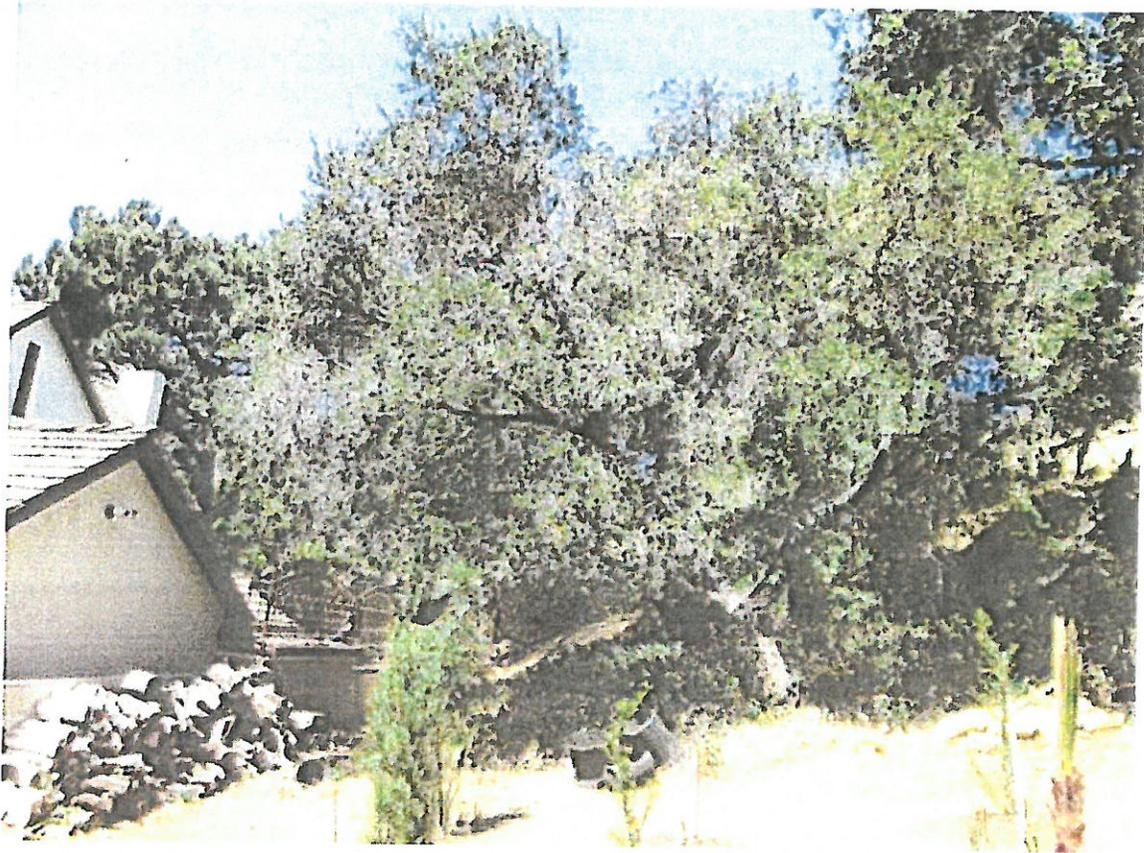
OAK #4 – LOOKING NORTH

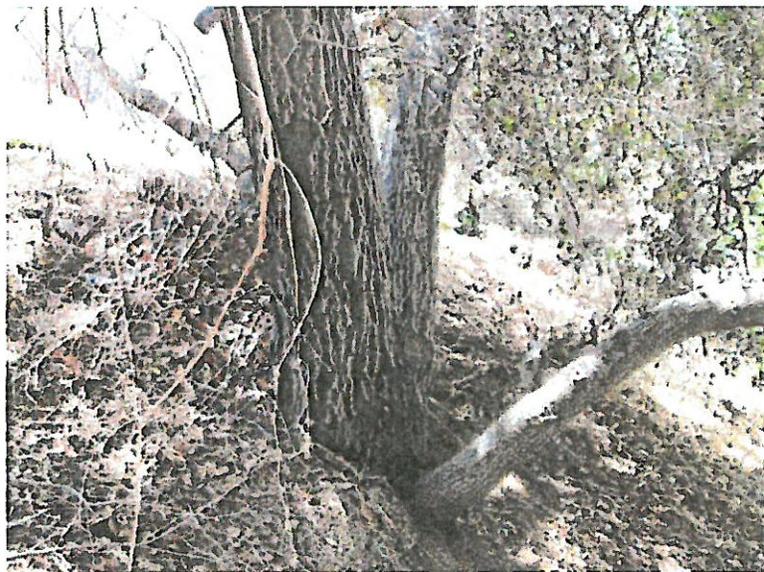
OAK #5 – CLOSEUP OF BASE

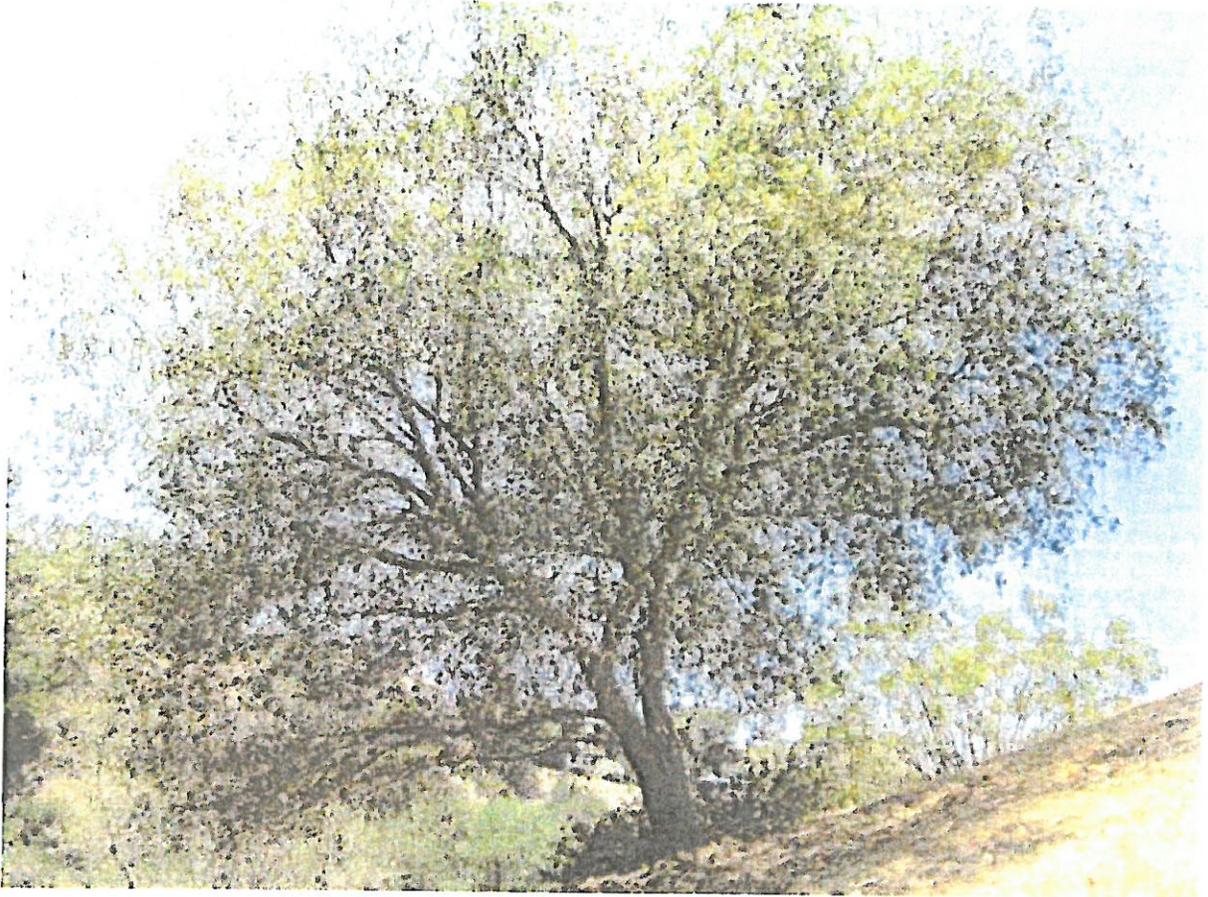
OAK #17 – LOOKING NE
