**PRELIMINARY GEOLOGIC AND GEOTECHNICAL
ENGINEERING INVESTIGATION**

Proposed Single-Family Residence and Swimming Pool

1766 Cielito Drive

Project 200416

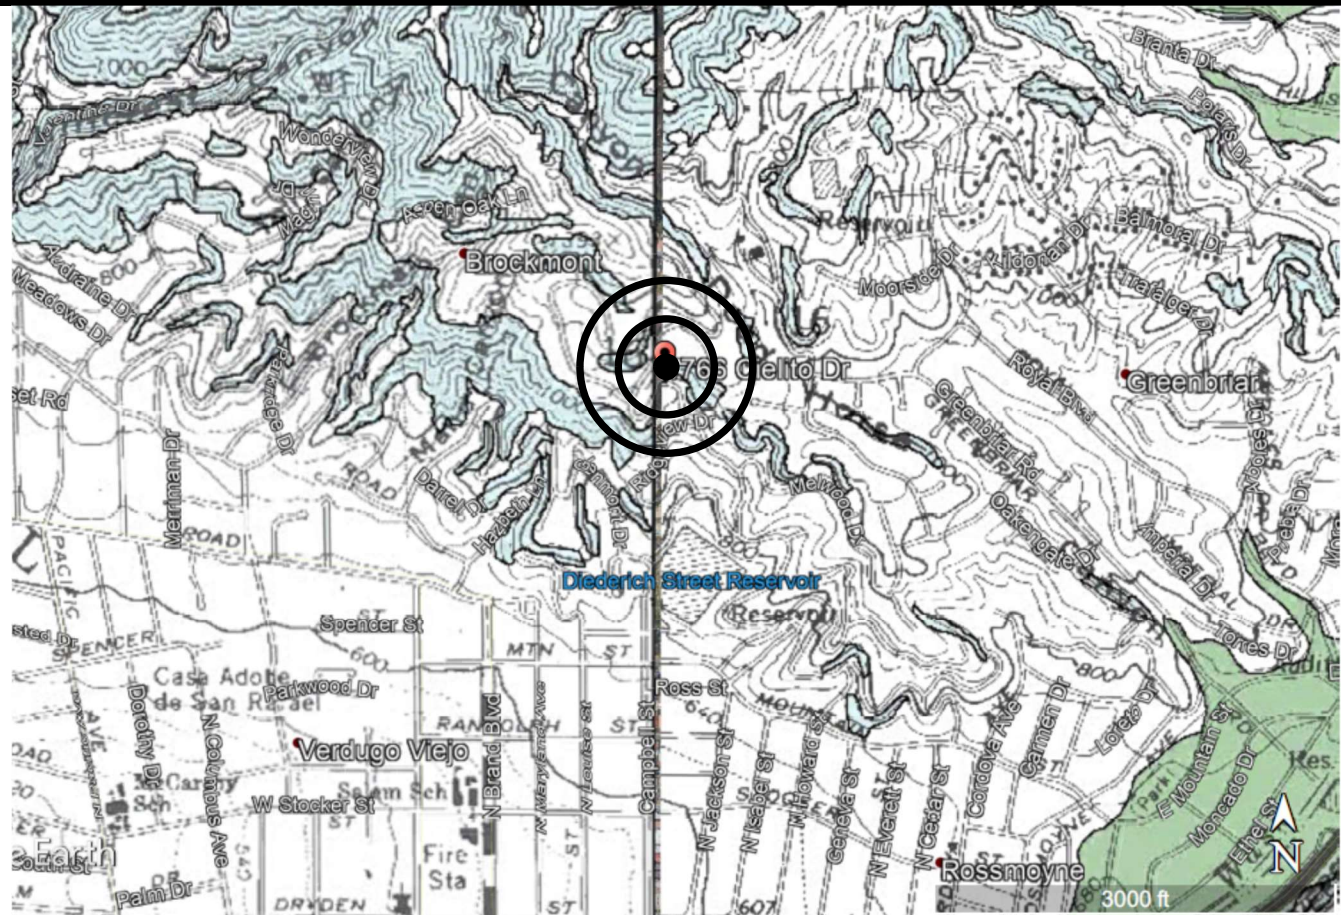
SEISMIC HAZARD MAP

Earthquake-Induced Landslides
Areas where previous occurrence of landslide movement, or local topographic, geological, geotechnical and subsurface water conditions indicate a potential for permanent ground displacements such that mitigation as defined in Public Resources Code Section 2693(c) would be required.

Liquefaction
Areas where historic occurrence of liquefaction, or local geological, geotechnical and groundwater conditions indicate a potential for permanent ground displacements such that mitigation as defined in Public Resources Code Section 2693(c) would be required.

State of California, Seismic Hazard Map of the Burbank & Pasadena
Quadrangle

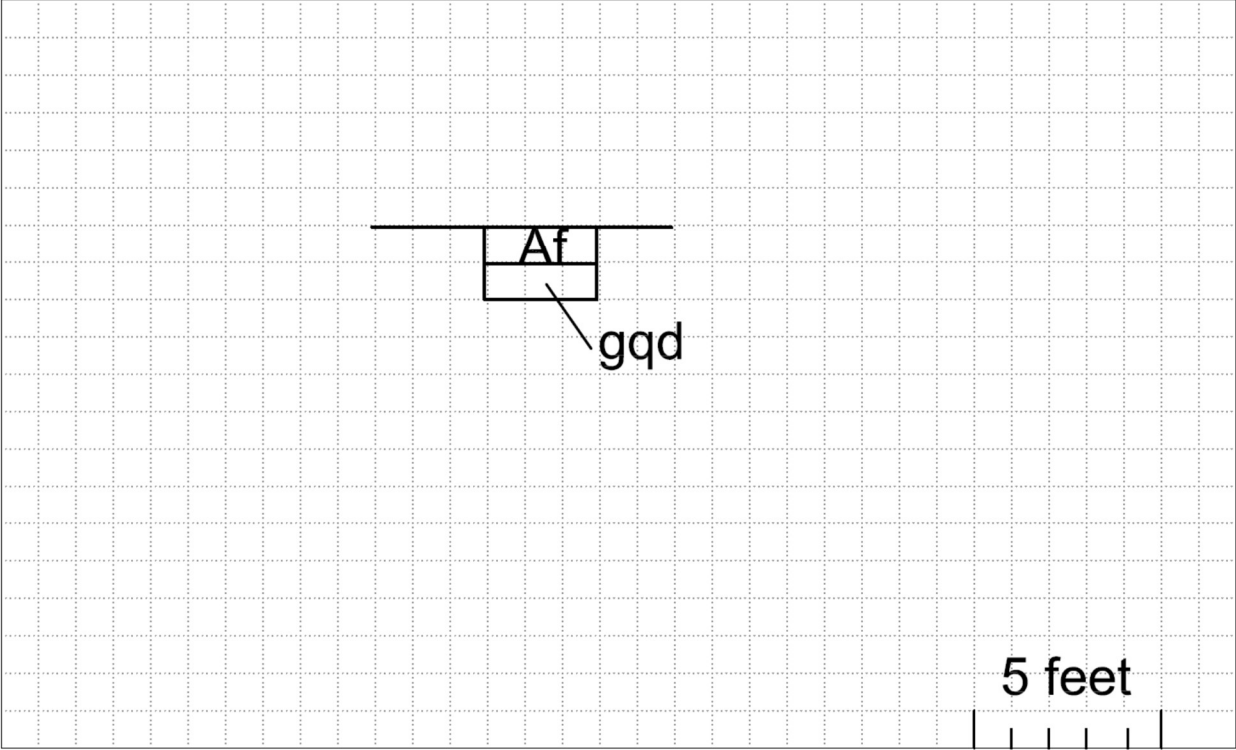
CreativeGeotechnical, Inc. Project #: 200416 Address: 1766 Cielito Drive	Date of Excavation: 04.18.2020 Logger: PRK	Test Pit TP-1
DESCRIPTIONS		Attitudes Bedding: (b) Joint: (j) Shear: (s) Fault: (f)
<p>0 – 1.0' ARTIFICIAL FILL (Af), silty sand, dark yellowish brown, loose</p> <p>1.0' – 2.0' BEDROCK (gqd), granite, dark gray, slightly weathered, very dense</p>		
TOTAL DEPTH: 2.0 ft. NO GROUNDWATER NO CAVING

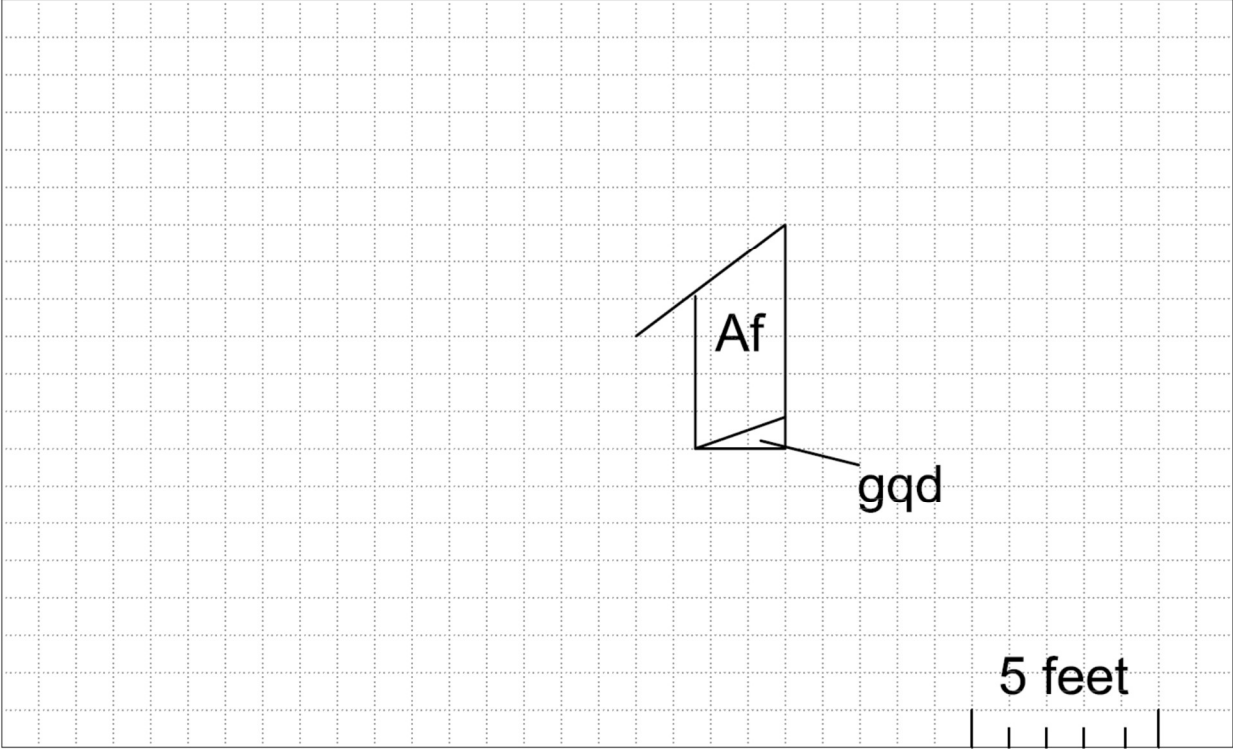
CreativeGeotechnical, Inc. Project #: 200416 Address: 1766 Cielito Drive	Date of Excavation: 04.18.2020 Logger: PRK	Test Pit TP-2
DESCRIPTIONS		Attitudes Bedding: (b) Joint: (j) Shear: (s) Fault: (f)
<p>0 – 5.0' ARTIFICIAL FILL (Af), silty sand with gravels and cobbles, dark yellowish brown, moderately dense, abundant roots, moist</p> <p>5.0' – 6.0' BEDROCK (gqd), granite, white to dark gray, slightly weathered and fractured, very dense</p>		
TOTAL DEPTH: 6.0 ft. NO GROUNDWATER NO CAVING

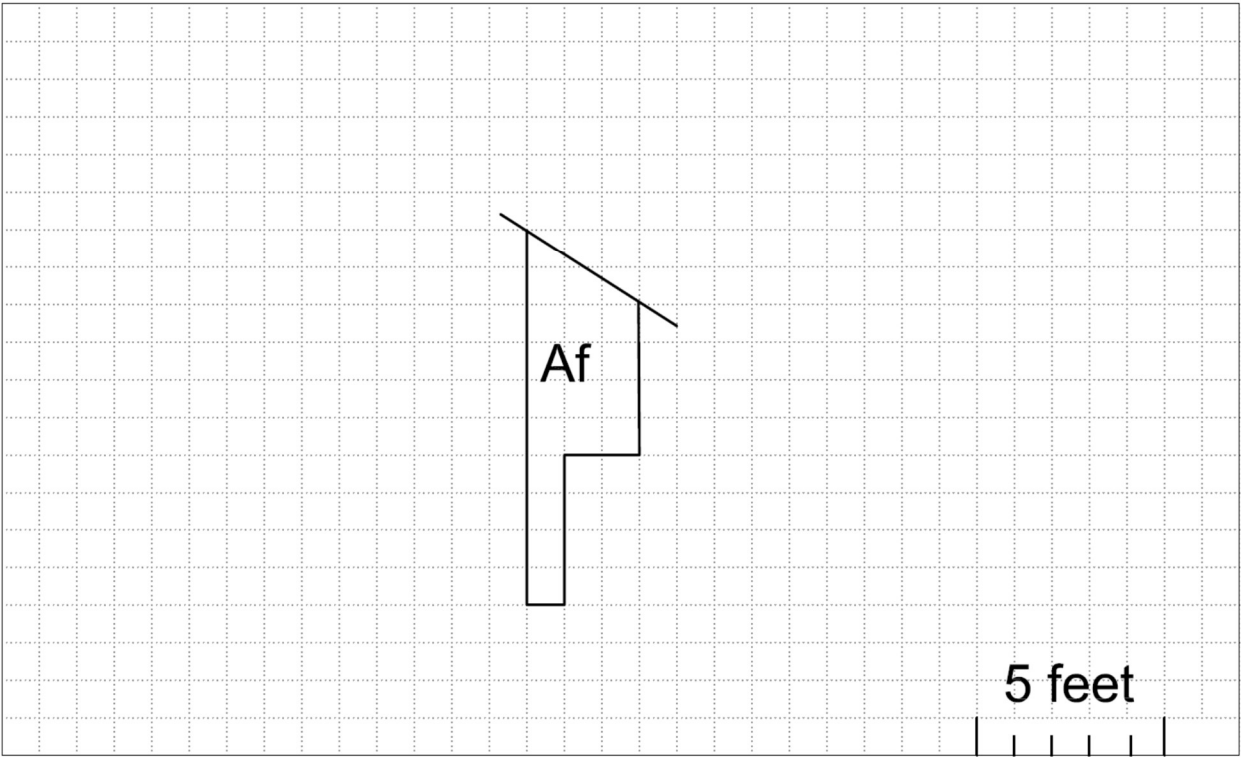
CreativeGeotechnical, Inc. Project #: 200416 Address: 1766 Cielito Drive	Date of Excavation: 04.18.2020 Logger: PRK	Test Pit TP-3
DESCRIPTIONS		Attitudes Bedding: (b) Joint: (j) Shear: (s) Fault: (f)
<p>0 – 10.0' ARTIFICIAL FILL (Af), silty sand with gravels and cobbles, dark yellowish brown, moderately dense, abundant roots, moist</p> <p>@10' Refusal due to gravels</p>		
TOTAL DEPTH: 10.0 ft. NO GROUNDWATER NO CAVING

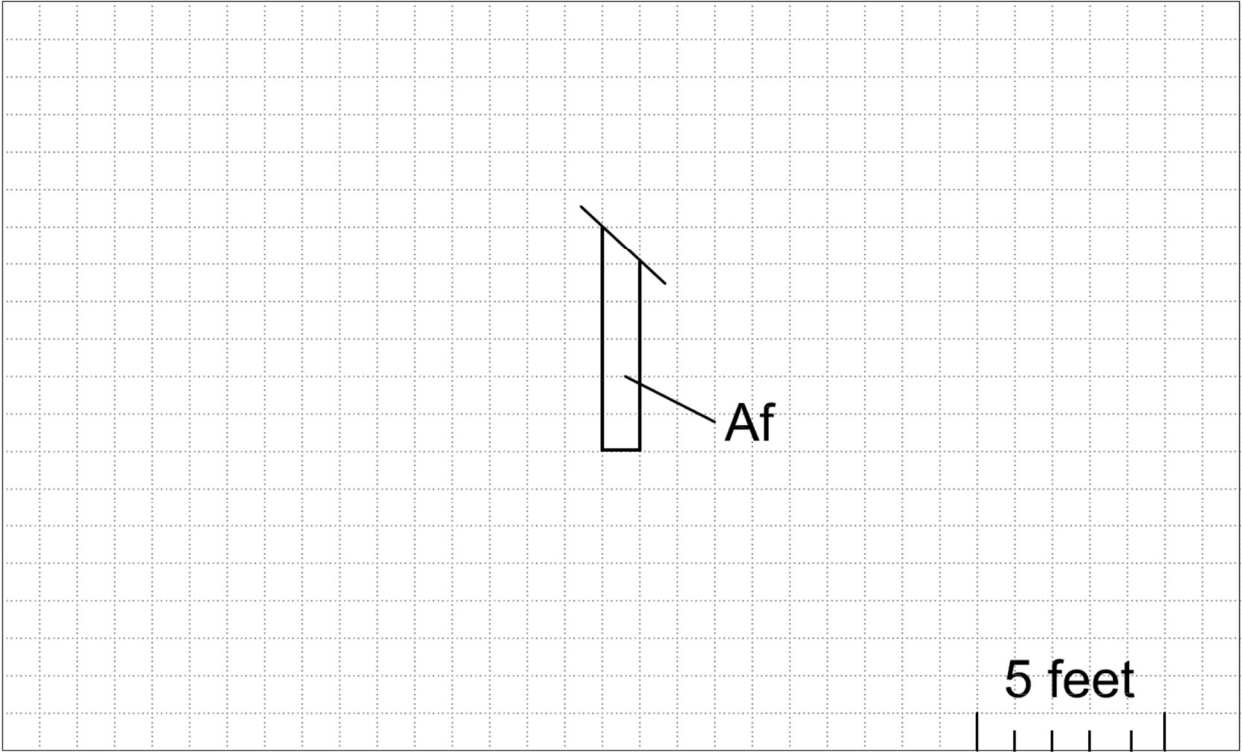
CreativeGeotechnical, Inc. Project #: 200416 Address: 1766 Cielito Drive	Date of Excavation: 04.18.2020 Logger: PRK	Test Pit TP-4
DESCRIPTIONS		Attitudes Bedding: (b) Joint: (j) Shear: (s) Fault: (f)
<p>0 – 6.0' ARTIFICIAL FILL (Af), silty sand with gravels and cobbles, dark yellowish brown, moderately dense, abundant roots, moist</p> <p>@6' Refusal due to gravels</p>		
TOTAL DEPTH: 6.0 ft. NO GROUNDWATER NO CAVING

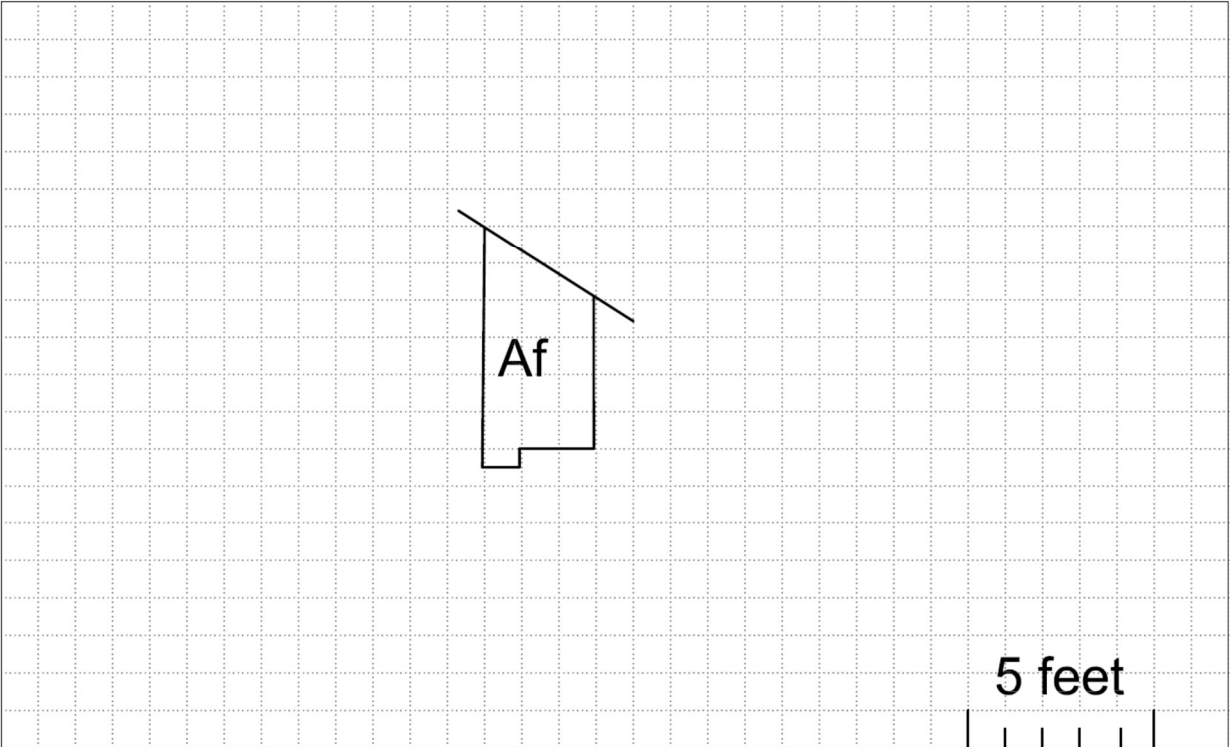
CreativeGeotechnical, Inc. Project #: 200416 Address: 1766 Cielito Drive	Date of Excavation: 04.18.2020 Logger: PRK	Test Pit TP-5
DESCRIPTIONS		Attitudes Bedding: (b) Joint: (j) Shear: (s) Fault: (f)
<p>0 – 6.5' ARTIFICIAL FILL (Af), silty sand with gravels, dark yellowish brown, moderately dense, abundant roots, moist</p> <p>@6.5' Refusal due to gravels</p>		
TOTAL DEPTH: 6.5 ft. NO GROUNDWATER NO CAVING

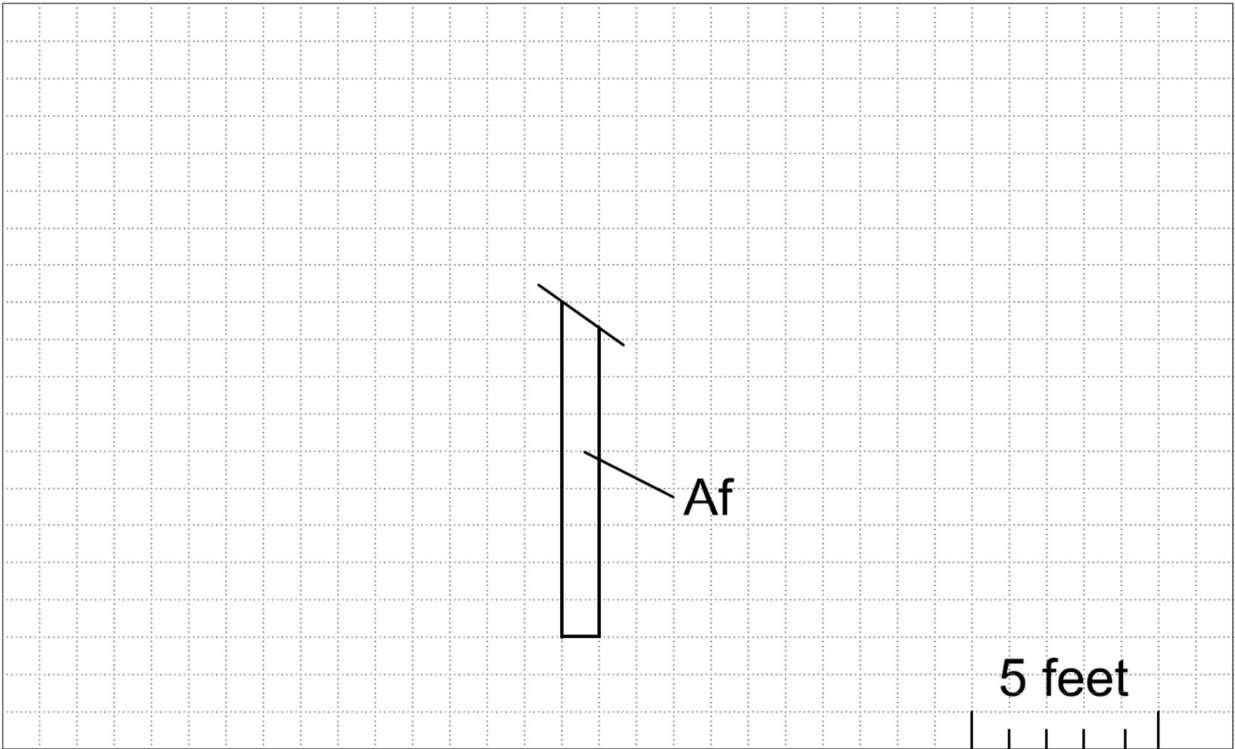
CreativeGeotechnical, Inc. Project #: 200416 Address: 1766 Cielito Drive	Date of Excavation: 04.18.2020 Logger: PRK	Test Pit TP-6
DESCRIPTIONS		Attitudes Bedding: (b) Joint: (j) Shear: (s) Fault: (f)
<p>0 – 9.0' ARTIFICIAL FILL (Af), silty sand with gravels, dark yellowish brown, moderately dense, abundant roots, moist</p> <p>@ 9' Refusal due to gravels</p>		
TOTAL DEPTH: 9.0 ft. NO GROUNDWATER NO CAVING

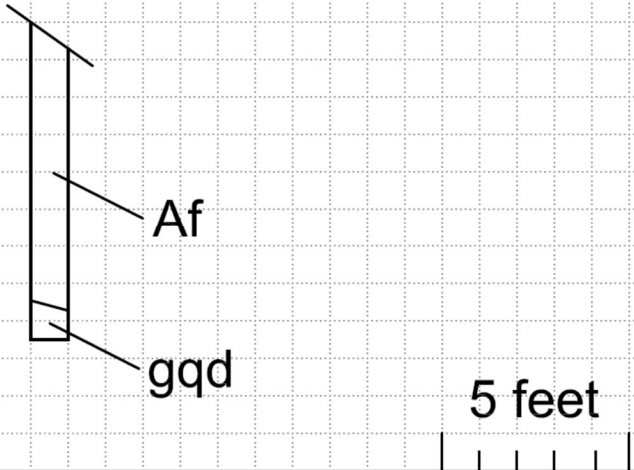
CreativeGeotechnical, Inc. Project #: 200416 Address: 1766 Cielito Drive	Date of Excavation: 04.18.2020 Logger: PRK	Test Pit TP-7
DESCRIPTIONS		Attitudes Bedding: (b) Joint: (j) Shear: (s) Fault: (f)
<p>0 – 5.5' ARTIFICIAL FILL (Af), silty sand with gravels and cobbles, dark yellowish brown, moderately dense, abundant roots, moist</p> <p>5.5' – 6.5' BEDROCK (gqd), granite, white to dark gray, moderately to slightly weathered and fractured, very dense</p>		
TOTAL DEPTH: 6.5 ft. NO GROUNDWATER NO CAVING

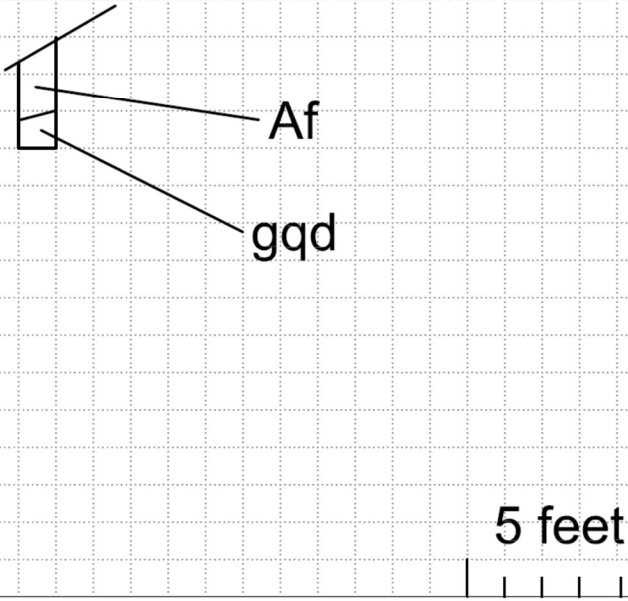
CreativeGeotechnical, Inc. Project #: 200416 Address: 1766 Cielito Drive	Date of Excavation: 04.18.2020 Logger: PRK	Test Pit TP-8
DESCRIPTIONS		Attitudes Bedding: (b) Joint: (j) Shear: (s) Fault: (f)
<p>0 – 2.0' ARTIFICIAL FILL (Af), silty sand, dark yellowish brown, loose</p> <p>2.0' – 3.0' BEDROCK (gqd), granite, white to dark gray, slightly weathered, very dense</p>		
TOTAL DEPTH: 3.0 ft. NO GROUNDWATER NO CAVING

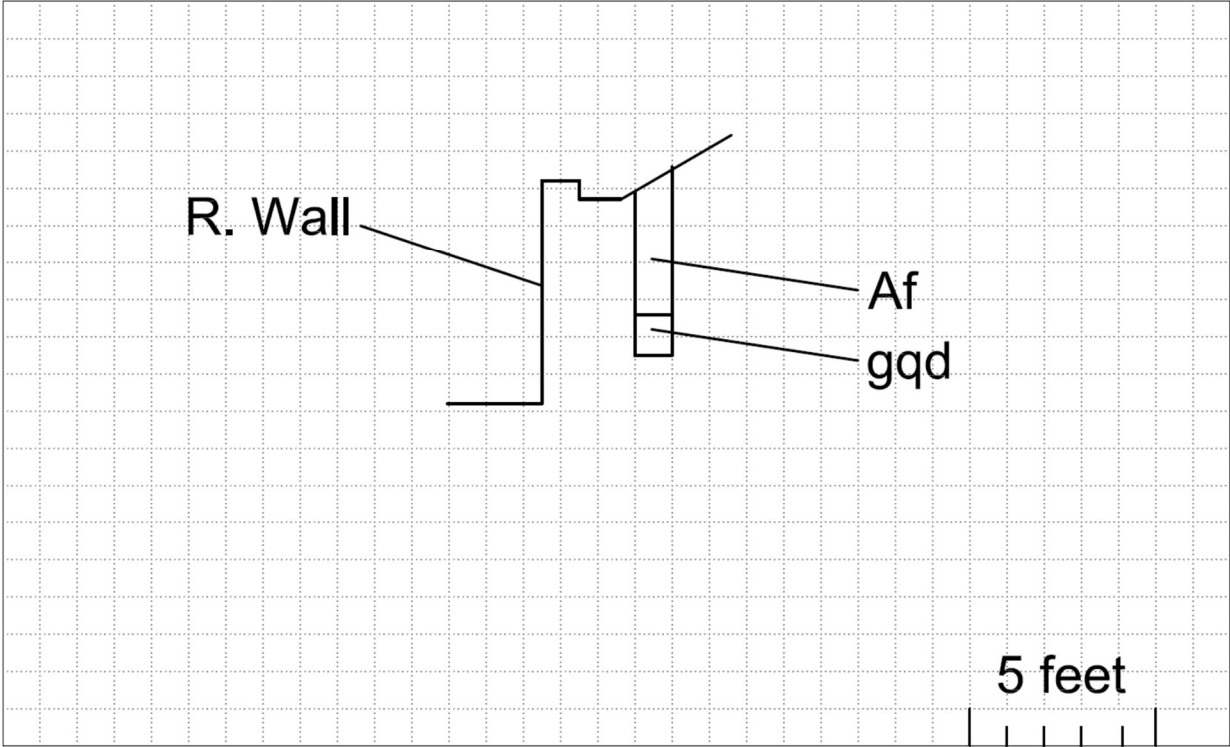
CreativeGeotechnical, Inc. Project #: 200416 Address: 1766 Cielito Drive	Date of Excavation: 04.18.2020 Logger: PRK	Test Pit TP-9
DESCRIPTIONS		Attitudes Bedding: (b) Joint: (j) Shear: (s) Fault: (f)
<p>0 – 4.0' ARTIFICIAL FILL (Af), silty sand with gravels, dark yellowish brown, loose, slightly moist</p> <p>4.0' – 5.0' BEDROCK (gqd), granite, white to dark gray, moderately to slightly weathered, very dense</p>		
TOTAL DEPTH: 5.0 ft. NO GROUNDWATER NO CAVING
